Contract #: 04-0120F4Cty: SF/ALA Rte: 80 PM: 13.2/13.9File #: 69.25B**QUALITY ASSURANCE -- NON-CONFORMANCE REPORT****Location:** Changxing Island, Shanghai, P.R. China**Report No:** NCR-000613**Prime Contractor:** American Bridge/Fluor Enterprises, a JV**Date:** 07-Jan-2010**Submitting Contractor:** Zhenhua Port Machinery Company, Ltd (ZPMC), Changxing Island**NCR #:** ZPMC-0586**Type of problem:**

Reference Description: Base Metal Repair without Engineer approval located at West Tower Lift 4**Description of Non-Conformance:**

PROJECT: San Francisco Oakland Bay SAS Bridge Superstructure
Caltrans Contract No. 04-0120F4
ABF Job No. 660110

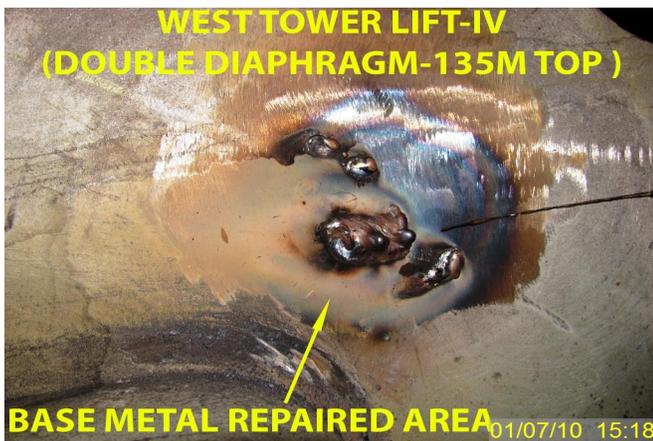
During the Quality Assurance (QA) random in-process visual inspection at inside of West Tower, Lift 4, 135m double diaphragm, top side, CT QA discovered the following issue:

-Base metal repairs being performed in way of temporary attachment removal areas on the top of the double diaphragm skin without the prior approval of the Engineer.

Propose a resolution for the identified non-conformance, documenting that the repaired base metal / welding repair is in compliance with the contract requirements. Documentation provided for the Engineer's review of the acceptability of the weld repair shall at a minimum include the procedure utilized/WRR and the NDT results.

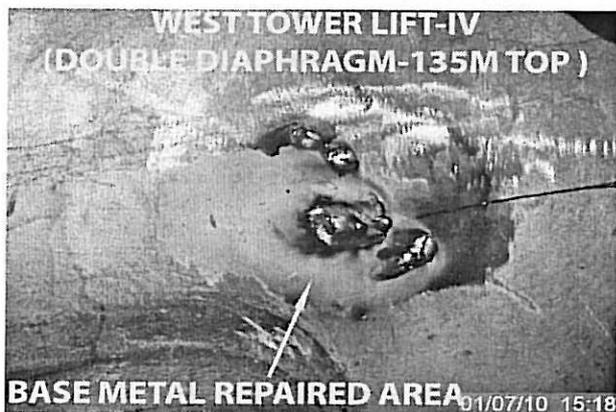
During the Quality Assurance (QA) random in-process visual inspection at inside of West Tower, Lift 4, 135m double diaphragm, top side, CT QA discovered the following issue:

-Base metal repairs being performed in way of temporary attachment removal areas on the top of the double diaphragm skin without the prior approval of the Engineer.

Propose a resolution for the identified non-conformance, documenting that the repaired base metal / welding repair is in compliance with the contract requirements. Documentation provided for the Engineer's review of the acceptability of the weld repair shall at a minimum include the procedure utilized/WRR and the NDT results.

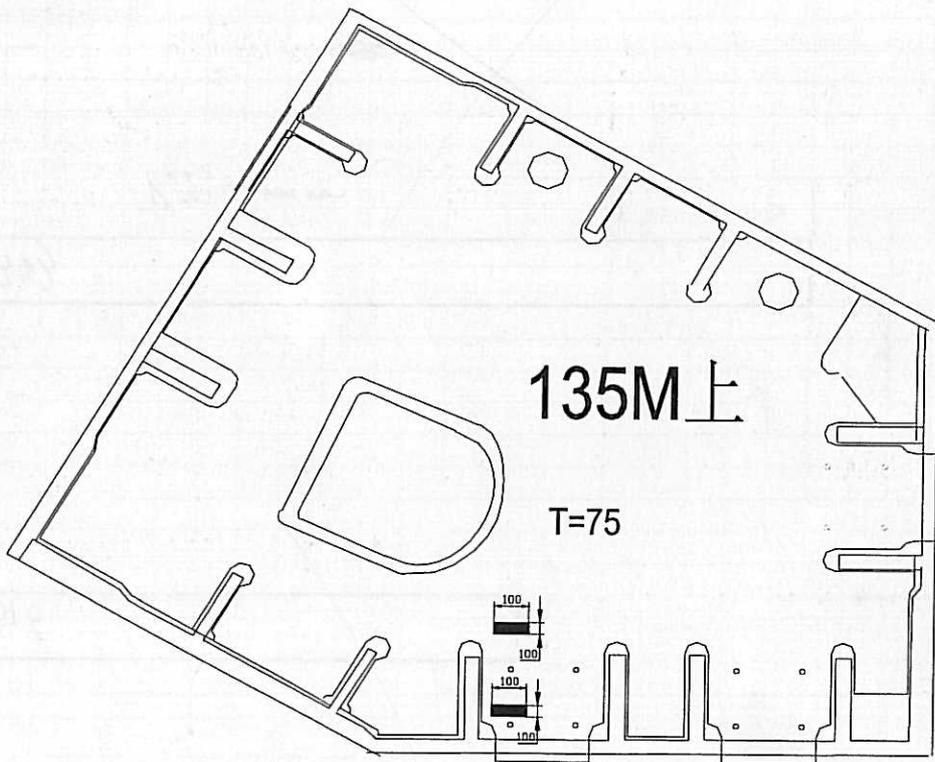
Draft of welding discontinuity:

After welding west tower fourth lifting 135m top diaphragm fit plate, the base metal was gouged after removing temporary attachment, 3mm in depth, 100mm in length, the detail sees the following draft.

注：阴影处为需要补焊区域。Remark: repair area in shadow.

1. Worker operated error caused base metal gouged.

- 1、Grind the building-up area;
- 2、Preheat and weld passes temperature according to the approved WPS, it should be 2-3mm than the theory size;
- 3、Grind the weld area smoothly after repairing;
- 4、Check the welding according to the approved shop drawing.
