QUALITY ASSURANCE -- NON-CONFORMANCE REPORT

Report No: NCR-000614

Welding	Concrete	Other	
Welding	Curing	Procedural	Bridge No: 34-0006
Joint fit-up	Coating	Other	Component: Segment 6AE to 6BE T-Rib Stiffener Weld
Procedural	Procedural	Description:

Reference Description: Welding was performed on Misaligned T-rib Stiffener to T-rib Stiffener splice joint at Segment 6AE/6BE

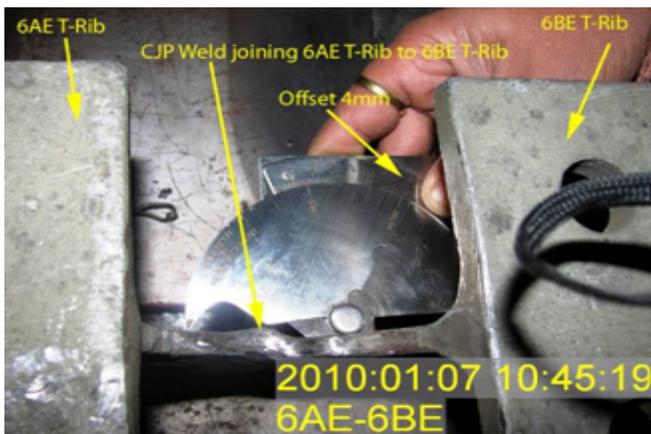
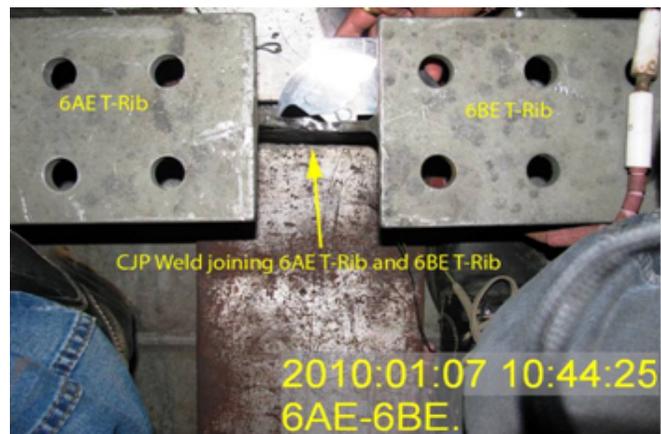
-Three (3) T-Rib web welds between the 6AE to 6BE (transverse splice) were misaligned across the weld joints.

- 1) SP307-001-032 (3rd T-Rib on SP from top-BP side)
- 2) SP334-001-023 (12th T-Rib on SP from top-BP side)
- 3) SP526-002-070 (1st T-Rib on SP from top-CB side)

-These welds are complete joint penetration (CJP) butt weld.

-The out of tolerance offset measurement across the welds were measured at 4mm.

-The maximum out of tolerance allowed per AWS D1.5 2002 is 3mm.

-Special Provisions Section 10-1.59 Steel Structures, Shop Welding G item 2: Misalignment between discontinuous members shall not exceed 10% of the thickness of the thinner member or 3mm, whichever is less.

-AWS D1.5 (02) Section 3.3.3: "Parts to be joined by groove welds shall be carefully aligned. Where the parts are effectively restrained against bending due to eccentricity in alignment, the offset from theoretical alignment shall not exceed 10 percent of the thickness of the thinner part joined, but in no case shall be more than 3 mm (1/8)."

Reference Resolution: ZPMC has cut the misaligned welds out and has realigned them. This correct alignment has been verified by the Department and this item has been removed from the punchlist to verify this.

ZPMC has cut the misaligned welds out and has realigned them. This correct alignment has been verified by the Department and this item has been removed from the punchlist to verify this. ZPMC is providing NDT documentation to show that the welds that were cut and rewelded are acceptable. Based on this ZPMC request closure of this NCR.

ZPMC has cut off these three ribs to rectify the flatness issue. ZPMC is providing NDT records show after rectification these split welds and affected fillet welds were tested acceptable. Please be noticed the weld ID SP526-002-070 was confirmed to be SP527-001-051. After NDT verification this issue has been removed from punchlist by CT's representative. Based on this, ZPMC is requesting this NCR to be closed.

Remove welds to correct alignment issue, reweld and perform NDT required to verify weld quality.

Welds were removed and members were brought within acceptable alignment tolerance. The Contractor submitted NDT documentation verifying new welds as well as welds affected by repair procedures are in conformance with Contract specifications.

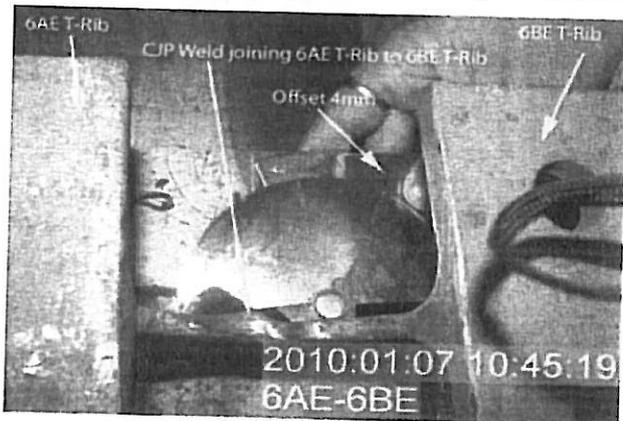
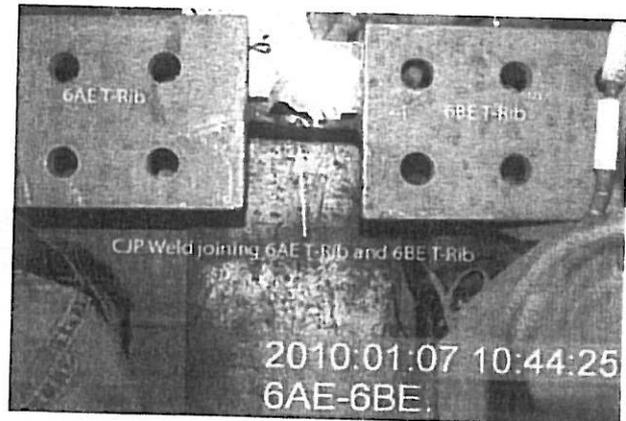
-Three (3) T-Rib web welds between the 6AE to 6BE (transverse splice) were misaligned across the weld joints.

- 1) SP307-001-032 (3rd T-Rib on SP from top-BP side)
- 2) SP334-001-023 (12th T-Rib on SP from top-BP side)
- 3) SP526-002-070 (1st T-Rib on SP from top-CB side)

-These welds are complete joint penetration (CJP) butt weld.

-The out of tolerance offset measurement across the welds were measured at 4mm.

-The maximum out of tolerance allowed per AWS D1.5 2002 is 3mm.

-Special Provisions Section 10-1.59 Steel Structures, Shop Welding G item 2: Misalignment between discontinuous members shall not exceed 10% of the thickness of the thinner member or 3mm, whichever is less.

-AWS D1.5 (02) Section 3.3.3: "Parts to be joined by groove welds shall be carefully aligned. Where the parts are effectively restrained against bending due to eccentricity in alignment, the offset from theoretical alignment shall not exceed 10 percent of the thickness of the thinner part joined, but in no case shall be more than 3 mm (1/8)."
