Contract #: 04-0120F4Cty: SF/ALA Rte: 80 PM: 13.2/13.9File #: 69.25B**QUALITY ASSURANCE -- NON-CONFORMANCE REPORT****Location:** Changxing Island, Shanghai, P.R. China**Report No:** NCR-000616**Prime Contractor:** American Bridge/Fluor Enterprises, a JV**Date:** 09-Jan-2010**Submitting Contractor:** Zhenhua Port Machinery Company, Ltd (ZPMC), Changxing Island**NCR #:** ZPMC-0589**Type of problem:**

Reference Description: Missed MT Indication by QC on 5AE/5BE Side Panel**Description of Non-Conformance:**

Job Name: SAS Superstructure

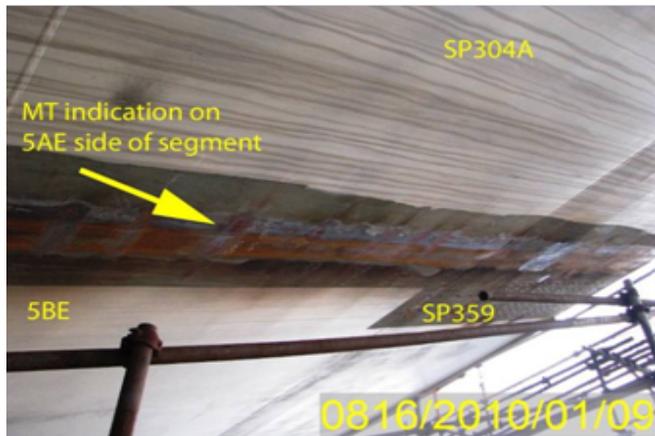
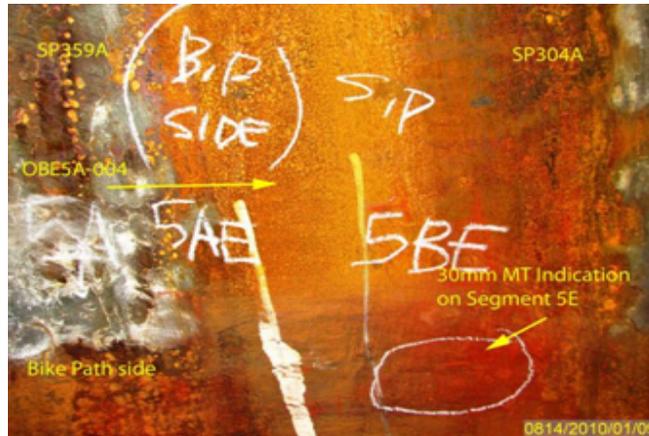
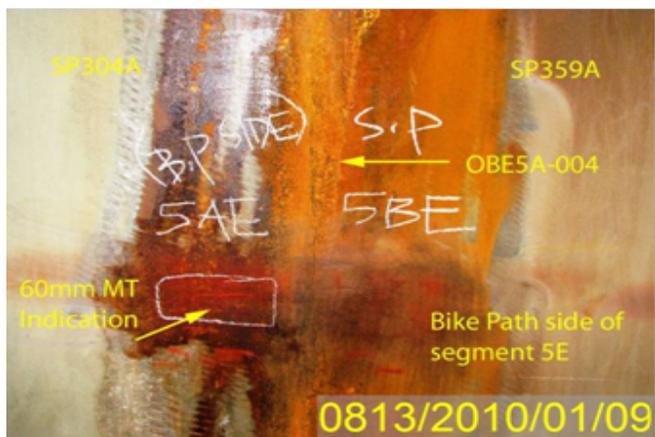
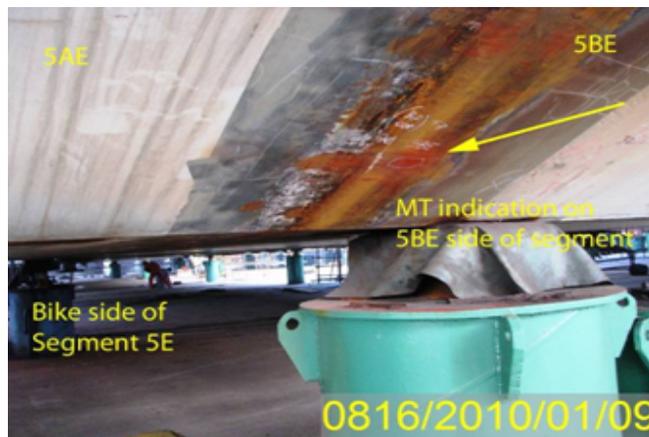
- Two (2) Longitudinal linear indication measuring approximately 60mm and 30mm in length.
- The Notice of Witness Inspection Number (NWIT) is 005023. The indication is located inside the area that has been previously tested and accepted by ZPMC Quality Control (QC) personnel. According to the contract documents ZPMC Quality Control (QC) is required to perform 100% MT of temporary attachment removal areas.

- The indications were found at temporary attachment removal areas on two (2) side panels.
- The Side Panel on 5AE is identified as: SP304A
- The Side Panel on 5BE is identified as: SP359A

- Length and Y location of the MT indication on SP304A (5AE) is as followed: 60mm in length and 1800mm off corner assembly weld splice on the bike path side of segment.

- Length and Y location of the MT indication on SP359A (5BE) is as followed: 30mm in length and 5555mm off corner assembly weld splice on the bike path side of segment.

- The CJP splice weld # is designated as OBE5A-004.

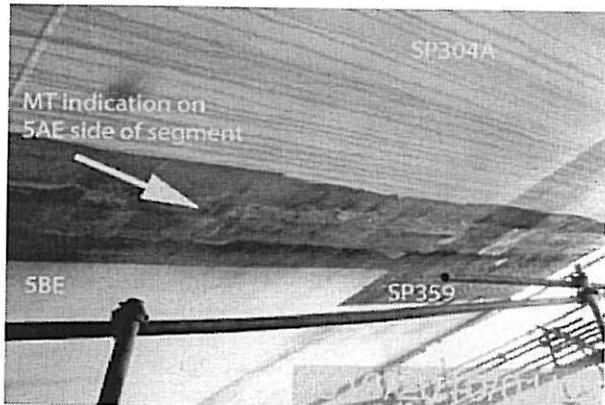
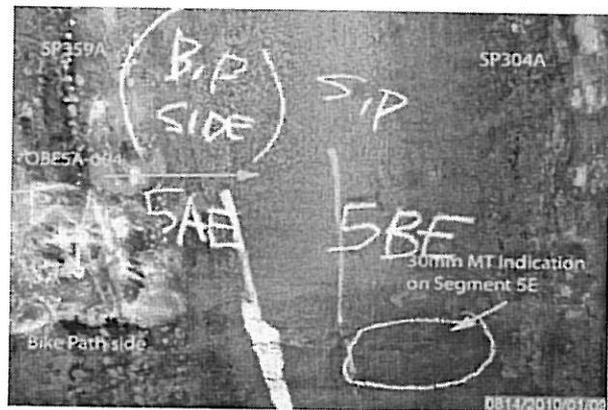
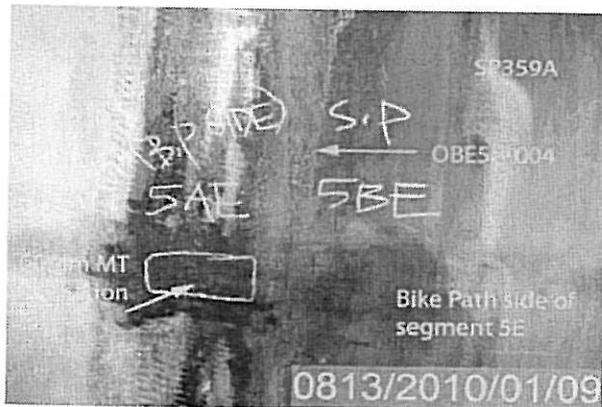
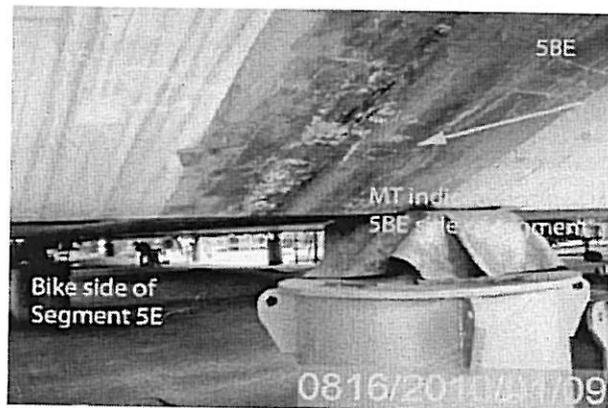
- Two (2) Longitudinal linear indication measuring approximately 60mm and 30mm in length.
- The Notice of Witness Inspection Number (NWIT) is 005023. The indication is located inside the area that has been previously tested and accepted by ZPMC Quality Control (QC) personnel. According to the contract documents ZPMC Quality Control (QC) is required to perform 100% MT of temporary attachment removal areas.

- The indications were found at temporary attachment removal areas on two (2) side panels.
- The Side Panel on 5AE is identified as: SP304A
- The Side Panel on 5BE is identified as: SP359A

- Length and Y location of the MT indication on SP304A (5AE) is as followed: 60mm in length and 1800mm off corner assembly weld splice on the bike path side of segment.

- Length and Y location of the MT indication on SP359A (5BE) is as followed: 30mm in length and 5555mm off corner assembly weld splice on the bike path side of segment.

- The CJP splice weld # is designated as OBE5A-004.

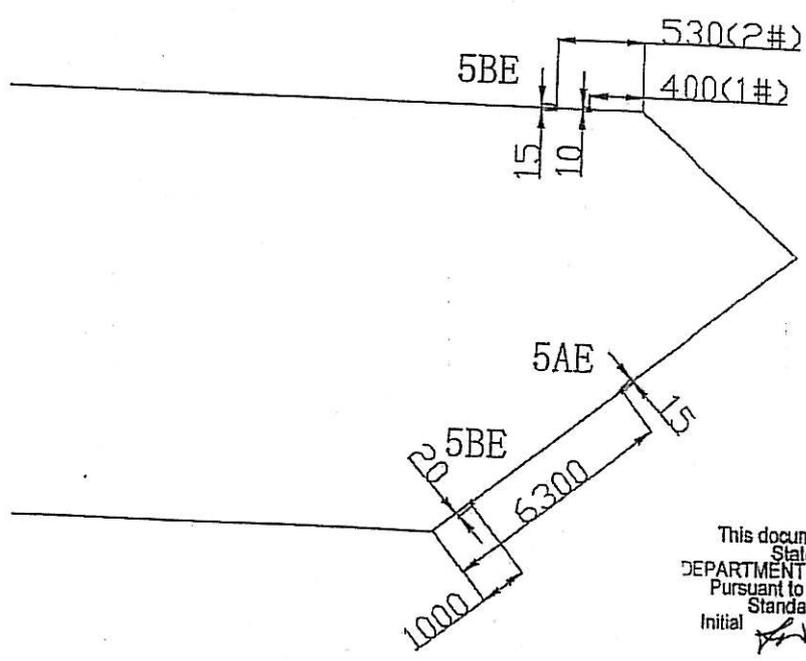
在对SP304A检测时, 发现1处横向裂纹。1、L=15mm
 在对SP305A检测时, 发现1处横向裂纹。1、L=20mm
 在对DP633A检测时, 发现2处横向裂纹。1、L=10mm;2、L=15mm
 Welder ID No. (焊工编号):048659 Position:(位置): 1G
 One transverse crack was found by use of MT on SP304A. ✓
 One transverse crack was found by use of MT on SP305A.
 Two transverse cracks were found by use of MT on DP633A.

1. 火焰加热时, 水汽没有完全的去掉或者这个区域预热不够;
1. Moisture wasn't completely removed during drying operation (preheating) or the area wasn't preheated sufficiently.

1. QC and a Lead CWI shall be present, direct and supervise all grinding and welding operations during this repair to ensure the repair is per the disposition requirements

2. QC and a Lead CWI shall have an approved copy of the CWR in hand prior to the repair.
3. Remove paint ≥ 25 mm in all direction of HAZ prior to MT.
4. Extend repair .50mm beyond each end of the crack and 50mm beyond the outermost cracks for multiple crack repairs.

5. Clean the excavation area of all loose debris including MT powder. Remove defects by grinding. Preheat to 65° C before removing cracks by grinding;
6. Perform base metal repair work prior to performing joint repair work when crack removal procedures result in damage than 3mm,

7. Prepare excavation in accordance with the New Repair Procedure prior to welding.
8. Perform VT and MT prior to welding to verify no defects exist;
9. Clean excavation area of all loose debris including MT powder after excavation. Preheat and weld according to repair WPS, the minimum preheat shall not less than 160° C—230° C;

10. Perform post weld heating according to repair WPS, the postheat shall between 230° C—315° C and for one hour minimum.
11. Allow the weld to cool to ambient temperature gradually. Control cooling rate after PWHT to no more than 50° C per hour

12. Grind the repair area flush with base metal or the adjacent weld;
13. Wait 48 hours at least after the repair area has cooled to ambient temperature before performing NDT.

14. Perform VT, MT and UT on repair area to ensure no defects exist.

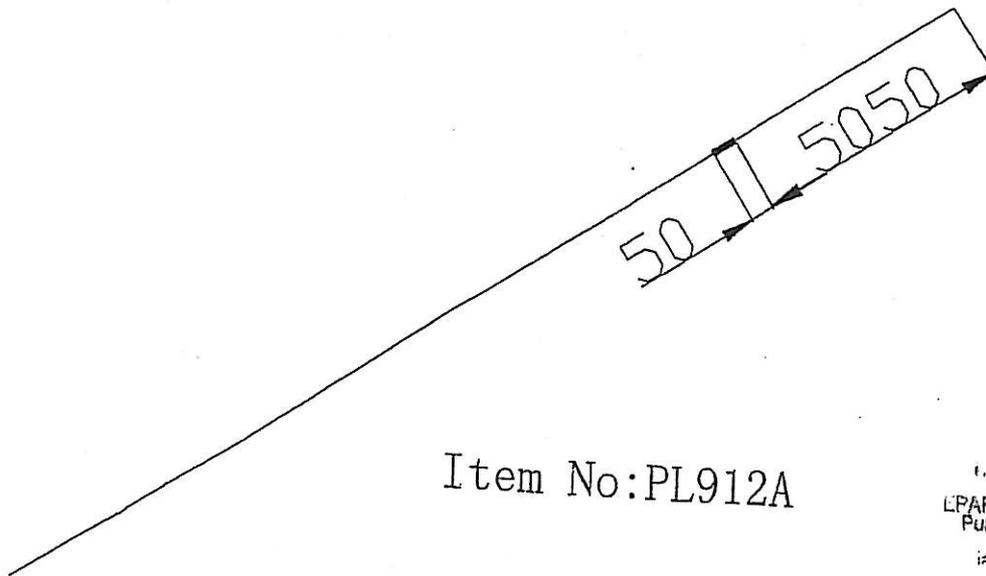
Item No: PL912A

One longitudinal crack was found by use of MT on base metal PL912A.

1. 火焰加热时, 水汽没有完全的去掉或者这个区域预热不够;
1. Moisture wasn't completely removed during drying operation (preheating) or the area wasn't preheated sufficiently.

1. QC and a Lead CWI shall be present, direct and supervise all grinding and welding operations during this repair to ensure the repair is per the disposition requirements

2. QC and a Lead CWI shall have an approved copy of the CWR in hand prior to the repair.
3. Remove paint $\geq 25\text{mm}$ in all direction of HAZ prior to MT.

4. Clean the excavation area of all loose debris including MT powder. Preheat to 65° C before removing cracks by grinding, repair area shall extend a minimum of 50mm beyond each end of single crack repairs.

5. If base metal is damaged by grinding, the damaged area shall be ground clean prior to performing weld repair. If gap $> 5\text{mm}$ is found during or after grinding, comply with the notification on changing fillet weld to CJP which is submitted for Engineer's review and approval form.

6. Prepare excavation in accordance with the New Repair Procedure prior to welding.
7. Before this repair, Verify with VT and MT repair areas are defects free, and also MT shall be performed on the base metal laying abroad cracks to ensure that no cracks were propagated to the base metal. Separate CWR approval is needed if cracks are found in the base metal, and only after this new CWR's approval can continue the repair.

8. Clean excavation area of all loose debris including MT powder after excavation. Preheat and weld according to repair WPS, the preheat shall between 160° C-230° C.

9. Perform post weld heating according to repair WPS, the postheat shall between 230° C-315° C and for one hour minimum.
10. Allow the weld to cool to ambient temperature gradually. Control cooling rate after PWHT to no more than 50° C per hour.

11. Grind the repaired area flush with base metal or the adjacent weld after post weld heating.
12. Wait 48 hours at least after the repair area has cooled to ambient temperature before performing NDT.

13. Perform MT inspection to all repair area according to Contract Drawings along with all additional NDT required by the applicable notes Special Provision Section 10-1.59 'Steel Structure', subsection 'inspection and testing'. NDT include VT, MT and UT if it is a CJP weld.
