Contract #: 04-0120F4Cty: SF/ALA Rte: 80 PM: 13.2/13.9File #: 69.25B**QUALITY ASSURANCE -- NON-CONFORMANCE REPORT****Location:** Changxing Island, Shanghai, P.R. China**Report No:** NCR-000617**Prime Contractor:** American Bridge/Fluor Enterprises, a JV**Date:** 09-Jan-2010**Submitting Contractor:** Zhenhua Port Machinery Company, Ltd (ZPMC), Changxing Island**NCR #:** ZPMC-0590**Type of problem:**

Reference Description: Missed MT Indication by QC on 5AW Deck Panel**Description of Non-Conformance:**

Dear: Mr. Charles Kanapicki
Job Name: SAS Superstructure

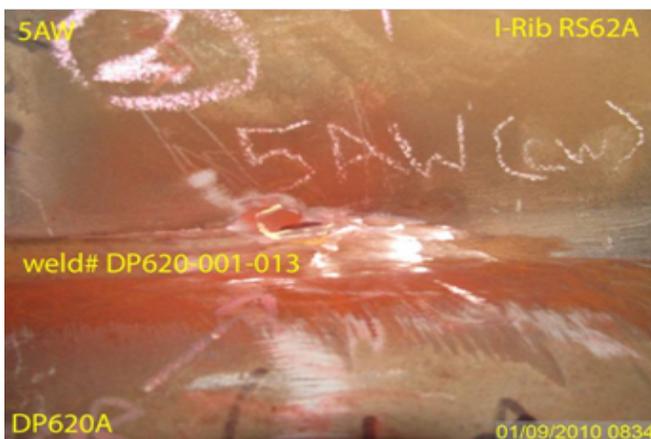
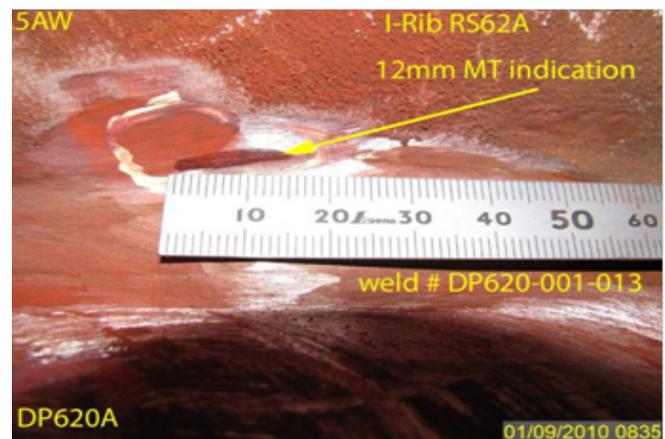
During the Quality Assurance Magnetic Particle Testing (MT) review of welds located on Segment 5AW, this Quality Assurance Inspector (QA) discovered the following issues:

- One (1) Longitudinal linear indication measuring approximately 12mm in length.
- The weld is identified as: DP620-001-013.
- This Fillet Weld joins I-Rib RS62A to Deck Plate DP620A in Corner Assembly CA15A.
- These welds are designated as Non-Seismic Performance Critical Member (SPCM).

The Notice of Witness Inspection Number (NWIT) is 005016. The indication is located inside the area that has been previously tested and accepted by ZPMC Quality Control (QC) personnel.

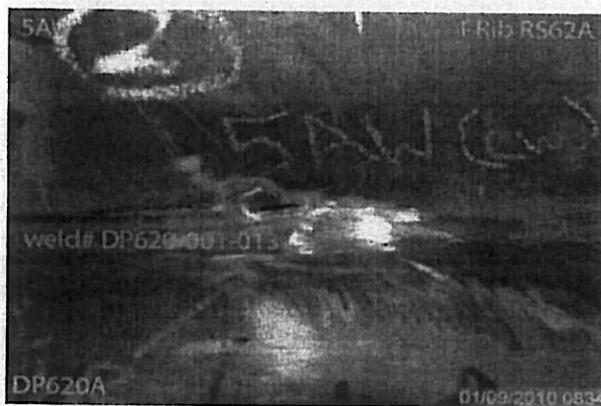
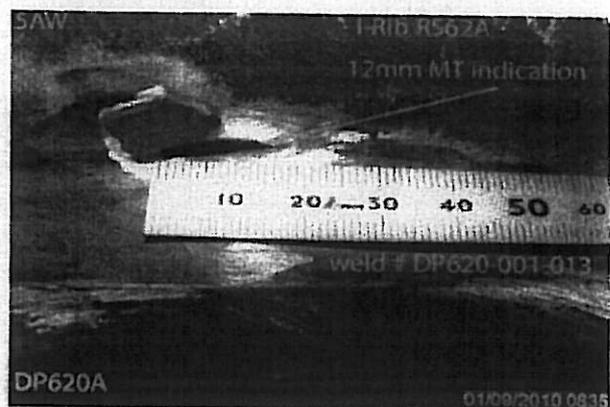
During the Quality Assurance Magnetic Particle Testing (MT) review of welds located on Segment 5AW, this Quality Assurance Inspector (QA) discovered the following issues:

-One (1) Longitudinal linear indication measuring approximately 12mm in length.

-The weld is identified as: DP620-001-013.

-This Fillet Weld joins I-Rib RS62A to Deck Plate DP620A in Corner Assembly CA15A.

The Notice of Witness Inspection Number (NWIT) is 005016. The indication is located inside the area that has been previously tested and accepted by ZPMC Quality Control (QC) personnel.

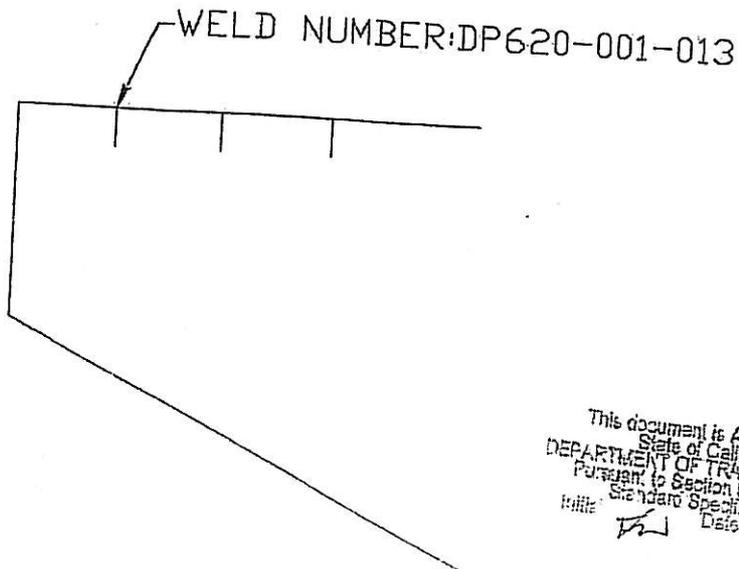
Draft of Welding Discontinuity:

One longitudinal crack was found by use of MT on DP620-001-013.

1. 火焰加热时, 水汽没有完全的去掉或者这个区域预热不够;
1. Moisture wasn't completely removed during drying operation (preheating) or the area wasn't preheated sufficiently.

12. 在焊缝冷却至环境温度至少经过48小时以后进行NDT检查;
 13. 返修后根据图纸进行MT检测, 并按照合同10-1.59 “钢结构” 中的“检测和试验” 要求进行附加MT检测。对于CJP焊缝, NDT为VT, MT和UT。
1. QC and a Lead CWI shall be present, direct and supervise all grinding and welding operations during this repair to ensure the repair is per the disposition requirements

2. QC and a Lead CWI shall have an approved copy of the CWR in hand prior to the repair.
 3. Remove paint ≥ 25 mm in all direction of HAZ prior to MT.
 4. Clean the excavation area of all loose debris including MT powder. Preheat to 65° C before removing cracks by grinding, repair area shall extend a minimum of 50mm beyond each end of single crack repairs.

5. If base metal is damaged by grinding, the damaged area shall be ground clean prior to performing weld repair. If gap > 5mm is found during or after grinding, comply with the notification on changing fillet weld to CJP which is submitted for Engineer's review and approval form.

6. Prepare excavation in accordance with the New Repair Procedure prior to welding.
 7. Before this repair, Verify with VT and MT repair areas are defects free, and also MT shall be performed on the base metal laying abroad cracks to ensure that no cracks were propagated to the base metal. Separate CWR approval is needed if cracks are found in the base metal, and only after this new CWR's approval can continue the repair.

8. Clean excavation area of all loose debris including MT powder after excavation. Preheat and weld according to repair WPS, the preheat shall between 160° C—230° C.

9. Perform post weld heating according to repair WPS, the postheat shall between 230° C—315° C and for one hour minimum.
 10. Allow the weld to cool to ambient temperature gradually. Control cooling rate after PWHT to no more than 50° C per hour.

11. Grind the repaired area flush with base metal or the adjacent weld after post weld heating.
 12. Wait 48 hours at least after the repair area has cooled to ambient temperature before performing NDT.

13. Perform MT inspection to all repair area according to Contract Drawings along with all additional NDT required by the applicable notes Special Provision Section 10-1.59 'Steel Structure', subsection: 'inspection, testing'. NDT include VT, MT and UT if it is a CJP weld.
