Contract #: 04-0120F4  
 Cty: SF/ALA Rte: 80 PM: 13.2/13.9  
 File #: 69.25B

## QUALITY ASSURANCE -- NON-CONFORMANCE REPORT

**Report No:** NCR-000618

**Reference Description:** ZPMC performed Critical Weld Repair without the Engineer's approval for a Side Panel to be used in Segment 12AE

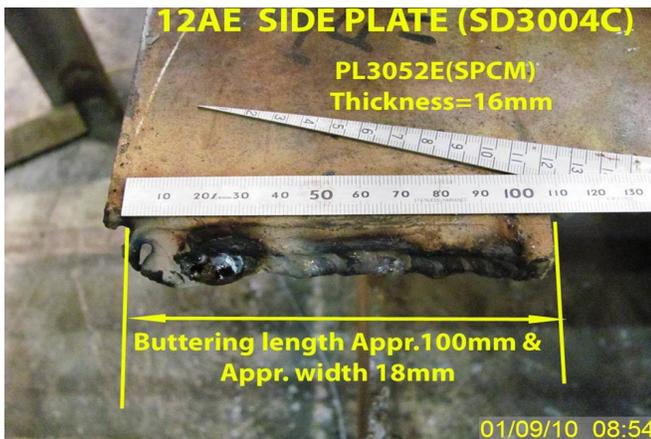
During in-process observations of the side panels being fabricated in bay 14, the Caltrans Quality Assurance Inspector (QA) observed the following:

- ZPMC personnel perform a Critical Weld Repair (CWR) without the Engineers approval.
- The repair being performed was weld buildup (buttering).
- The amount of buttering is approximately 18mm, the allowable per code in this case is 4mm.
- The material is 16mm thick A709 Grade 345 Seismic Performance Critical Material (SPCM).
- The Side Panel is identified as SP3004C for Segment 12AE.
- The plate number is identified as PL-3052E.

AWS D1.5/2002, Section 12.17.2: Noncritical weld repairs are generally welds to deposit additional weld beads or layers to compensate for insufficient weld size and to fill limited excavations to remove unacceptable edge or surface discontinuities, rollover or undercut, including: (7) Deposition of weld metal up to 10mm deep

or ¼ the base metal thickness, whichever is less to correct for length or joint geometry.

AWS D1.5 2002, Section 12.17.4: "All critical repairs to base metal and welds shall be approved by the Engineer prior to beginning the repair..."

**Reference Resolution:** ZPMC has performed NDT after the weld built up and is submitting the NDT documentation to show the weld is acceptable.

Perform NDT required to verify weld quality.

Contractor submitted NDT report verifying weld metal added to plate is in conformance with Contract weld quality requirements.
