Contract #: 04-0120F4
 Cty: SF/ALA Rte: 80 PM: 13.2/13.9
 File #: 69.25B

QUALITY ASSURANCE -- NON-CONFORMANCE REPORT

Report No: NCR-000619

Reference Description: The Contractor performed welding without using the run-off tabs at termination for Segment 6CE

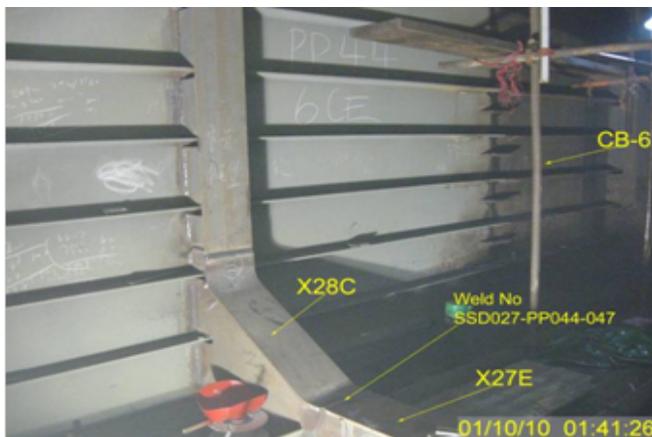
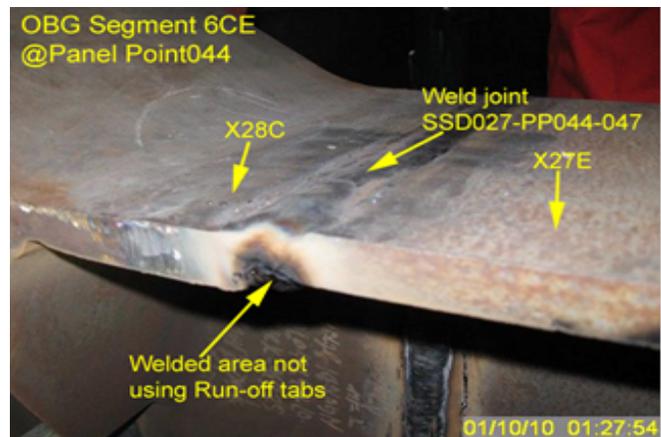
- Complete Joint Penetration (CJP) weld being performed without using the run-off tabs.
- The use of run-off tabs is specified in AWS D1.5 2002 section 3.12.1.
- The member is identified as a partial height crossbeam diaphragm.
- The weld is a Complete Joint Penetration (CJP) butt joint identified as SSD027-PP044-047.
- The weld is joining corner section diaphragm flange (X28C) to the straight section of diaphragm flange (X27E).
- The weld is located on the diaphragm connected to the FL3 floor beam at Panel Point 044 on segment 6CE.
- OBG Segment 6CE is located in the segment Trial Assembly Yard.

American Weld Society (AWS) D1.5 2002 section 3.12.1 “Welds shall be terminated at the end of a joint in a manner that will ensure sound welds. Whenever possible, this shall be done using weld tabs (extension bars and run off plates) placed in a manner that will duplicate the joint detail being welded”.

ZPMC is providing the CWR that was used to repair the weld after defects were found and the subsequent NDT which shows that the weld is acceptable. ZPMC QA has instructed the responsible production team that they must pay close attention to these types of issues. Based on this ZPMC requests closure of this NCR.

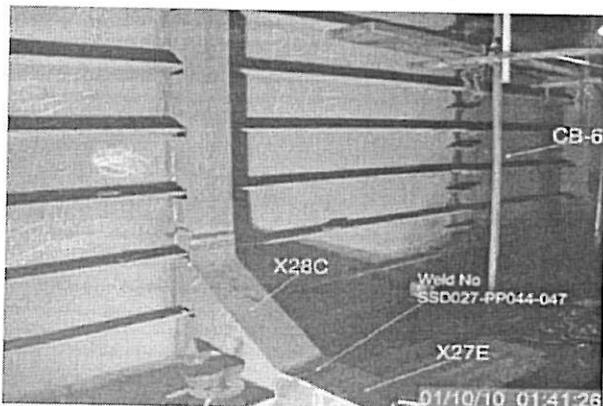
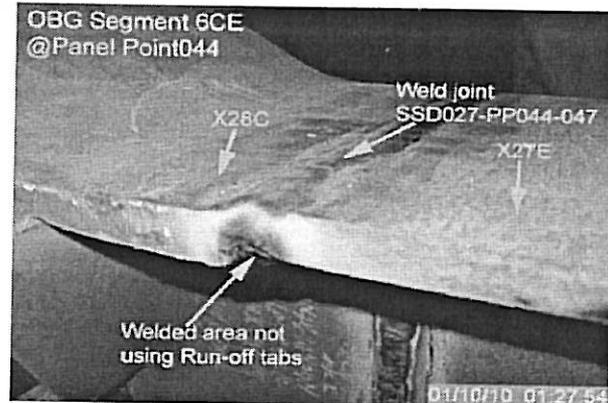
- Complete Joint Penetration (CJP) weld being performed without using the run-off tabs.
- The use of run-off tabs is specified in AWS D1.5 2002 section 3.12.1.
- The member is identified as a partial height crossbeam diaphragm.
- The weld is a Complete Joint Penetration (CJP) butt joint identified as SSD027-PP044-047.
- The weld is joining corner section diaphragm flange (X28C) to the straight section of diaphragm flange (X27E).
- The weld is located on the diaphragm connected to the FL3 floor beam at Panel Point 044 on segment 6CE.
- OBG Segment 6CE is located in the segment Trial Assembly Yard.

American Weld Society (AWS) D1.5 2002 section 3.12.1 "Welds shall be terminated at the end of a joint in a manner that will ensure sound welds. Whenever possible, this shall be done using weld tabs (extension bars and run off plates) placed in a manner that will duplicate the joint detail being welded".

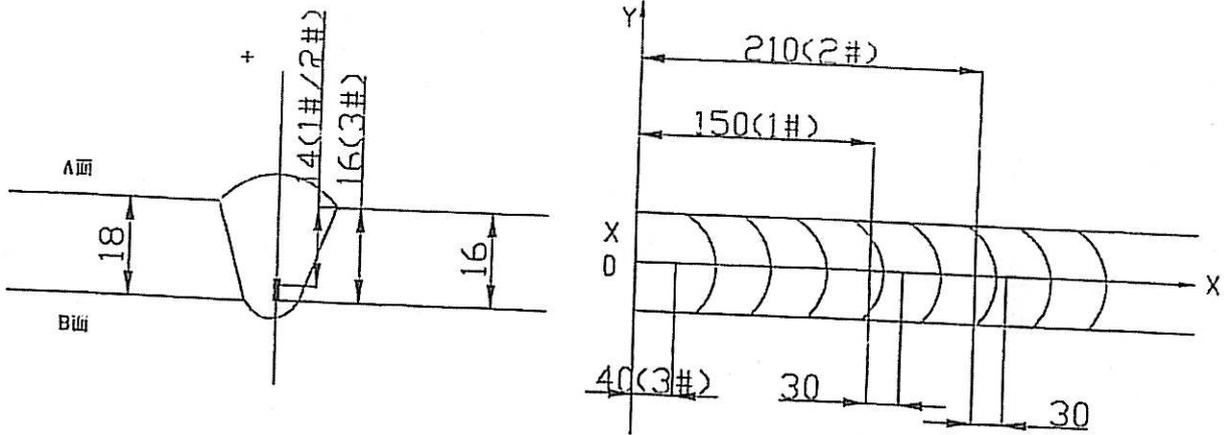
WELD NUMBER: SSD27-PP045-047

A Rejectable indication was found by Ultrasonic Inspection for a third repair.
(UT三次缺陷) SSD27-PP045-047

1. 焊工在第一次反面清根时, 没有注意, 导致焊接缺陷没有全部去除;
 2. 在焊返修前, QC没有确认所有的焊接缺陷已经去除。
1. The welder was not observant during the first backgouging operation resulting in the indications not being completely removed.
 2. QC did not verify the indications had been removed prior to re-welding.

14. 将修补区域打磨与母材或相邻焊缝平齐;
 15. 在焊缝冷却至环境温度等48小时以后进行NDT检查;
 16. 根据批准的车间图纸VT, MT, UT检测返修后的焊缝。附加NDT检测按照合同10-1.59 “钢结构” 中的 “检测和试验” 进行。
1. QC and a Lead CWI shall be present and direct all gouging, grinding and welding operations during this repair.

2. QC and a Lead CWI shall have a copy of the CWR in hand and shall be at the repair location prior to the repair.
 3. QC and the Lead CWI shall direct the repair to ensure the repair is per the disposition requirements.

4. Clean excavation area of all loose debris including UT powder, and preheat to 65° C prior to gouging or grinding.
 5. Gouge and/or grind accurately from nearer side from metal edge ($D \leq 0.65T$, “D” is depth of defects, “T” is thickness of metal) to remove all defects.

6. Prepare a right joint according to approved WPS.
 7. Grind repair area smooth to a shiny finish with tapered ends to ensure staggered stops and starts, and perform VT and MT to ensure the defects have been removed.

8. Clean the excavation area of all loose debris including MT powder and UT gel.
 9. QC and a Lead CWI shall verify and document all defects have been removed prior to repair welding.

10. Preheat according to Table 1 and weld according to approved WPS..
 11. QC and a CWI shall enforce interpass cleaning by performing a visual inspection prior to the disposal of each pass.

12. Perform post weld heating according to the Table 1 of the New Repair Procedure.
 13. Allow the weld to cool to ambient temperature gradually. Control cooling rate after PWHT to no more than 50° C per hour.

14. Grind the repaired area flush with base metal or the adjacent weld after post weld heating.
 15. Wait 48 hours after the repair area has cooled to ambient temperature before performing NDT.

16. Check the weld by performing VT, MT and UT to the repair area according to the drawings. Additional NDT in accordance with the applicable notes in Special Provisions Section 10-1.59 ‘Steel Structure’, subsection ‘Inspection and Testing’.
