Contract #: 04-0120F4Cty: SF/ALA Rte: 80 PM: 13.2/13.9File #: 69.25B**QUALITY ASSURANCE -- NON-CONFORMANCE REPORT****Location:** Changxing Island, Shanghai, P.R. China**Report No:** NCR-000620**Prime Contractor:** American Bridge/Fluor Enterprises, a JV**Date:** 10-Jan-2010**Submitting Contractor:** Zhenhua Port Machinery Company, Ltd (ZPMC), Changxing Island**NCR #:** ZPMC-0593**Type of problem:**

Welding	Concrete	Other	
Welding	Curing	Procedural	Bridge No: 34-0006
Joint fit-up	Coating	Other	Component: Open rib Stiffener on Edge Panel of 5AW to 5BW
Procedural	Procedural	Description:

Reference Description: Straightness/flatness deviation outside of allowable tolerance noted at Open rib Stiffener to Open rib Stiffener joint (Edge Panel of 5AW to 5BW)

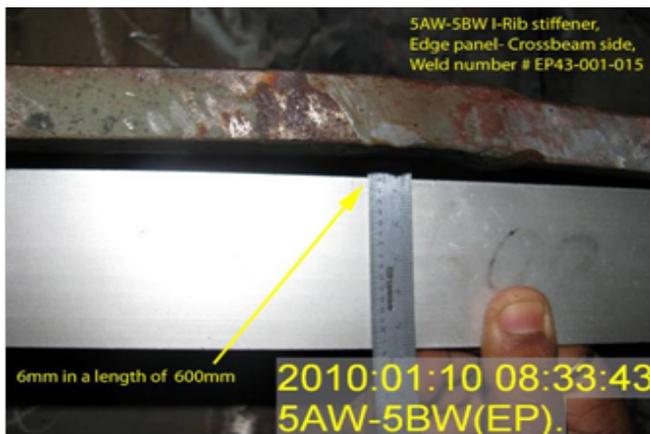
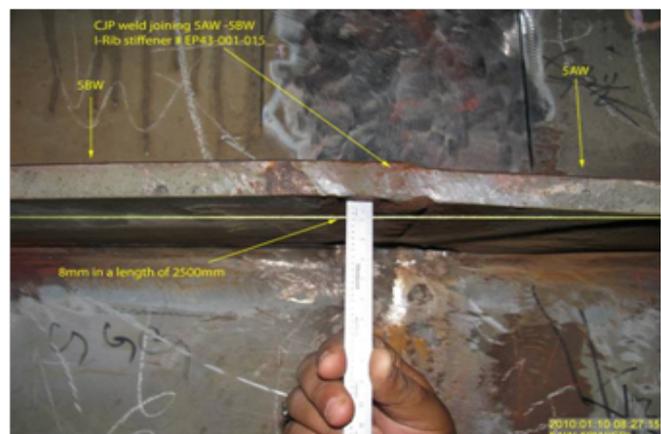
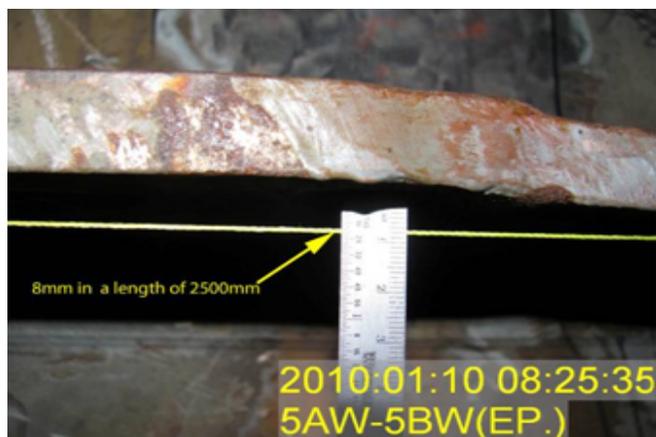
- One I-Rib weld between the 5AW to 5BW (Edge panel-I-Rib stiffener) was misaligned across the weld joint.
- The Edge Panel (EP) I-Rib stiffener weld joint is identified as: EP043-001-015 (Cross beam side)
- This weld is complete joint penetration (CJP) butt weld.
- The material is designated as non Seismic Performance Critical Members (Non SPCM).
- The out of flatness measurement across the weld joint is 6mm over a length of 600mm, where the 600mm ruler is centered over the weld joint. The maximum allowable deviation per the Standard Specifications is 5mm.

-Per AASHTO Bridge Construction Specifications, the straightness of longitudinal stiffeners issue was observed. A maximum deviation of 8mm was measured over a length of 2500mm by placing a fully tensioned string line adjacent to both ends of the stiffener where the diaphragm/floorbeam intercepted the stiffener. The maximum allowable deviation for straightness is $L/480$ ($2500/480$) = 5.2mm

ZPMC has removed the weld and rewelded the splice to correct the misalignment. The work was verified by the Department and removed from the punchlist after complete. ZPMC is providing the internal NCR that was written, as well as the weld repair report and NDT to show that weld is acceptable. Based on this ZPMC requests closure of this NCR.

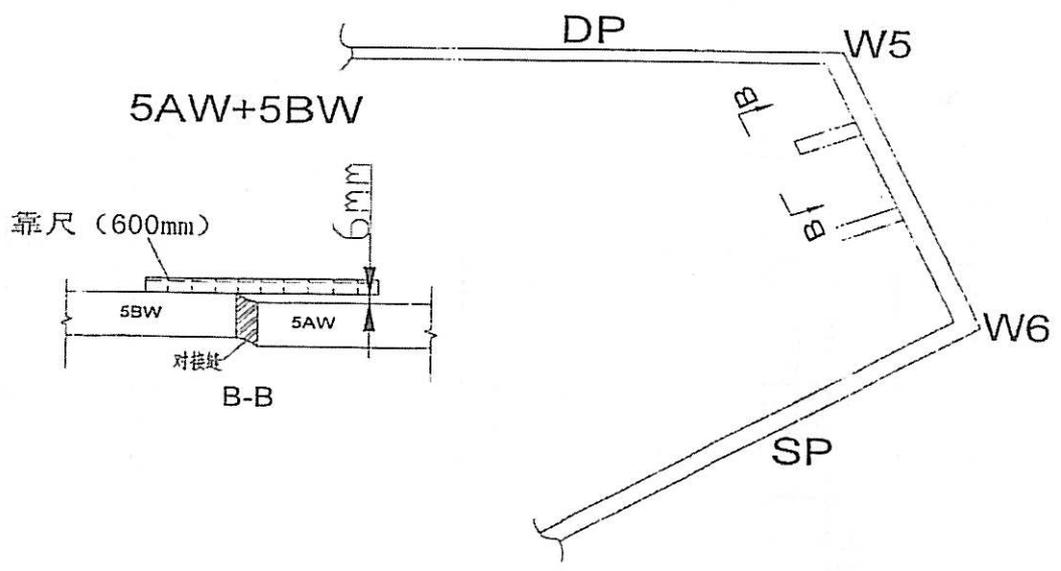
焊缝返修位置示意图:
Draft of welding discontinuity:

焊缝缺陷描述:
Description of welding discontinuity:
 经检测发现: 5AW+5BW (焊后) 靠联系梁侧斜腹板上有一处I肋对接存在错边。详见如图所示:
 It was found that one "I" rib on the web plate next to the connection plate in Segment 5AW+5BW was misaligned after welding. Please see the details in the following sketch.

Welding distortion and fabrication error.

1. 采用打磨或碳刨的方法去除对接端口处I肋与腹板之间部份长度焊缝, 去除焊缝长度根据实际情况定。同时用切割的方法去除I肋的对接焊缝。碳刨前根据相应WPS预热;
 2. 采用外力调整对接端口I肋斜势不大于1: 10, 对接错边量在公差范围内。
 3. 根据相应返修WPS准备焊接接头;
 4. 根据相应WPS预热及返修;
 5. 将返修处焊缝打磨与周边焊缝平齐;
 6. 根据图纸要求进行检测。
-
1. Remove the welds between I-Ribs and the edge plate at the splice by grinding or gouging. The length of removed weld will be decided according to actual situation. Meanwhile, remove the butt weld between I-Ribs by cutting. Preheat according to the WPS prior to gouging.
 2. Adjust the misalignment of I-Ribs to meet the tolerance. The transition is not more than 1:10.
 3. Prepare the excavation according to the relevant WPS.
 4. Preheat and weld according to the WPS.
 5. Grind the weld flush to the adjacent weld or base metal.
 6. Check the weld according to the shop drawings.
