Contract #: 04-0120F4Cty: SF/ALA Rte: 80 PM: 13.2/13.9File #: 69.25B**QUALITY ASSURANCE -- NON-CONFORMANCE REPORT****Location:** Changxing Island, Shanghai, P.R. China**Report No:** NCR-000621**Prime Contractor:** American Bridge/Fluor Enterprises, a JV**Date:** 10-Jan-2010**Submitting Contractor:** Zhenhua Port Machinery Company, Ltd (ZPMC), Changxing Island**NCR #:** ZPMC-0594**Type of problem:**

Reference Description: Repair of cracks without CWR on Lift 12E Longitudinal Shear Plate**Description of Non-Conformance:**

Contract #: 04-0120F4Cty: SF/ALA Rte: 80 PM: 13.2/13.9File #: xx.25A**QUALITY ASSURANCE -- NON-CONFORMANCE RESOLUTION****Location:** Changxing Island, Shanghai, P.R. China**Report No:** NCS-000486**Prime Contractor:** American Bridge/Fluor Enterprises, a JV**Date:** 27-Jan-2010**Submitting Contractor:** Zhenhua Port Machinery Company, Ltd (ZPMC), Changxing Island **NCR #:** ZPMC-0594**Type of problem:**

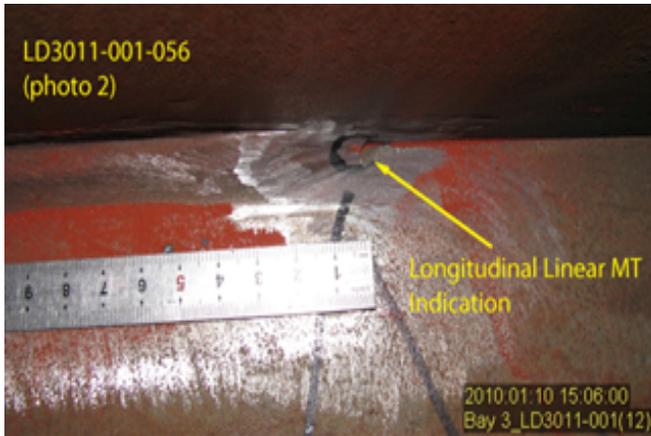
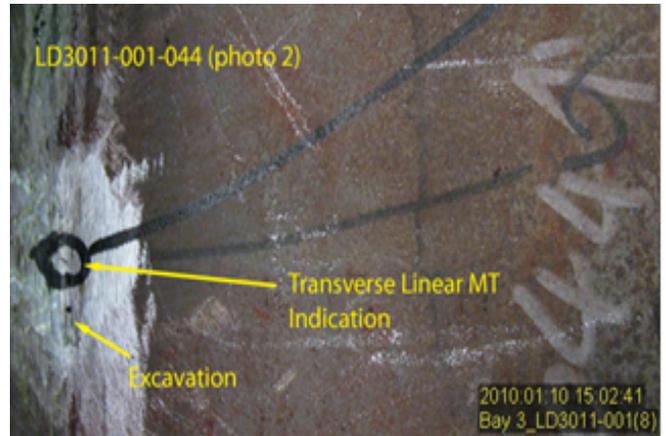
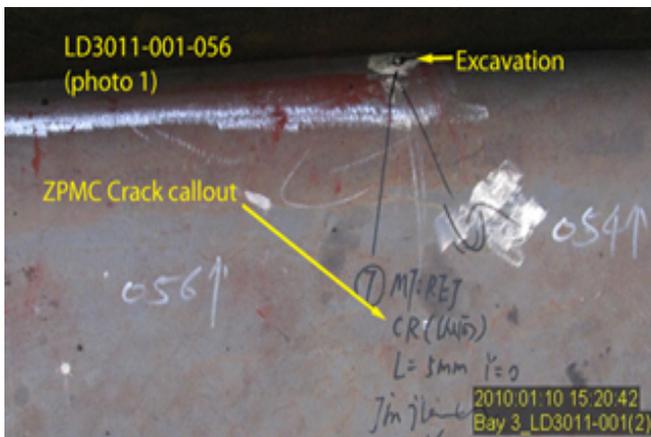
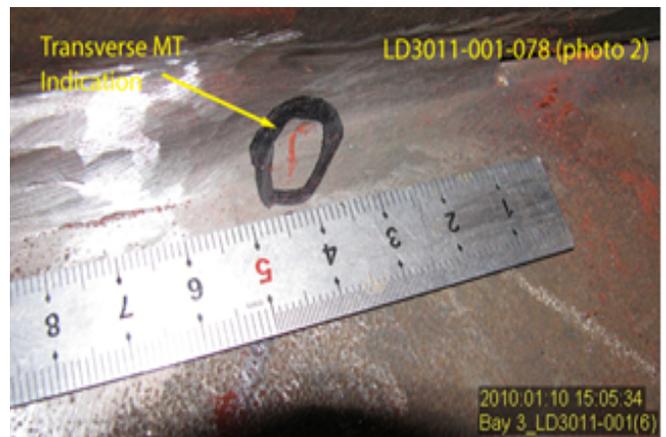
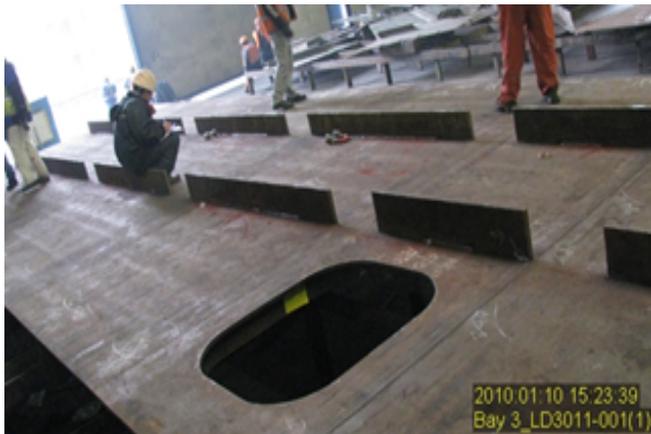
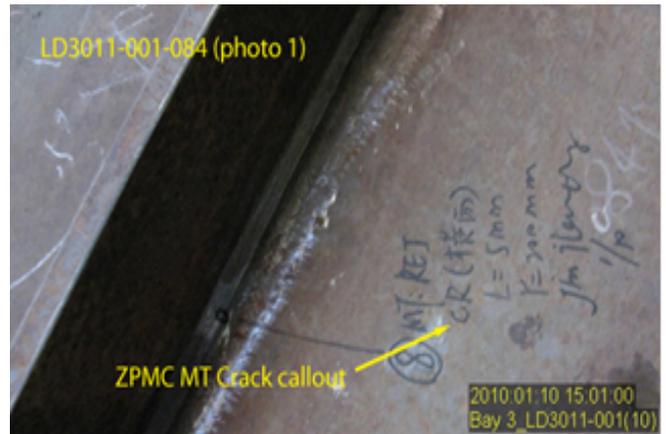
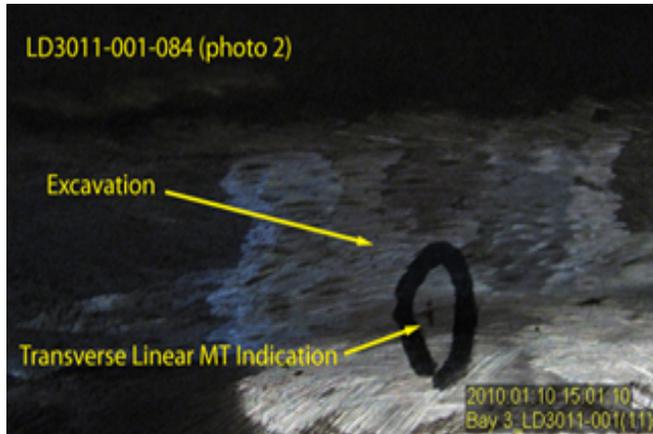
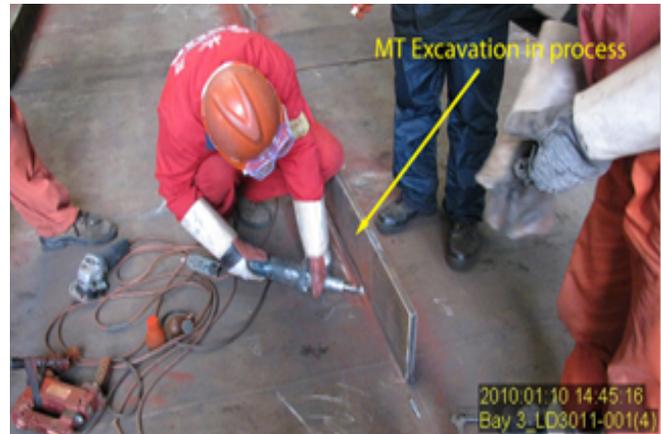
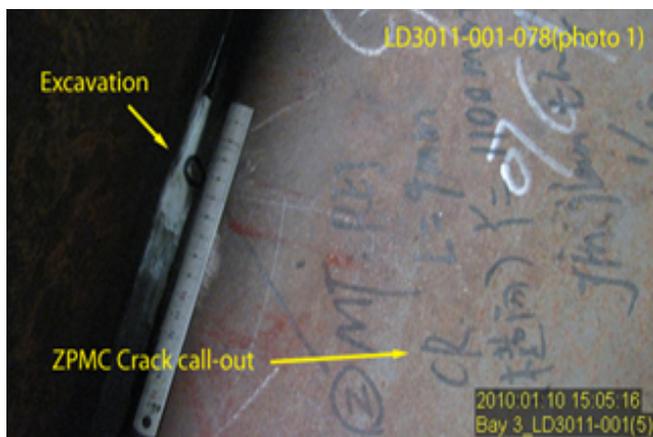
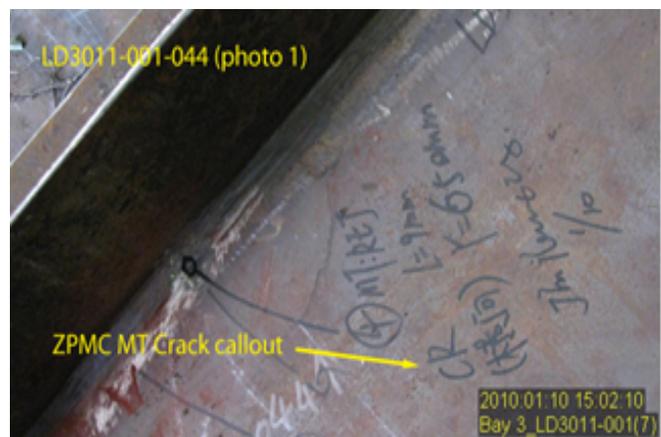
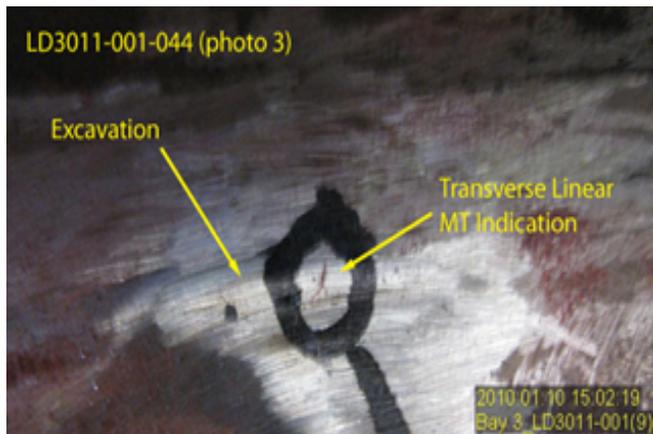
- ZPMC Production Personnel excavating Linear MT Indications identified by ZPMC's MT Technician as cracks, without an approved Critical Weld Repair (CWR) for Lift 12E near working point E4.

- One (1) Longitudinal linear indication measuring approximately 5mm in length; Y location is identified as 0mm.
- The weld is identified as: LD3011-001-056.

- One (1) Transverse linear indication measuring approximately 5mm in length; Y location is identified as 200mm.
- The weld is identified as: LD3011-001-084.

- One (1) Transverse linear indication measuring approximately 9mm in length; Y location is identified as 650mm.
- The weld is identified as: LD3011-001-044.

- One (1) Transverse linear indication measuring approximately 9mm in length; Y location is identified as 1100mm.
- The weld is identified as: LD3011-001-078.

- These welds are all Fillet Welds joining Longitudinal Diaphragm Stiffeners to Longitudinal Diaphragm (LD3011A) web plate.
- The Longitudinal Diaphragm (Longitudinal Shear Plate) is located in the Sub-Assembly Bay 3.

The Engineer has reviewed the information provided in the NPR. The indication found turned out to be a crack and it has been repaired with an approved CRW. NDT has also been done to show that the repair was successful. Please be aware that a CWI must be present with an approved CWR and preheat must be applied prior to excavating cracks.

The Contractor is of the opinion that this NCR was written while ZPMC personnel was in process of determining the severity of the indication. ZPMC production personnel stopped work after being notified of the Non Conformance. A CWR was approved for the repair and the weld has since been Green Tagged
