Contract #: 04-0120F4  
 Cty: SF/ALA Rte: 80 PM: 13.2/13.9  
 File #: 69.25B

## QUALITY ASSURANCE -- NON-CONFORMANCE REPORT

**Report No:** NCR-000623

**Reference Description:** Missed MT Indication by QC in East Tower Lift 4 on Skin C

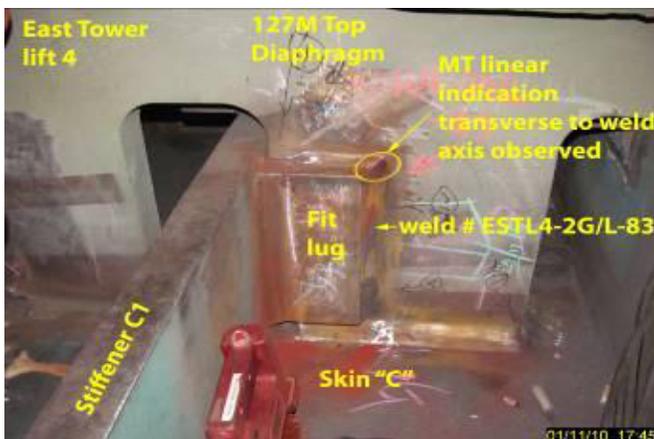
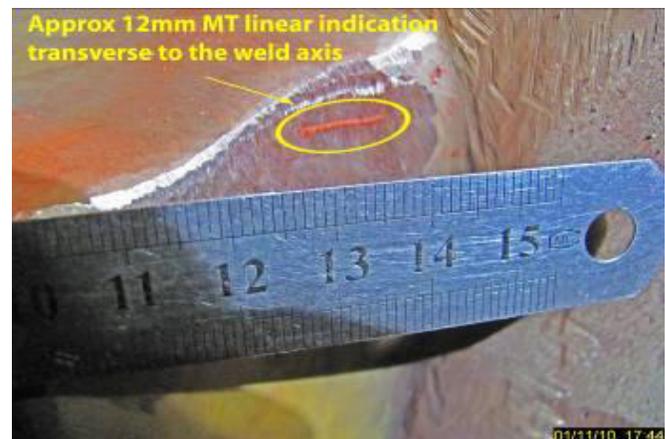
During the Quality Assurance (QA) Magnetic Particle Testing (MT) review of welds located in East Tower lift 4 fit lug on skin C, this QA Inspector discovered the following issues:

- One (1) linear indication transverse to the weld axis measuring approximately 12mm in length.
- The weld is identified as: ESTL4-2G/L-83
- The weld is a fillet weld joining the 127M Top Diaphragm to Fit Lug near stiffener C1.
- This material is designated as non-Seismic Performance Critical Member (non-SPCM).
- The member is located in Tower Bay 11

**Reference Resolution:** ZPMC has removed the missed indication by grinding and is providing NDT documentation to show the weld is acceptable. ABF QCM has conducted refresher MT training with the ZPMC inspectors.

ZPMC has removed the missed indication by grinding and is providing NDT documentation to show the weld is acceptable. To reduce incidents of missed indication the ABF QCM has conducted refresher MT training with the ZPMC inspectors on December 23, 2009. In addition, ZPMC will begin performing 100% verification of tested areas beginning January 18, 2010 as a means of preventing future missed indications. ABFJV has purchased powder dispensers for all the ZPMC MT technicians as a means to help control the amount of powder applied during MT testing. Based on the above actions ZPMC requests this NCR be placed closed.

The indication was removed by grinding (without the need for welding) and verified by MT (T787-MT-7846). MT refresher training was held on 12/22/09. Documentation for this training was provided.

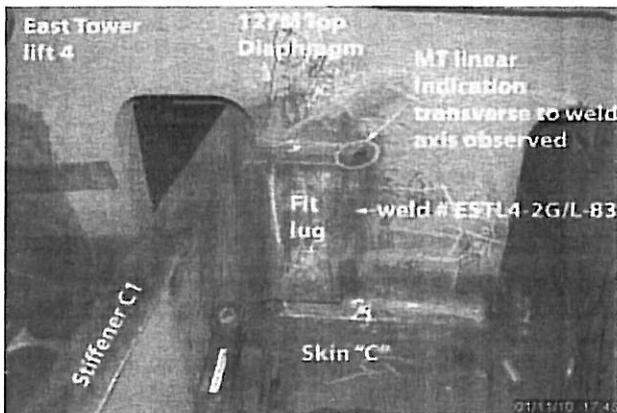
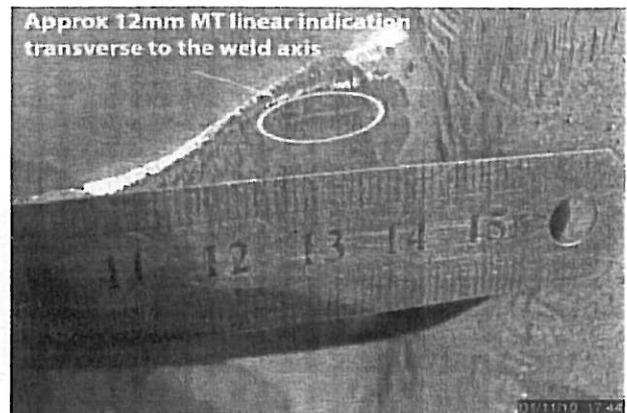
During the Quality Assurance (QA) Magnetic Particle Testing (MT) review of welds located in East Tower lift 4 fit lug on skin C, this QA Inspector discovered the following issues:

- One (1) linear indication transverse to the weld axis measuring approximately 12mm in length.
- The weld is identified as: ESTL4-2G/L-83
- The weld is a fillet weld joining the 127M Top Diaphragm to Fit Lug near stiffener C1.
- This material is designated as non-Seismic Performance Critical Member (non-SPCM).
- The member is located in Tower Bay 11
