QUALITY ASSURANCE -- NON-CONFORMANCE REPORT

Location: Changxing Island, Shanghai, P.R. China**Report No:** NCR-000624**Prime Contractor:** American Bridge/Fluor Enterprises, a JV**Date:** 11-Jan-2010**Submitting Contractor:** Zhenhua Port Machinery Company, Ltd (ZPMC), Changxing Island**NCR #:** ZPMC-0597**Type of problem:**

Reference Description: Class "A" UT indication discovered after ZPMC NDT testing and acceptance on Segment 5BE/5CE deck transverse weld

Job Name: SAS Superstructure
Document No: 05.03.06-000587

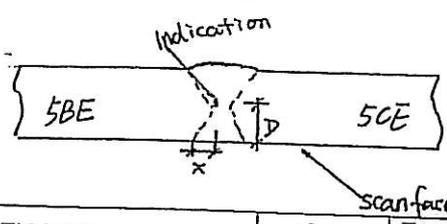
Lift / Segment No.: 5BE/5CE | Location: C4 & C5 R1 | Report Number: UT-5E-015R1

Weld No.	Indication No.	Scan Face	Dimensions (mm)				Indication Rating "d"	Evaluation	Inspector	Inspection Date
			"Y" from O Axis	"X"	Length "L"	Depth "D"				
OBESA-009-1 (C5)	1	Outside	2110	15	6	7.83	+17	TLI-REJ	S021	2010.1.15
	2		2120	15	8	7.8	+17			
	3		3428	15	5	12	+14			
	4		3438	15	8	9.9	+15		S004	
	5		3448	15	5	13.1	+17

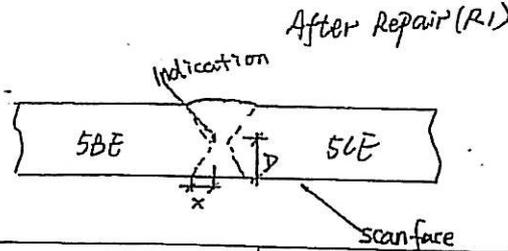
Lift / Segment No.: 5BE/5CE Location: A1. A2 RI Report Number: UT-5E-011R1

Weld No.	Indication No.	Scan Face	Dimensions (mm)				Indication Rating "d"	Evaluation	Inspector	Inspection Date
			"y" from O Axis	"x"	Length "L"	Depth "D"				
0BE5-008 (A1RI)	/	outside	/	/	/	/	ACC	S013	2010.1.10	
0BE5-009 (A2RI)	/	outside	/	/	/	/	ACC	S016	2010.1.10	
0BE5-008	1	outside	9360	10	15	10.5	4	CLASS A REJ	CT	11 JAN 10
ADDITIONAL CT FINDINGS 11 JAN 10

Repair indication and perform required NDT.
