**DEPARTMENT OF TRANSPORTATION**  
 DIVISION OF ENGINEERING SERVICES  
 Office of Structural Materials  
 Quality Assurance and Source Inspection

Contract #: 04-0120F4  
 Cty: SF/ALA Rte: 80 PM: 13.2/13.9  
 File #: 69.25B

## QUALITY ASSURANCE -- NON-CONFORMANCE REPORT

**Report No:** NCR-000626

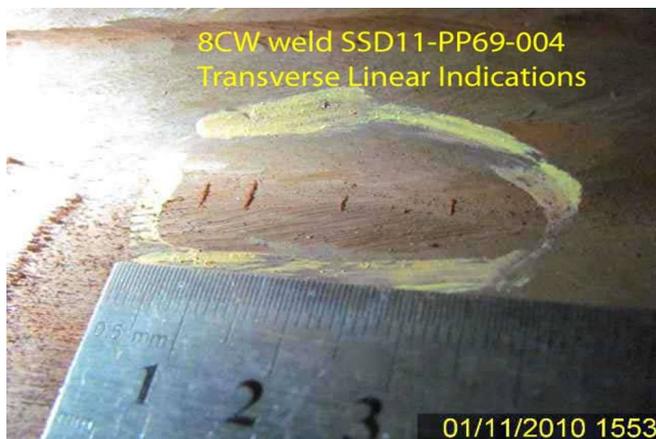
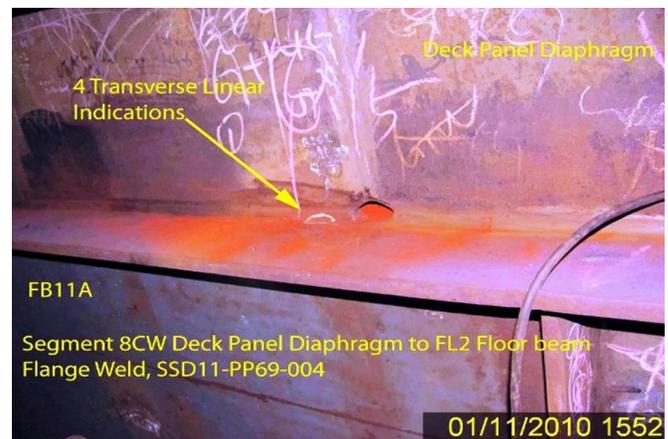
During the Quality Assurance Magnetic Particle Testing (MT) review of welds located on Segment 8CW, this Quality Assurance Inspector (QA) discovered the following issues:

- Four (4) Transverse linear indications measuring approximately from 2 mm to 6 mm in length.
- The weld is identified as: SSD11-PP69-004 @ Panel Point 069.
- This weld was turned into a Complete Joint Penetration (CJP) T-joint weld joining the upper floor beam flange to the deck panel diaphragm previously.
- This OBG Segment is located at outside yard.
- The Notice of Witness Inspection Number (NWIT) is 005037.
- The indication is located in an area that has been previously tested and accepted by ZPMC Quality Control (QC) personnel. According to the contract documents ZPMC Quality Control (QC) is required to perform 100% Magnetic particle Testing (MT) of this weld.

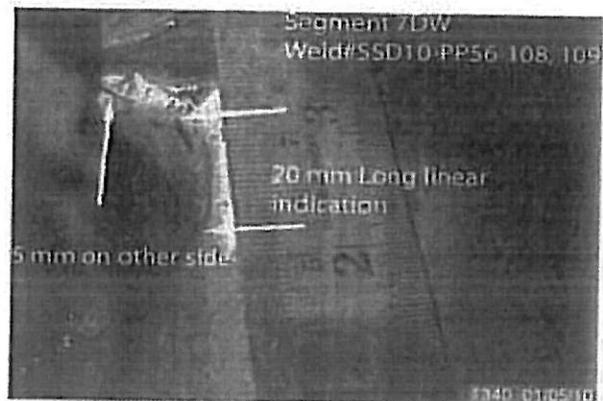
- The OBG segment 7DW is located outside in the Trial Assembly area.

The Notice of Witness Inspection Number (NWIT) is 004993. The indication is located inside the area that has been previously tested and accepted by ZPMC Quality Control (QC) personnel. ZPMC's QC personnel are required to perform twenty five (25%) percent MT inspection of this weld.

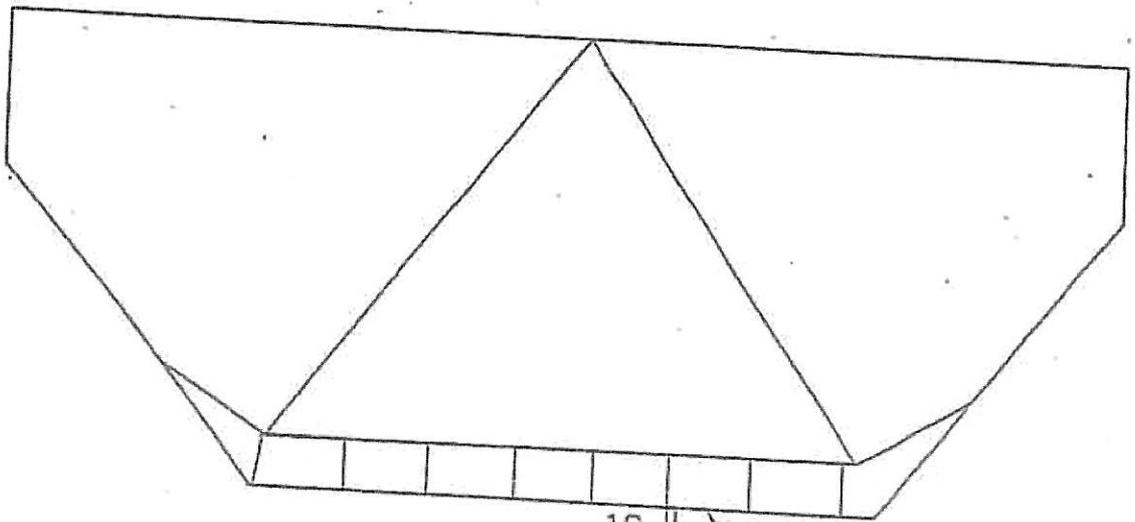
WELD NUMBER:SSD10-PP56-108

One longitudinal crack was found by use of MT on SSD10-PP56-108.

- 1. 火焰加热时, 水汽没有完全的去掉或者这个区域预热不够;
- 1. Moisture wasn't completely removed during drying operation (preheating) or the area wa sn't preheated sufficiently.

- 1. QC and a Lead CWI shall be present, direct and supervise all grinding and welding operations during this repair to ensure the repair is per the disposition requirements

- 2. QC and a Lead CWI shall have an approved copy of the CWR in hand prior to the repair.
- 3. Remove paint ≥25mm in all direction of HAZ prior to MT.
- 4. Clean the excavation area of all loose debris including MT powder. Preheat to 65° C before removing cracks by grinding, repair area shall extend a minimum of 50mm beyond each end of single crack repairs.

- 5. If base metal is damaged by grinding, the damaged area shall be ground clean prior to performing weld repair. If gap > 5mm is found during or after grinding, comply with the notification on changing fillet weld to CJP which is submitted for Engineer's review and approval form.

- 6. Prepare excavation in accordance with the New Repair Procedure prior to welding.
- 7. Before this repair, Verify with VT and MT repair areas are defects free, and also MT shall be performed on the base metal laying abroad cracks to ensure that no cracks were propagated to the base metal. Separate CWR approval is needed if cracks are found in the base metal, and only after this new CWR's approval can continue the repair.

- 8. Clean excavation area of all loose debris including MT powder after excavation. Preheat and weld according to repair WPS, the preheat shall between 160° C-230° C.

- 9. Perform post weld heating according to repair WPS, the postheat shall between 230° C-315° C and for on a hour minimum.
- 10. Allow the weld to cool to ambient temperature gradually. Control cooling rate after PWHT to no more than 50° C per hour.

- 11. Grind the repaired area flush with base metal or the adjacent weld after post weld heating.
- 12. Wait 48 hours at least after the repair area has cooled to ambient temperature before performing NDT.

- 13. Perform MT inspection to all repair area according to Contract Drawings along with all additional NDT required by the applicable notes Special Provision Section 10-1.59 'Steel Structure', subsection 'Inspection testing'. NDT include VT, MT and UT if it is a CJP weld.

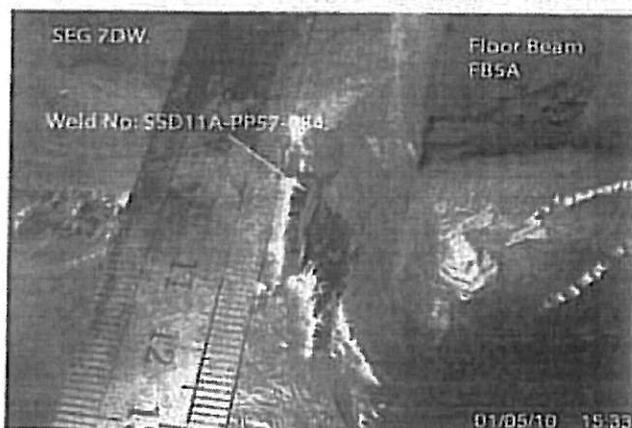
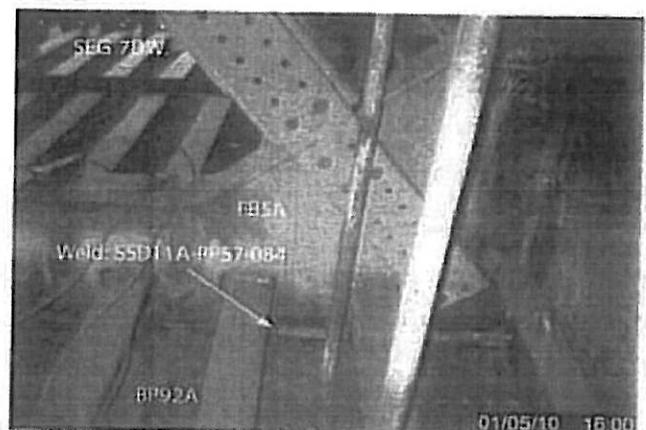
-The approved shop drawings, detail this weld as a Fracture Critical Weld (FCW).

-Segment 7DW is located at outside yard, north end of bays 13 and 14.

The Notice of Witness Inspection Number (NWIT) is 004993. The indication is located within the area that has been previously tested and accepted by ZPMC Quality Control (QC) personnel. ZPMC's QC personnel are required to perform twenty five (25%) percent MT inspection of this weld.
