Contract #: 04-0120F4  
 Cty: SF/ALA Rte: 80 PM: 13.2/13.9  
 File #: 69.25B

## QUALITY ASSURANCE -- NON-CONFORMANCE REPORT

**Report No:** NCR-000627

<b>Welding</b>	<b>Concrete</b>	<b>Other</b>	
<b>Welding</b>	<b>Curing</b>	<b>Procedural</b>	<b>Bridge No:</b> 34-0006
<b>Joint fit-up</b>	<b>Coating</b>	<b>Other</b>	<b>Component:</b> Segment 8CW Floor Beam to Bottom Panel Joint
<b>Procedural</b>	<b>Procedural</b>	<b>Description:</b> Missed MT indication by QC

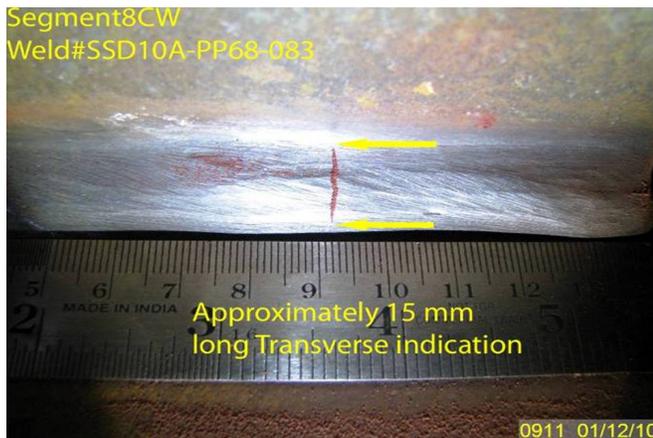
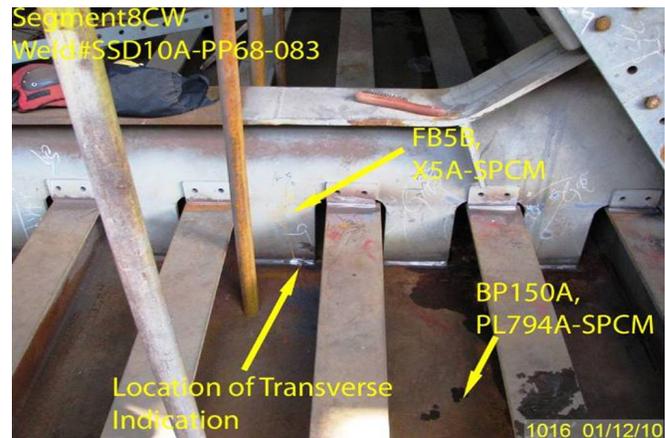
**Reference Description:** One Transverse Indication discovered with MT after ZPMC had tested and accepted this weld in Segment 8CW

- One (1) Transverse linear indication measuring approximately 15mm in length.
- The Y location is 140mm from the left end of the weld.
- The indication is clearly marked on the material near the weld.
- The weld is identified as: SSD10A-PP68-083.
- This weld is a Fillet Weld joining the Bottom Plate (BP150A) to Floor Beam (FB5B) web plate.
- This weld is designated as Seismic Performance Critical Member (SPCM) on the approved drawing (SEGSD10).
- OBG segment 8CW is located outside in west of Blast Shop area.

The Notice of Witness Inspection Number (NWIT) is 005037. The indication is located inside the area that has been previously tested and accepted by ZPMC Quality Control (QC) personnel. ZPMC's QC personnel are required to perform twenty five (25%) percent MT inspection of this weld.

Repair indication and perform the required NDT.

ABF submitted internal NDT documentation verifying the weld is now in conformance with Contract specifications. Per Team China discussions, documentation from ZPMC verifying the repairs were made and NDT was performed by ZPMC technicians will be submitted at a later date and added to the Data Base.
