Contract #: 04-0120F4Cty: SF/ALA Rte: 80 PM: 13.2/13.9File #: 69.25B**QUALITY ASSURANCE -- NON-CONFORMANCE REPORT****Location:** Changxing Island, Shanghai P.R. China**Report No:** NCR-000630**Prime Contractor:** American Bridge/Fluor Enterprises, a JV**Date:** 12-Jan-2010**Submitting Contractor:** Zhenhua Port Machinery Company, Ltd (ZPMC), Changxing Island**NCR #:** ZPMC-0603**Type of problem:**

Reference Description: Missed MT Longitudinal and Transverse Indications by QC located in East Tower Lift 4: C/D corner diagonal plate to skin C and diaphragm to C/D corner diagonal plate

Subject: NCR No. ZPMC-0603

Reference Description: Missed MT Indications/ East Shaft Lift 4 Skin C/ Longitudinal and Transverse Indications

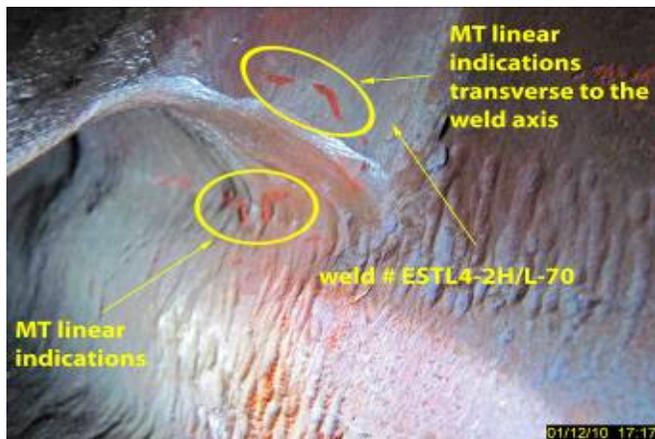
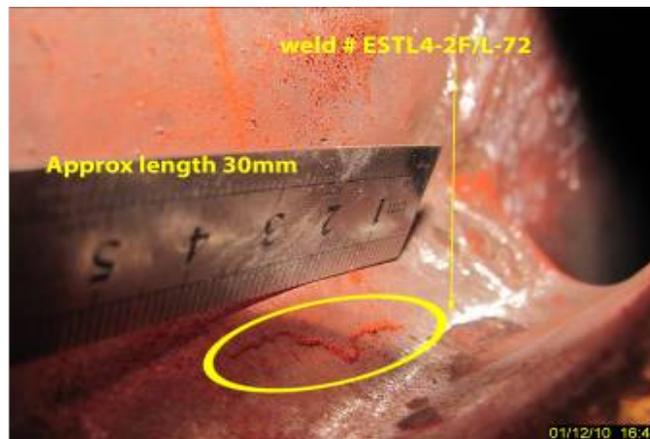
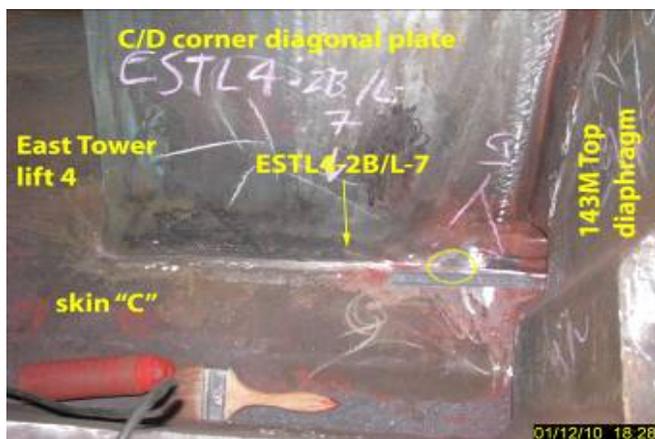
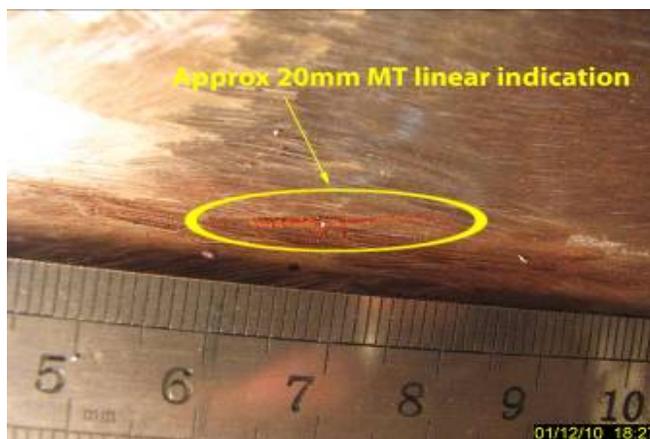
During the Quality Assurance (QA) Magnetic Particle Testing (MT) review of welds located in East Tower lift 4 inside Bay 11, the QA Inspector discovered linear indications on the following welds:

- Weld #ESTL4-2B/L-7: One (1) longitudinal linear indication measuring approximately 20mm in length.
- Weld #ESTL4-2F/L-72: One (1) longitudinal linear indication measuring approximately 30mm in length.

- Weld #ESTL4-2F/L-73: Two (2) transverse linear indications measuring approximately 10mm and 8mm in length.
- Weld #ESTL4-2H/L-1: Three (3) longitudinal linear indications measuring approximately 12mm, 9mm and 6mm in length.

- Weld #ESTL4-2H/L-70: Two (2) longitudinal linear indications measuring approximately 13mm and 10mm in length and two (2) transverse linear indications measuring approximately 8mm and 5mm in length.

- Weld #ESTL4-2K/L-1: One (1) longitudinal linear indication measuring approximately 13mm in length.
- Weld #ESTL4-2K/L-2: Two (2) transverse linear indications measuring approximately 8mm and 6mm in length.

- All indications are clearly marked on the material near the weld.
- For details, see Magnetic particle Testing (MT) report generated by this QA for this date.

Reference Resolution: ZPMC has removed the missed indications by grinding and is providing NDT documentation to show that the welds are acceptable. ABF QCM has conducted refresher MT training with the ZPMC inspectors.

ZPMC removed indications by grinding and provided documentation to show that the welds are acceptable (T787-MT-7842,7843,7844,7845). Welds were verified by QA (green tag #12027). MT refresher training was conducted on 12/22/09. Documentation for this training was provided. ABF purchased MT powder dispensers for ZPMC MT technicians to enhance their performance.

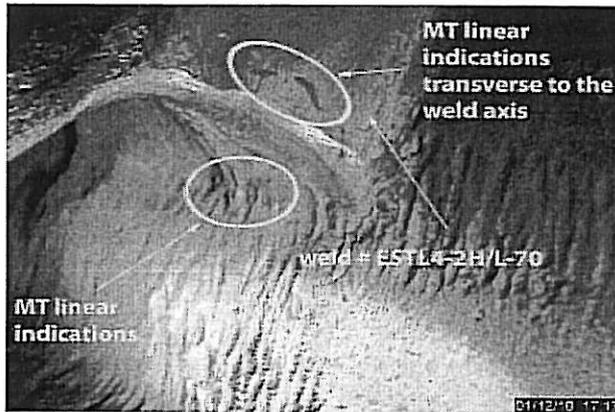
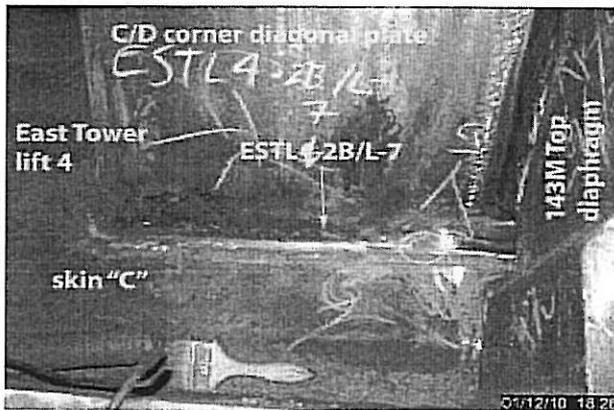
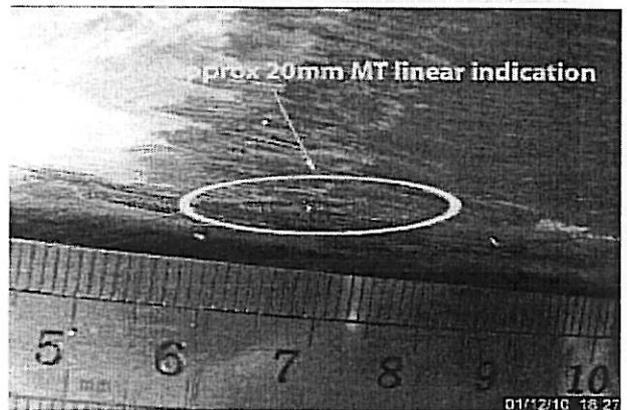
During the Quality Assurance (QA) Magnetic Particle Testing (MT) review of welds located in East Tower lift 4 inside Bay 11, the QA Inspector discovered linear indications on the following welds:

-Weld #ESTL4-2B/L-7: One (1) longitudinal linear indication measuring approximately 20mm in length.

-Weld #ESTL4-2F/L-72: One (1) longitudinal linear indication measuring approximately 30mm in length.

-Weld #ESTL4-2F/L-73: Two (2) transverse linear indications measuring approximately 10mm and 8mm in length.

-Weld #ESTL4-2H/L-1: Three (3) longitudinal linear indications measuring approximately 12mm, 9mm and 6mm in length.

-Weld #ESTL4-2H/L-70: Two (2) longitudinal linear indications measuring approximately 13mm and 10mm in length and two (2) transverse linear indications measuring approximately 8mm and 5mm in length.

-Weld #ESTL4-2K/L-1: One (1) longitudinal linear indication measuring approximately 13mm in length.

-Weld #ESTL4-2K/L-2: Two (2) transverse linear indications measuring approximately 8mm and 6mm in length.

-All indications are clearly marked on the material near the weld.
