Contract #: 04-0120F4Cty: SF/ALA Rte: 80 PM: 13.2/13.9File #: 69.25B**QUALITY ASSURANCE -- NON-CONFORMANCE REPORT****Location:** Changxing Island, Shanghai, P.R. China**Report No:** NCR-000631**Prime Contractor:** American Bridge/Fluor Enterprises, a JV**Date:** 13-Jan-2010**Submitting Contractor:** Zhenhua Port Machinery Company, Ltd (ZPMC), Changxing Island**NCR #:** ZPMC-0604**Type of problem:**

**Reference Description:** Missed Longitudinal and Transverse MT Linear Indications by QC in Segment 8CW LD and FB

# QUALITY ASSURANCE -- NON-CONFORMANCE REPORT

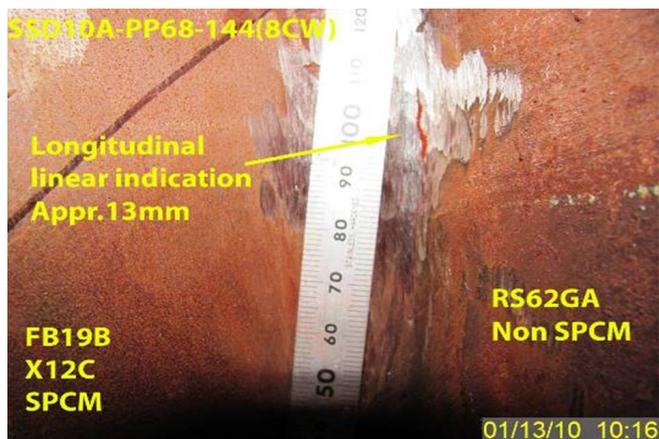
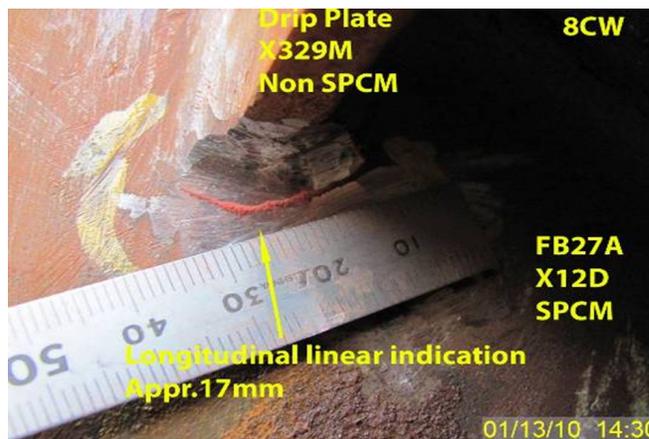
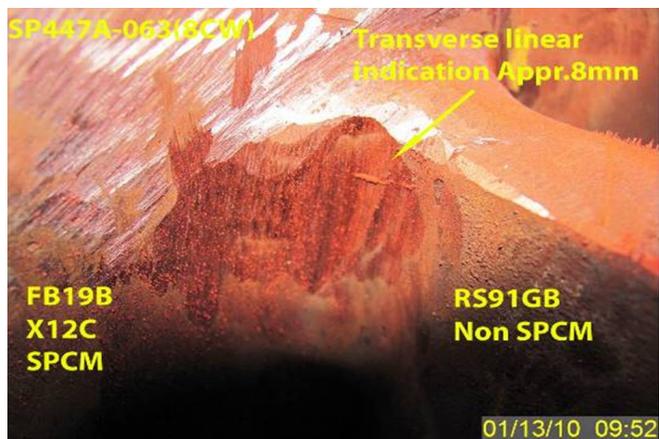
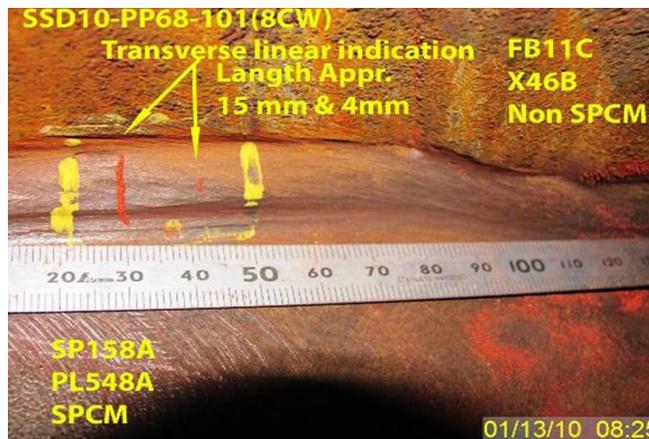
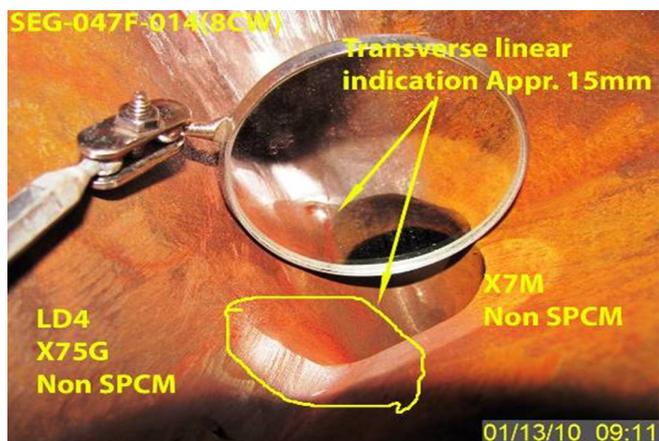
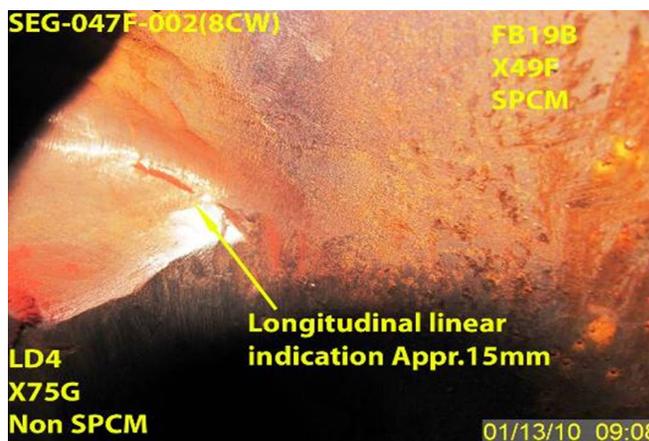
During the Quality Assurance (QA) Magnetic Particle Testing (MT) review of welds located on Segment 8CW, this QA Inspector discovered the following linear indications:

-Weld #SSD10-PP68-101 (SPCM): Two (2) Transverse linear indications measuring approximately 15mm and 4mm. Members are identified as FB11C (X46B) Non SPCM to SP158A (PL548A) SPCM.

-Weld #SEG047F-002 (SPCM): One (1) Longitudinal linear indication measuring approximately 15 mm. Members are identified as FB19B (X49F) SPCM to LD4 (X75G) Non SPCM.

-Weld #SEG047F-014 (non SPCM): One (1) Transverse linear indication measuring approximately 15 mm. Members are identified as LD4 (X75G) Non SPCM to FB19B (X7M) Non SPCM.

-Weld #SP447A-063 (SPCM): One (1) Transverse linear indication measuring approximately 8 mm. Members are identified as FB19B (X12C) SPCM to Side Plate 'I' Stiffener (RS91GB) Non SPCM.

-Weld #SSD10A-PP68-144 (SPCM): One (1) Longitudinal linear indication measuring approximately 13 mm. Members are identified as FB19B (X12C) SPCM to Deck Plate 'I' Stiffener (RS62GA) Non SPCM.

-Weld Connecting Drip plate to Floor Beam (FB27A) at Panel Point PP70 (Cross Beam Side) (SPCM): One (1) Transverse linear indication measuring approximately 17 mm. Members are identified as Drip plate (329M) Non SPCM to Floor Beam FB27A (X12D) Seismic Performance Critical Material (SPCM). This weld does not appear to be identified by number on the contractors weld maps.

has been previously tested by ZPMC Quality Control (QC) personnel.

Propose a resolution for the identified non-conformance with revised procedures to prevent future occurrences. Missed Mt indications are a chronic problem. Provide training and equipment as required to ensure that these indications are found by the ZPMC MT technician that missed them. Provide documentation of such training to the engineer. A response for the resolution of this issue is expected within 7 days.

**Reference Resolution:** ZPMC has repaired the noted indications and is providing NDT reports to show that the welds are acceptable. Based on this ZPMC requests closure of this NCR.

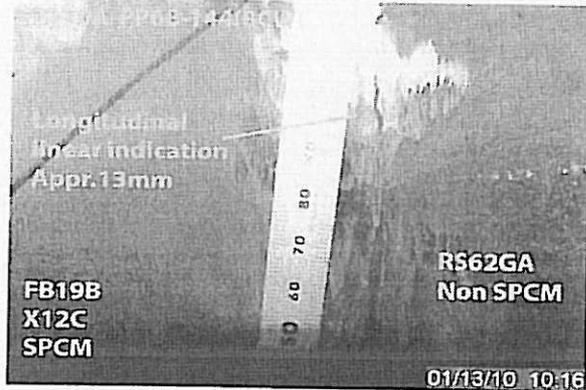
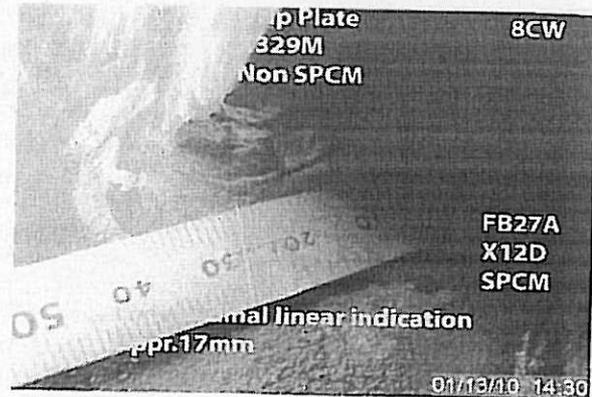
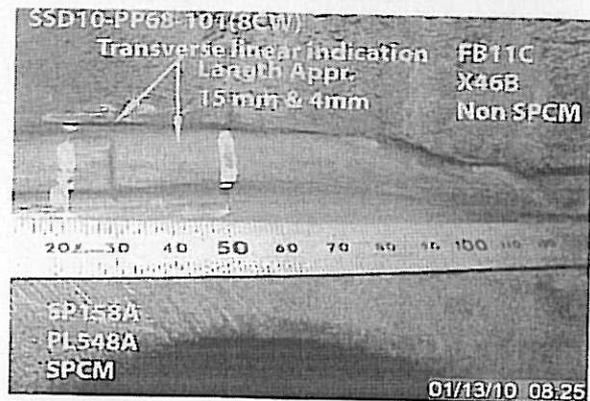
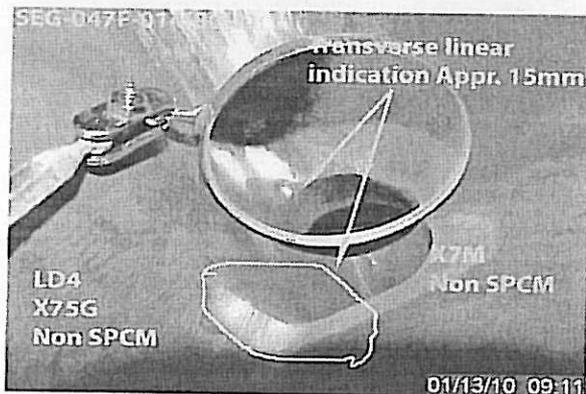
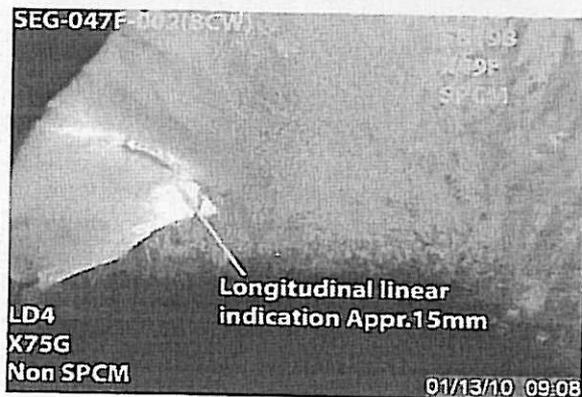
During the Quality Assurance (QA) Magnetic Particle Testing (MT) review of welds located on Segment 8CW, this QA Inspector discovered the following linear indications:

- Weld #SSD10-PP68-101 (SPCM): Two (2) Transverse linear indications measuring approximately 15mm and 4mm. Members are identified as FB11C (X46B) Non SPCM to SP158A (PL548A) SPCM.

- Weld #SEG047F-002 (SPCM): One (1) Longitudinal linear indication measuring approximately 15 mm. Members are identified as FB19B (X49F) SPCM to LD4 (X75G) Non SPCM.

- Weld #SEG047F-014 (non SPCM): One (1) Transverse linear indication measuring approximately 15 mm. Members are identified as LD4 (X75G) Non SPCM to FB19B (X7M) Non SPCM.

- Weld #SP447A-063 (SPCM): One (1) Transverse linear indication measuring approximately 8 mm. Members are identified as FB19B (X12C) SPCM to Side Plate 'I' Stiffener (RS91GB) Non SPCM.

- Weld #SSD10A-PP68-144 (SPCM): One (1) Longitudinal linear indication measuring approximately 13 mm. Members are identified as FB19B (X12C) SPCM to Deck Plate 'I' Stiffener (RS62GA) Non SPCM.

- Weld Connecting Drip plate to Floor Beam (FB27A) at Panel Point PP70 (Cross Beam Side) (SPCM): One (1) Transverse linear indication measuring approximately 17 mm. Members are identified as Drip plate (329M) Non SPCM to Floor Beam FB27A (X12D) Seismic Performance Critical Material (SPCM). This weld does not appear to be identified by number on the contractors weld maps.

has been previously tested by ZPMC Quality Control (QC) personnel.

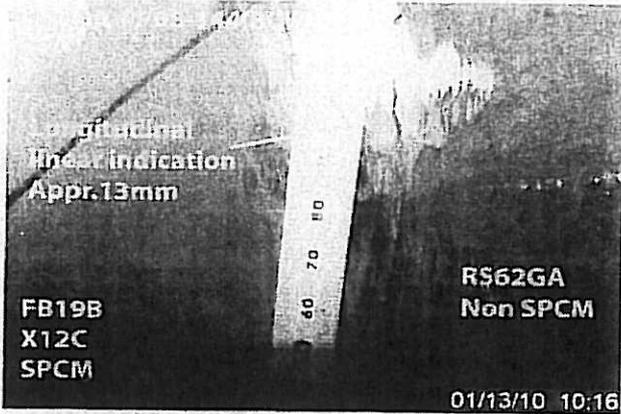
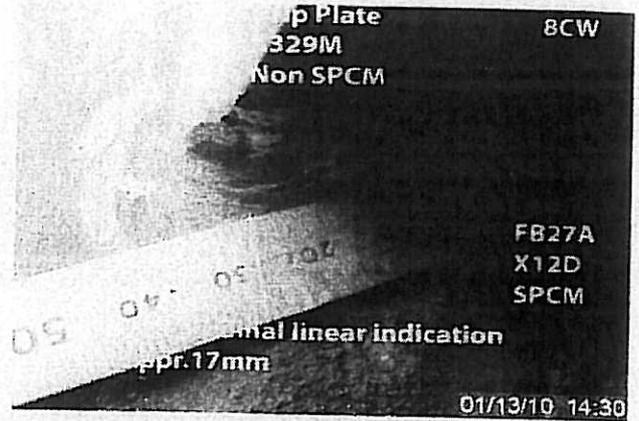
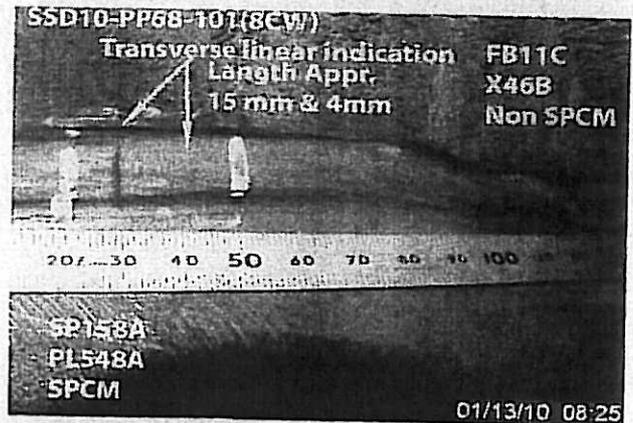
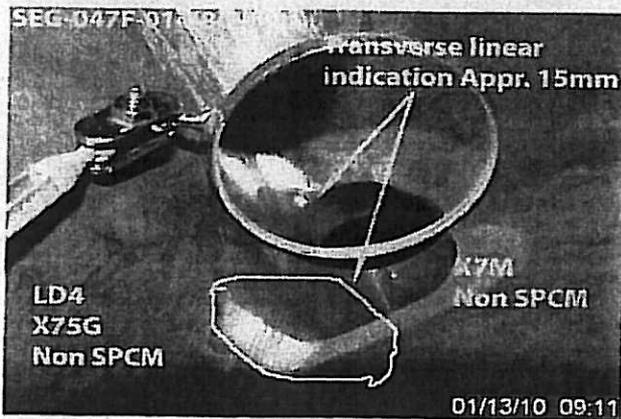
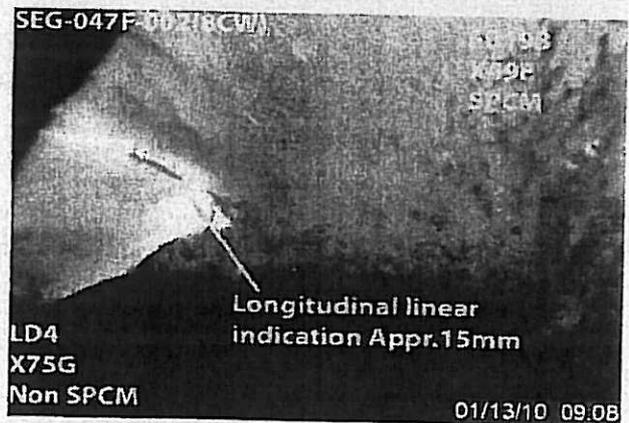
has been previously tested by ZPMC Quality Control (QC) personnel.

Propose a resolution for the identified non-conformance with revised procedures to prevent future occurrences. Missed Mt indications are a chronic problem. Provide training and equipment as required to ensure that these indications are found by the ZPMC MT technician that missed them. Provide documentation of such training to the engineer. A response for the resolution of this issue is expected within 7 days.
