Contract #: 04-0120F4  
 Cty: SF/ALA Rte: 80 PM: 13.2/13.9  
 File #: 69.25B

## QUALITY ASSURANCE -- NON-CONFORMANCE REPORT

**Report No:** NCR-000632

**Reference Description:** ZPMC welder was observed welding outside of his qualified position on 6CW to 7AW Side Panel temporary attachments

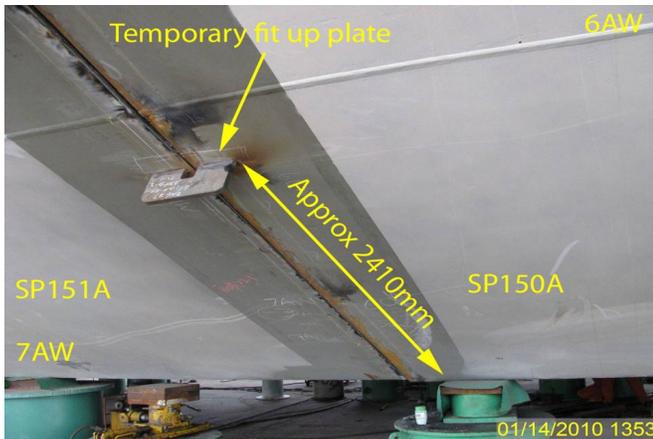
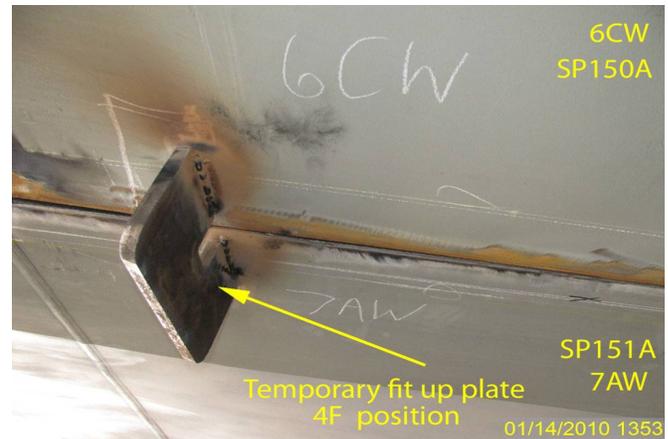
- Welder Xiao Di #203204 (2F) welding in the 4F position which he is not qualified.
- Welding was performed on temporary fit up plates SP150A (6CW) to SP151A (7AW) at the Side Plate Segment field splice, Counter Weight side.
- Fit up plate was welded approximately 2410mm from the Side Plate to Bottom plate splice weld.
- The material for 6CW SP150A (PL524A) is designated as Seismic Performance Critical Member (SPCM).
- The material for 7AW SP151A (PL527A) is designated as Non-Seismic Performance Critical Member (Non-SPCM).
- Segment 6CW/7AW is located outside in the Trial Assembly area.

AWS D1.5 (2002) Section 5.22.2.2 2F (horizontal) – “Qualification in the 2F (horizontal) position shall qualify for flat and horizontal position fillet welding of plate and structural shapes”.

Ensure the welder Xiao Di welds in the positions for which he is approved. A response for the resolution of this issue is expected within 7 days.

Contractor submitted documentation verifying that a Caltrans QA Inspector witnessed Mr. Xiao Di, welder ID No. 203204, perform Welder Qualification Testing on 03-09-2010 in the overhead position. The welder demonstrated his ability to weld in said position and is now qualified.

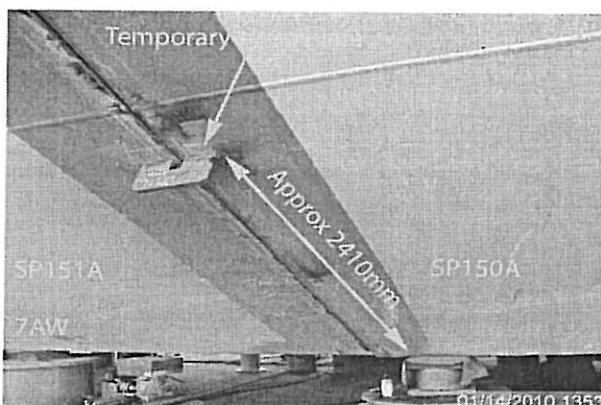
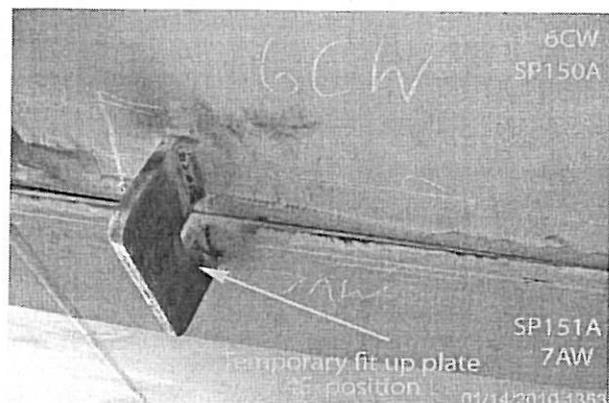
- Welder Xiao Di #203204 (2F) welding in the 4F position which he is not qualified.
- Welding was performed on temporary fit up plates SP150A (6CW) to SP151A (7AW) at the Side Plate Segment field splice, Counter Weight side.
- Fit up plate was welded approximately 2410mm from the Side Plate to Bottom plate splice weld.
- The material for 6CW SP150A (PL524A) is designated as Seismic Performance Critical Member (SPCM).
- The material for 7AW SP151A (PL527A) is designated as Non-Seismic Performance Critical Member (Non-SPCM).
- Segment 6CW/7AW is located outside in the Trial Assembly area.

AWS D1.5 (2002) Section 5.22.2.2 2F (horizontal) – “Qualification in the 2F (horizontal) position shall qualify for flat and horizontal position fillet welding of plate and structural shapes”.

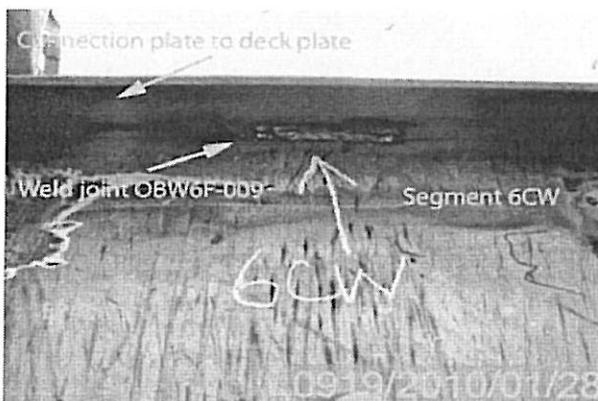
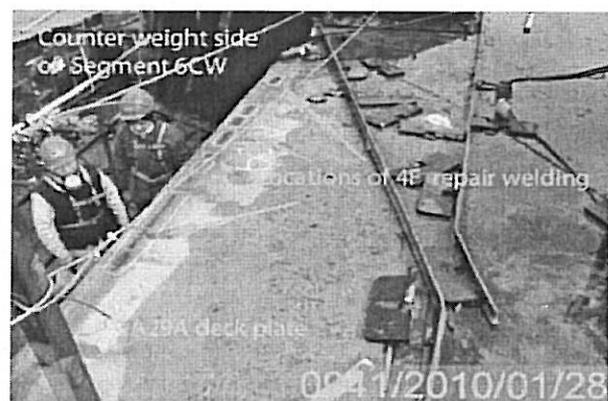
- ZPMC welder Xiao Di # 066401 was observed welding in the 4F overhead welding position, which he is only qualified in 3F vertical position.
- Welding was performed on the Connection Plate to Deck Plate.
- The Deck Plate is identified as CA29A.
- The weld is identified as OBW6F-009.
- This weld is a Complete Joint Penetration (CJP).
- A total of eight (8) repairs were performed on the bottom side of weld joint OBW6F-009.
- These repairs are located on the Counter Weight side of segment 6CW at the W3 line.
- Lift 6W is located in the OGB Trial Assembly Area.

AWS D1.5 (2002) 5.22.2.3; 3F (Vertical). Qualification in the 3F (vertical) position shall qualify for flat, horizontal, and vertical position fillet welding of plate and structural shapes.

Propose a resolution for the identified non-conformance with revised procedures to prevent future occurrences and also provide documentation to show that the weld quality conforms to contract requirements.
