Contract #: 04-0120F4Cty: SF/ALA Rte: 80 PM: 13.2/13.9File #: 69.25B**QUALITY ASSURANCE -- NON-CONFORMANCE REPORT****Location:** Changxing Island, Shanghai, P.R. China**Report No:** NCR-000633**Prime Contractor:** American Bridge/Fluor Enterprises, a JV**Date:** 14-Jan-2010**Submitting Contractor:** Zhenhua Port Machinery Company, Ltd (ZPMC), Changxing Island**NCR #:** ZPMC-0606**Type of problem:****Welding****Concrete****Other****Welding****Curing****Procedural****Bridge No:** 34-0006**Joint fit-up****Coating****Other****Component:** 6BW-6CW Side and Bottom Panel T-Rib and I-Rib**Procedural****Procedural****Description:**

Reference Description: 6BW to 6CW Stiffener to Stiffener weld joints were welded with offset exceeding 3mm

Job Name: SAS Superstructure

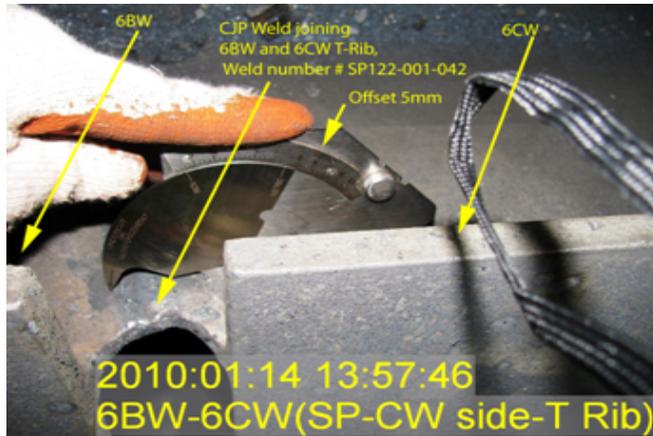
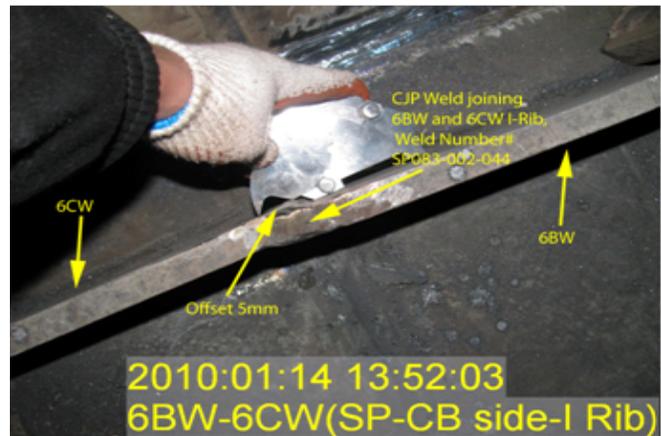
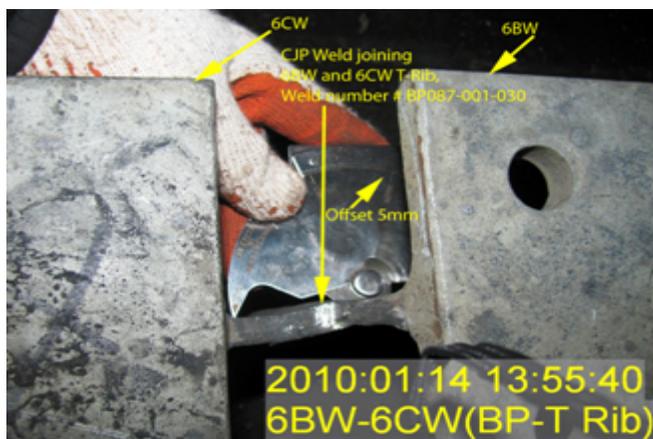
-Two (2) T-Rib web welds and One (1) I-Rib weld between the 6BW to 6CW (transverse splice) were misaligned across the weld joints.

- 1) SP083-002-044 (1st I-Rib on SP from top-CB side)
- 2) BP087-001-030 (6th T-Rib on BP from work point W3)
- 3) SP122-001-042 (7th T-Rib on SP from bottom-CW side)

-The out of tolerance offset measurement across the welds were measured at 5mm.

-The maximum out of tolerance allowed per AWS D1.5 2002 is 3mm.

Special Provisions Section 10-1.59 Steel Structures, Shop Welding G item 2; Misalignment between discontinuous members shall not exceed 10% of the thickness of the thinner member or 3mm, whichever is less.

AWS D1.5 (02) Section 3.3.3; "Parts to be joined by groove welds shall be carefully aligned. Where the parts are effectively restrained against bending due to eccentricity in alignment, the offset from theoretical alignment shall not exceed 10 percent of the thickness of the thinner part joined, but in no case shall be more than 3 mm (1/8)."

Reference Resolution: ZPMC cut off the ribs and re-welded them to rectify the misalignment issue. The alignment is now acceptable and has been removed from the punchlist to show that the alignment is acceptable.

ZPMC cut off the ribs and re-welded them to rectify the misalignment issue. The alignment is now acceptable and has been removed from the punchlist to show that the alignment is acceptable. ZPMC is providing the repair report used to correct the misalignment as well as the NDT after to show the cut welds are acceptable. Based on this ZPMC requests that this NCR be closed.

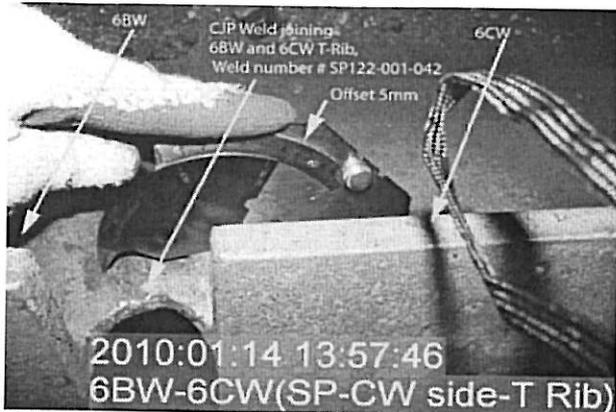
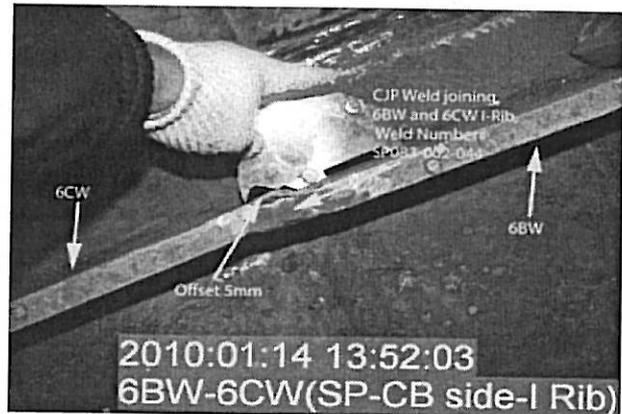
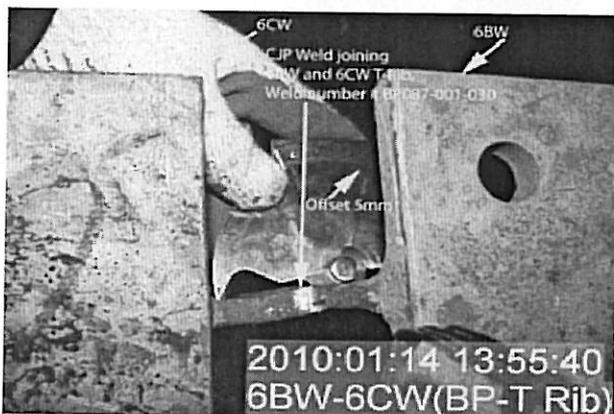
-Two (2) T-Rib web welds and One (1) I-Rib weld between the 6BW to 6CW (transverse splice) were misaligned across the weld joints.

- 1) SP083-002-044 (1st I-Rib on SP from top-CB side)
- 2) BP087-001-030 (6th T-Rib on BP from work point W3)
- 3) SP122-001-042 (7th T-Rib on SP from bottom-CW side)

-The out of tolerance offset measurement across the welds were measured at 5mm.

-The maximum out of tolerance allowed per AWS D1.5 2002 is 3mm.

Special Provisions Section 10-1.59 Steel Structures, Shop Welding G item 2; Misalignment between discontinuous members shall not exceed 10% of the thickness of the thinner member or 3mm, whichever is less.

AWS D1.5 (02) Section 3.3.3; "Parts to be joined by groove welds shall be carefully aligned. Where the parts are effectively restrained against bending due to eccentricity in alignment, the offset from theoretical alignment shall not exceed 10 percent of the thickness of the thinner part joined, but in no case shall be more than 3 mm (1/8)."

Remove weld to correct fit-up issue, reweld and perform NDT required to verify weld quality.

Welds were removed and members were brought with in Contract fit-up tolerance and NDT documentation was submitted verifying the welds are in conformance with Contract specifications. An internal NCR was also issued by the Contractor in regards to this issue.

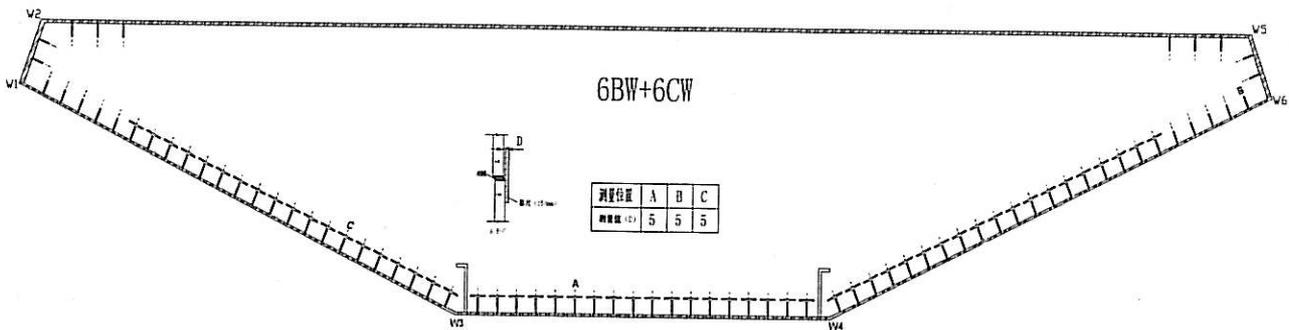
Draft of welding discontinuity:

After inspection: I-ribs and T-ribs were misalignment at 6BW and 6CW, the detail position sees the following draft, weld ID: SP083-001-044, BP087-001-030, SP122-001-042

Weld distortion and fabricate error.

1. Remove the welds between I-Ribs/T-Ribs, I-Ribs/T-Ribs and BP/SP at the splice by grinding or cutting. The weld length to be removed will be determined by actual situation. Preheat according to the WPS prior to gouging.
2. Adjust the misalignment of T-Ribs/I-Ribs to meet the tolerance. The transition is not more than 1:10.
3. Prepare the excavation according to the relevant WPS.
4. Preheat and weld according to the WPS.
5. Grind the weld flush to the adjacent weld or base metal.
6. Check the welds according to the shop drawings.
