Contract #: 04-0120F4Cty: SF/ALA Rte: 80 PM: 13.2/13.9File #: 69.25B**QUALITY ASSURANCE -- NON-CONFORMANCE REPORT****Location:** Changxing Island, Shanghai, P.R. China**Report No:** NCR-000634**Prime Contractor:** American Bridge/Fluor Enterprises, a JV**Date:** 15-Jan-2010**Submitting Contractor:** Zhenhua Port Machinery Company, Ltd (ZPMC), Changxing Island**NCR #:** ZPMC-0607**Type of problem:**

**Reference Description:** Weld Repair on 2 linear cracks performed without CWR on Segment 8CW Floor Beam to Longitudinal Diaphragm

**Job Name:** SAS Superstructure

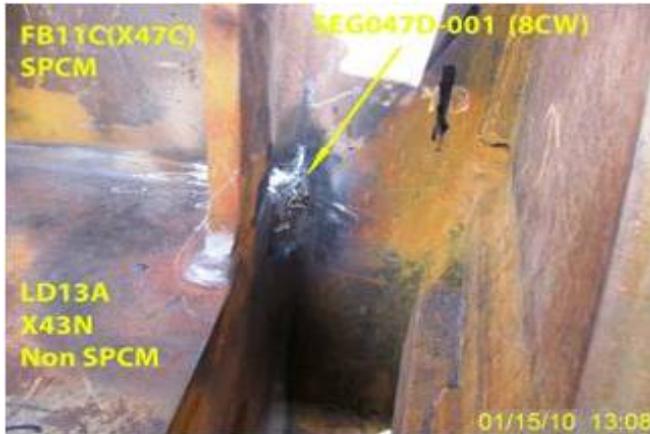
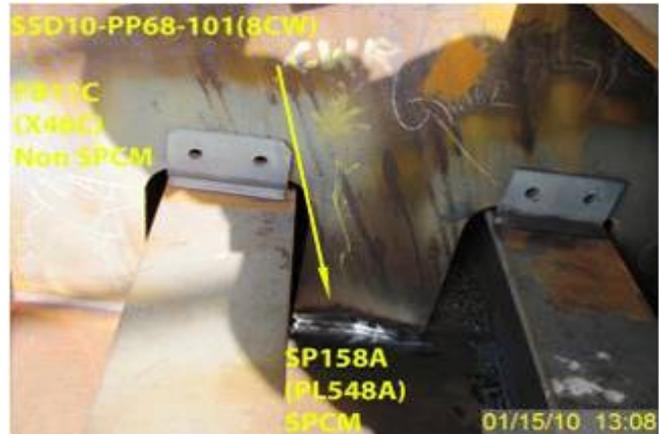
- ZPMC performed two (2) weld repairs of linear cracks (verified by Magnetic Particle Testing (MT) on January 13, 2010) without the prior approval of the engineer.
- This fillet weld is identified as: SSD10-PP68-101.
- This fillet weld joins the Side Plate (SP158A) to Floor Beam (FB11C).
- This fillet weld is located at panel point 68 (PP68) on the Counter Weight side.
- This weld is designated as Seismic Performance Critical Member (SPCM).
- The Side Plate is identified as plate number PL548A (SPCM).
- The Floor Beam is Identified as plate number X46B (Non SPCM).

- This complete joint penetration weld (CJP) is identified as: SEG047D-001
- This CJP weld joins the Longitudinal Diaphragm (LD13A) to Floor Beam (FB11C).
- The CJP is located at PP68 on the Counter Weight side.
- This weld is designated as Seismic Performance Critical Member (SPCM).
- The Longitudinal Diaphragm is identified as plate number X43N (Non SPCM).
- The Floor Beam is Identified as plate number X47C (SPCM).
- OBG segment 8CW is located outside on the west side of the Blast Shop.

AWS D1.5-2002 Section 12.17.1 WPS Requirements; "Repair welding shall be done in conformance with an approved WPS."

AWS D1.5-2002 Section 12.17.4 Approval; "All critical repairs to base metal and welds shall be approved by the Engineer prior to beginning the repair and shall be documented giving details of the type of discontinuity and extent of repair."

AWS D1.5-2002 Section 3.7.4; Prior approval of the Engineer shall be obtained for repairs to base metal, repairs of major or delayed cracks.

Do not initiate weld repair without prior approval of the engineer. Submit NDT records indicating these two welds are sound. A response for the resolution of this issue is expected within 7 days.

**Reference Resolution:** ZPMC has repaired the welds in question and performed NDT to show that the welds are acceptable. Based on this ZPMC requests closure of this NCR.

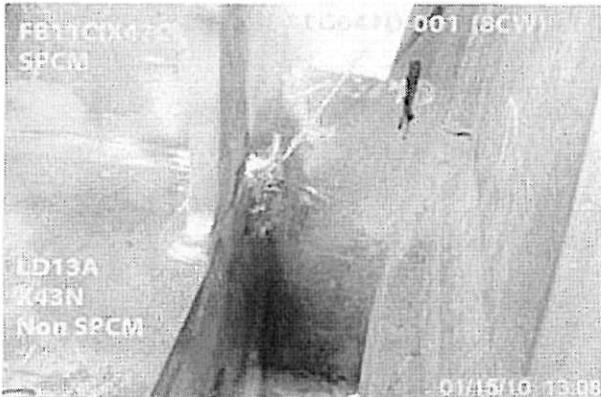
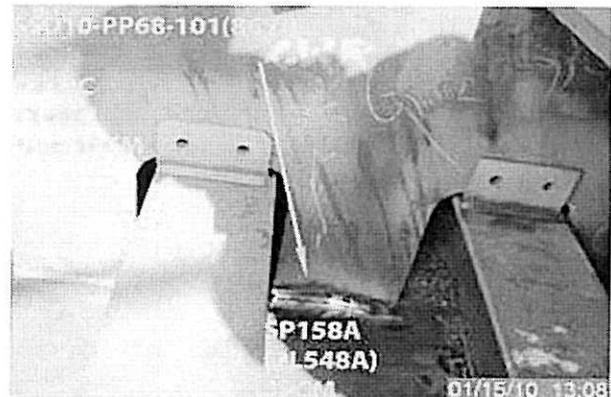
- ZPMC performed two (2) weld repairs of linear cracks (verified by Magnetic Particle Testing (MT) on January 13, 2010) without the prior approval of the engineer.
- This fillet weld is identified as: SSD10-PP68-101.
- This fillet weld joins the Side Plate (SP158A) to Floor Beam (FB11C).
- This fillet weld is located at panel point 68 (PP68) on the Counter Weight side.
- This weld is designated as Seismic Performance Critical Member (SPCM).
- The Side Plate is identified as plate number PL548A (SPCM).
- The Floor Beam is Identified as plate number X46B (Non SPCM).

- This complete joint penetration weld (CJP) is identified as: SEG047D-001
- This CJP weld joins the Longitudinal Diaphragm (LD13A) to Floor Beam (FB11C).
- The CJP is located at PP68 on the Counter Weight side.
- This weld is designated as Seismic Performance Critical Member (SPCM).
- The Longitudinal Diaphragm is identified as plate number X43N (Non SPCM).
- The Floor Beam is Identified as plate number X47C (SPCM).
- OBG segment 8CW is located outside on the west side of the Blast Shop.

AWS D1.5-2002 Section 12.17.1 WPS Requirements; "Repair welding shall be done in conformance with an approved WPS."

AWS D1.5-2002 Section 12.17.4 Approval; "All critical repairs to base metal and welds shall be approved by the Engineer prior to beginning the repair and shall be documented giving details of the type of discontinuity and extent of repair."

AWS D1.5-2002 Section 3.7.4; Prior approval of the Engineer shall be obtained for repairs to base metal, repairs of major or delayed cracks.

Provide NDT documentation to verify weld quality and issue an internal NCR in regards to the quality management issue.

Contractor submitted NDT documentation verifying repairs meet Contract weld quality requirements and issued an internal NCR in regards to this issue.
