QUALITY ASSURANCE -- NON-CONFORMANCE REPORT

Report No: NCR-000637

Welding	Concrete	Other	
Welding	Curing	Procedural	Bridge No: 34-0006
Joint fit-up	Coating	Other	Component: West Tower Lift 4
Procedural	Procedural	Description:

Reference Description: ZPMC used different type filler wires performing the weld repair at the joint connecting 345 grade to 485 grade material located at West Tower Lift 4

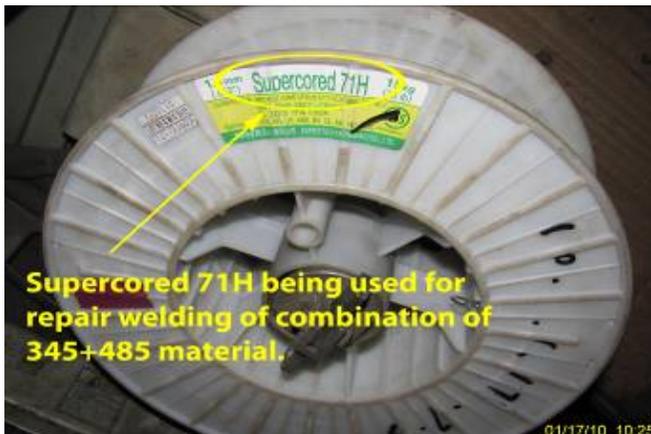
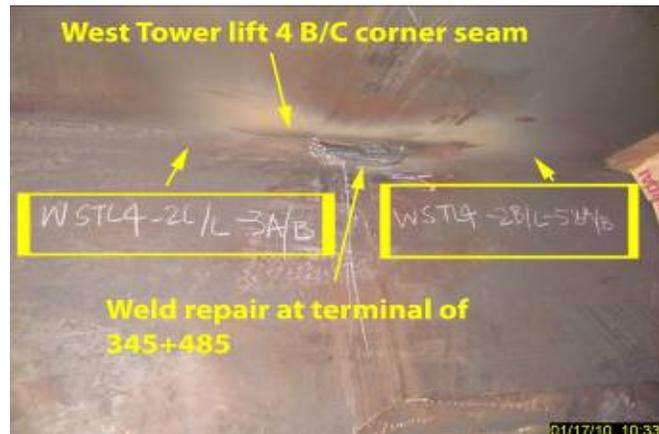
During the random Quality Assurance(QA) in process verification of West Tower lift 4, this QA Inspector observed the following issues:

- ZPMC welding personnel performing weld repair of B/C corner seam of West tower lift 4 using Flux Cored Arc Welding (FCAW) process.
- The weld numbers are identified as WSTL4-2L/L-3A/B for 485 grade material and WSTL4-2B/L-58A/B for 345 grade material.
- ZPMC personnel performing the weld repair at the joint connecting 345 grade to 485 grade material using WPS-345-FCAW-1G(1F)-REPAIR with Supercored 71H filler wire.
- The required filler wire for welding of these joints is K-71TSR with WPS-345+485-FCAW-1G-REPAIR.
- The weld joint is a Complete Joint Penetration (CJP) weld.
- The material is designated as non Seismic Performance Critical Member (non SPCM).
- The member is located at Tower bay no. 11.

The above referenced weld repair is rejected. In accordance with Section 5-1.09, "Removal of Rejected And Unauthorized Work", of the Standard Specifications, this weld repair is to be removed and replaced with the proper filler wire utilizing the correct WPS.

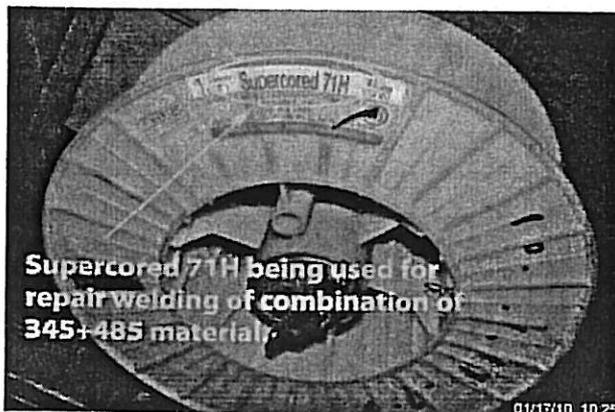
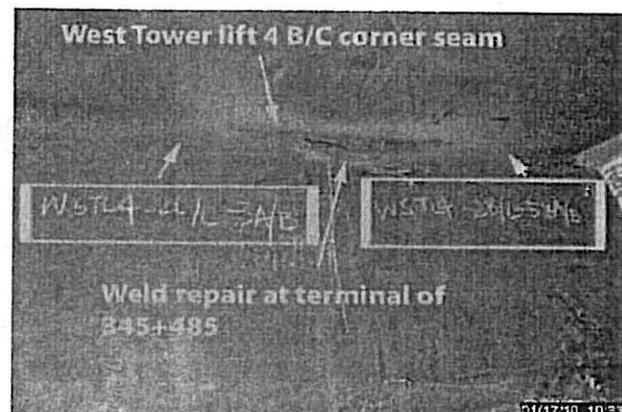
During the random Quality Assurance(QA) in process verification of West Tower lift 4, this QA Inspector observed the following issues:

- ZPMC welding personnel performing weld repair of B/C corner seam of West tower lift 4 using Flux Cored Arc Welding (FCAW) process.
- The weld numbers are identified as WSTL4-2L/L-3A/B for 485 grade material and WSTL4-2B/L-58A/B for 345 grade material.
- ZPMC personnel performing the weld repair at the joint connecting 345 grade to 485 grade material using WPS-345-FCAW-1G(1F)-REPAIR with Supercored 71H filler wire.
- The required filler wire for welding of these joints is K-71TSR with WPS-345+485-FCAW-1G-REPAIR.
- The weld joint is a Complete Joint Penetration (CJP) weld.
- The material is designated as non Seismic Performance Critical Member (non SPCM).
- The member is located at Tower bay no. 11.

The above referenced weld repair is rejected. In accordance with Section 5-1.09, "Removal of Rejected And Unauthorized Work", of the Standard Specifications, this weld repair is to be removed and replaced with the proper filler wire utilizing the correct WPS.

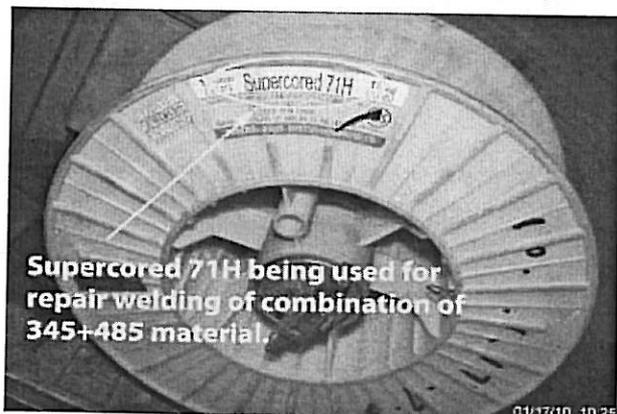
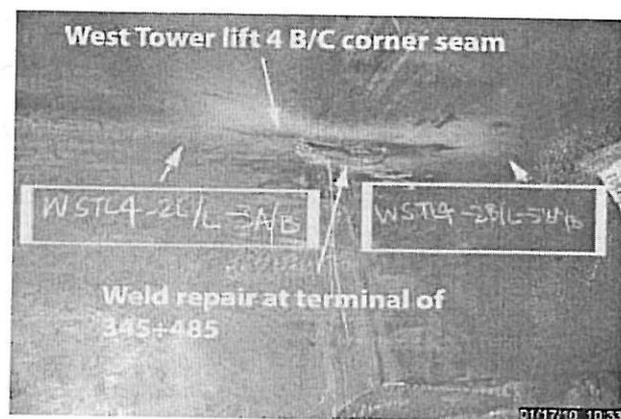
During the random Quality Assurance(QA) in process verification of West Tower lift 4, this QA Inspector observed the following issues:

- ZPMC welding personnel performing weld repair of B/C corner seam of West tower lift 4 using Flux Cored Arc Welding (FCAW) process.
- The weld numbers are identified as WSTL4-2L/L-3A/B for 485 grade material and WSTL4-2B/L-58A/B for 345 grade material.
- ZPMC personnel performing the weld repair at the joint connecting 345 grade to 485 grade material using WPS-345-FCAW-1G(1F)-REPAIR with Supercored 71H filler wire.
- The required filler wire for welding of these joints is K-71TSR with WPS-345+485-FCAW-1G-REPAIR.
- The weld joint is a Complete Joint Penetration (CJP) weld.
- The material is designated as non Seismic Performance Critical Member (non SPCM).
- The member is located at Tower bay no. 11.

ZPMC has completely removed the weld in question and rewelded it using the correct filler metal. NDT documentation will be provided at a later date, based on this ZPMC request closure of this NCR.
