Contract #: 04-0120F4Cty: SF/ALA Rte: 80 PM: 13.2/13.9File #: 69.25B**QUALITY ASSURANCE -- NON-CONFORMANCE REPORT****Location:** Changxing Island, Shanghai, P.R. China**Report No:** NCR-000640**Prime Contractor:** American Bridge/Fluor Enterprises, a JV**Date:** 18-Jan-2010**Submitting Contractor:** Zhenhua Port Machinery Company, Ltd (ZPMC), Changxing Island**NCR #:** ZPMC-0612**Type of problem:**

Reference Description: Perform of CWR repair on Lift 12 Longitudinal Diaphragm without following the approved procedure

Dear: Mr. Charles Kanapicki
Job Name: SAS Superstructure

Subject: NCR No. ZPMC-0612

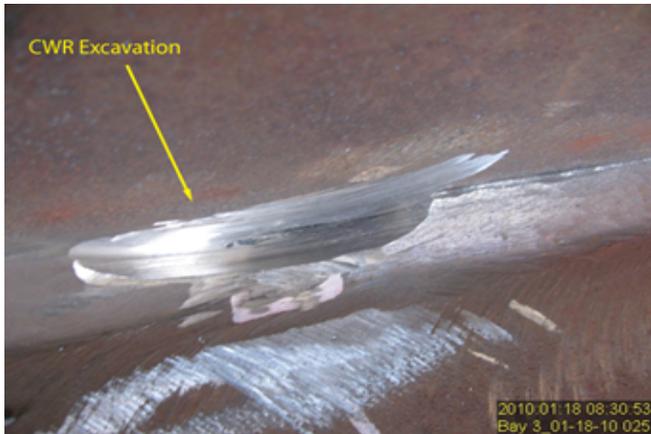
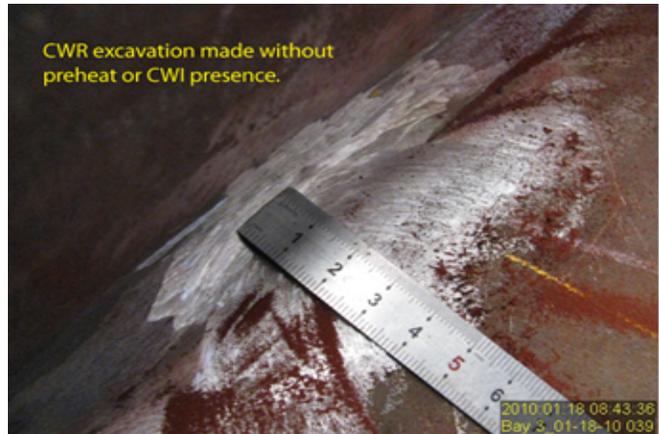
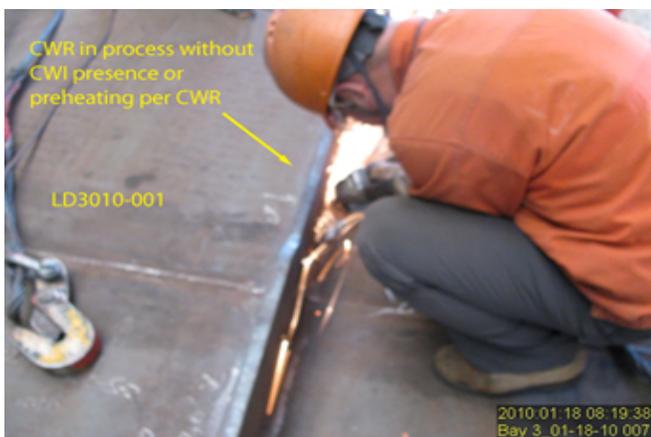
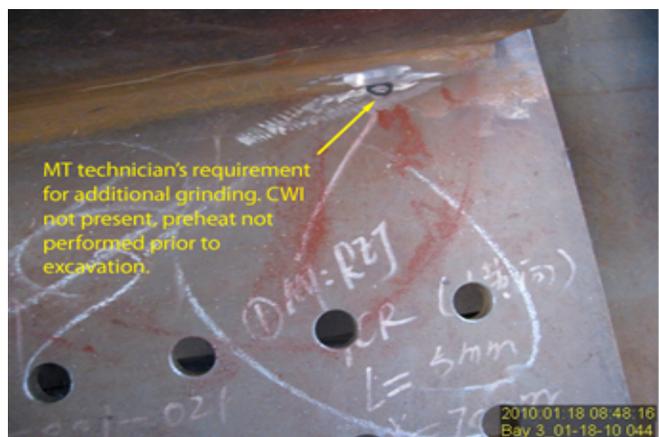
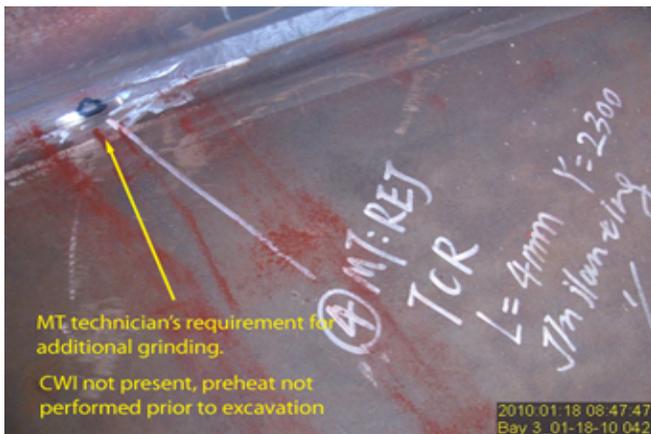
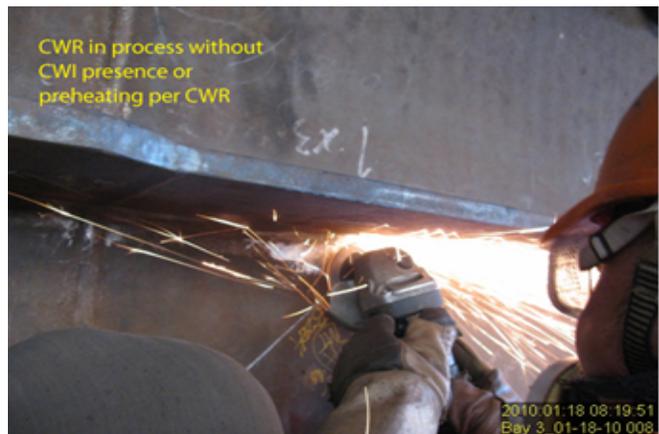
- ZPMC personnel were excavating Magnetic Particle (MT) Indications identified by ZPMC's MT Technician as cracks. The ZPMC worker did not have the approved Critical Weld Repair (CWR) B-1050 and B-1051 on hand during the repair.

- ZPMC Quality Control (QC) Certified Weld Inspector (CWI) was not present.
- ZPMC personnel were performing crack removal by grinding without preheat per these approved CWRs.

- Members are identified as LD3008-001 and LD3010-001.
- CWRs identified as B-CWR1051 for LD3008-001 and B-CWR1050 for LD3010-001 specify that QC CWI shall be present with the approved CWR in hand and preheat to 650 C prior to excavation by grinding.

- The following areas were being excavated:
 - LD3008-001; Weld 21; Y=75mm, Weld 14; Y=2300mm, Weld 08; Y=1100mm, Weld 07; Y=400mm, and Weld 06; Y=500mm.

- LD3010-001; Weld 49; Y=300mm, and Weld 43; Y=0mm.
- These welds are all fillet weld T-joints joining longitudinal diaphragm stiffeners to longitudinal diaphragm web plates.

Propose a resolution for the identified non-conformance with revised procedures to prevent future occurrences. A response for the resolution of this issue is expected within 7 days.

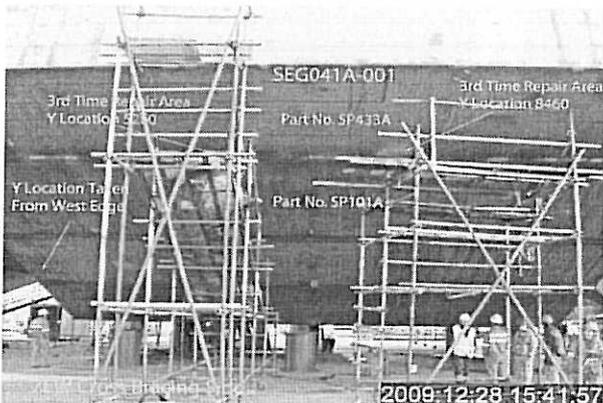
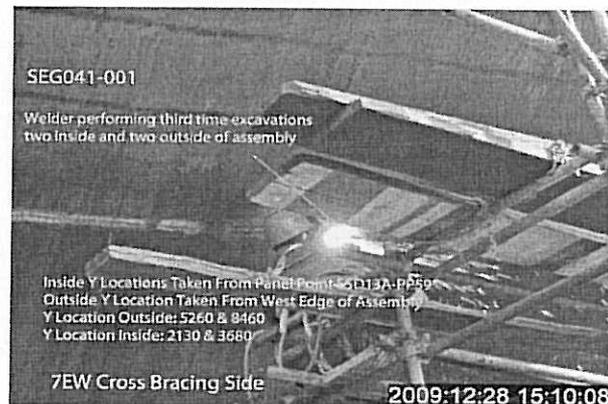
This QA observed ZPMC welding personnel performing third (3rd) time weld repair excavations to Seismic Performance Critical Material (SPCM) weld without the Engineer's approval or an Critical Weld Report (CWR) in the following four (4) locations:

- "Y" = 5260mm and 8460mm on the outside surface pulling from the west end of the segment.
- "Y" = 2130mm and 3680mm on the inside surface pulling from Panel Point 059.
- The Orthotropic Box Girder (OBG) segment is identified as 7EW.
- The weld is identified as SEG041A-001.
- The weld is designated as SPCM on the approved drawings.
- The weld is a Complete Joint Penetration (CJP) butt joint joining Side Panel identified as SP433A (SPCM) to SP101A.

Caltrans Special Provisions section 8-3.01 specifies In addition to the provisions in AWS D1.5, section 3.7.4 and section 12.17, third time repairs of welds, or base metal, regardless of NDT method,...require prior approval of the Engineer.”

Do not perform 3 time SPCM repair without notification and approval of a CWR. Submit UT test data to verify weld soundness.

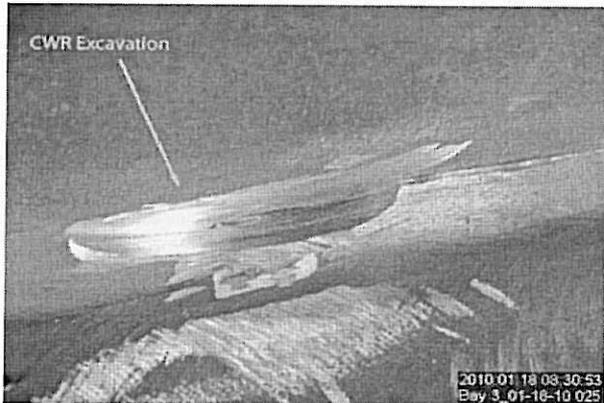
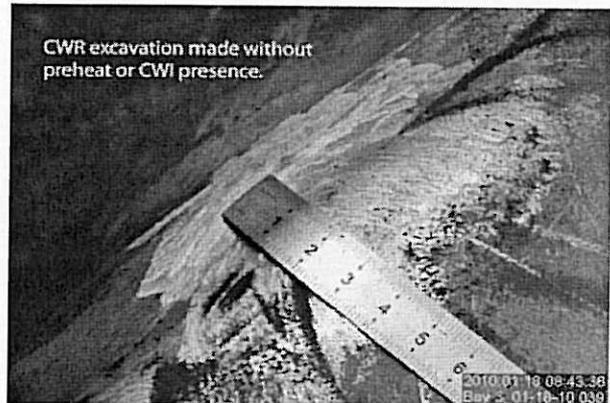
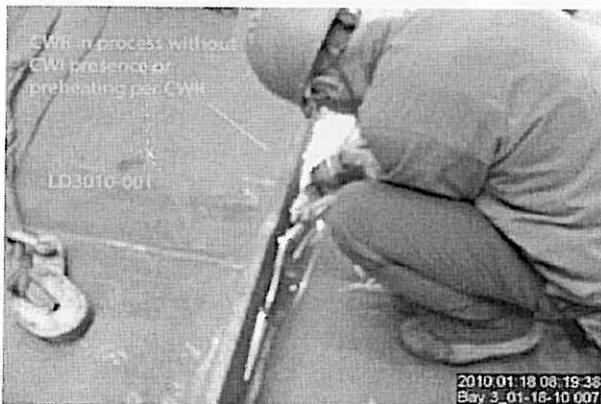
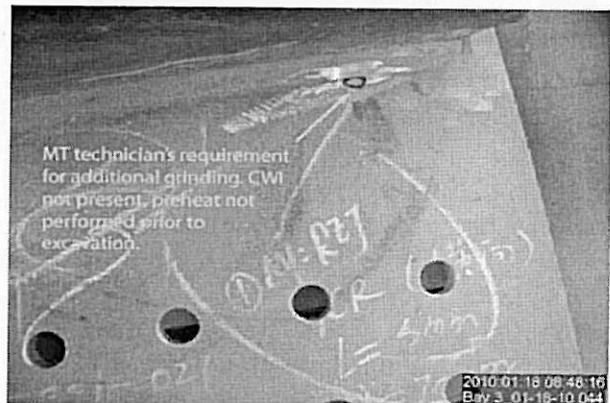
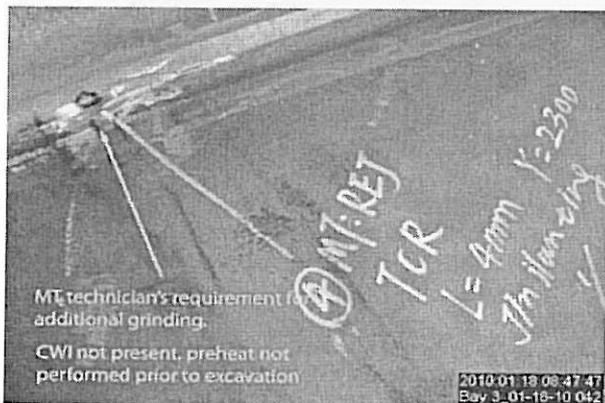
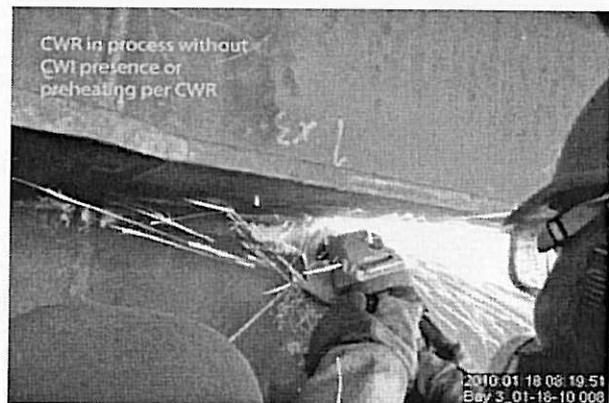
- ZPMC personnel were excavating Magnetic Particle (MT) Indications identified by ZPMC's MT Technician as cracks. The ZPMC worker did not have the approved Critical Weld Repair (CWR) B-1050 and B-1051 on hand during the repair.

- ZPMC Quality Control (QC) Certified Weld Inspector (CWI) was not present.
- ZPMC personnel were performing crack removal by grinding without preheat per these approved CWRs.

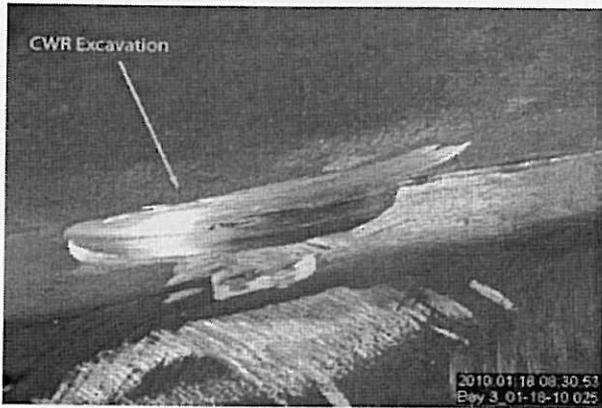
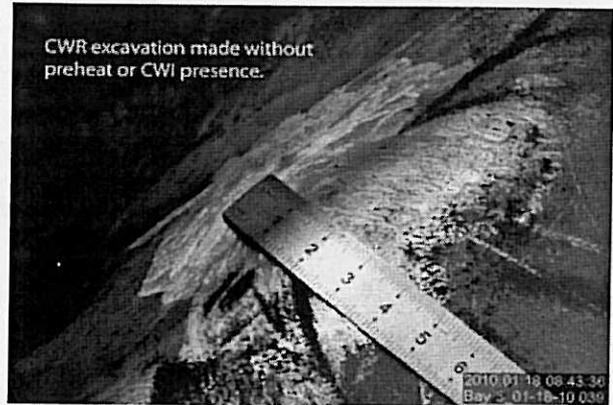
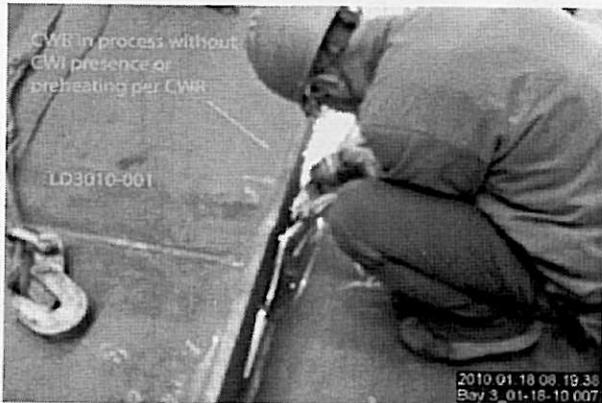
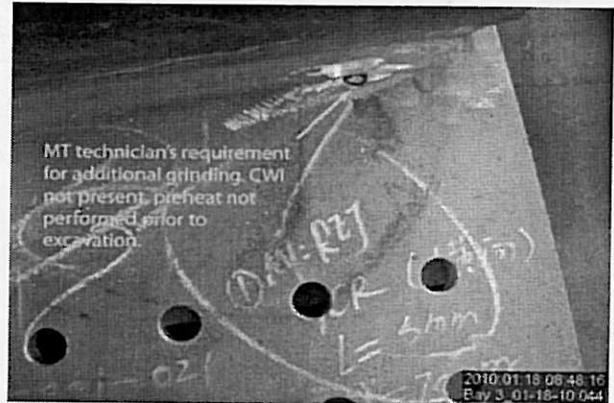
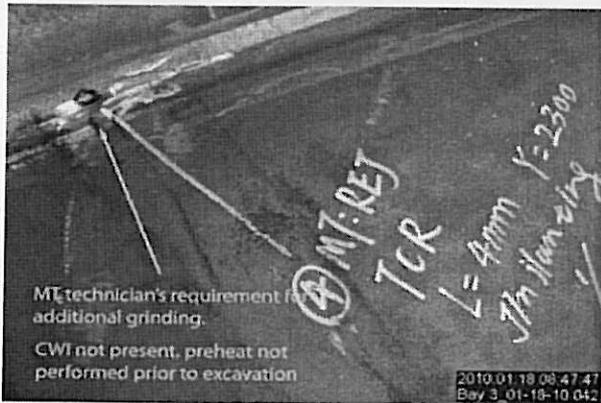
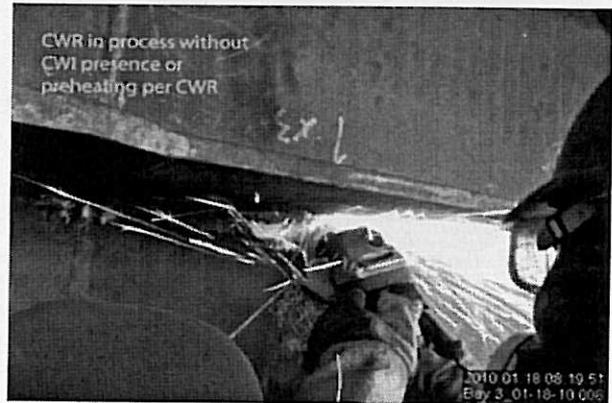
- ZPMC personnel were excavating Magnetic Particle (MT) Indications identified by ZPMC's MT Technician as cracks. The ZPMC worker did not have the approved Critical Weld Repair (CWR) B-1050 and B-1051 on hand during the repair.

- ZPMC Quality Control (QC) Certified Weld Inspector (CWI) was not present.
- ZPMC personnel were performing crack removal by grinding without preheat per these approved CWRs.

Contractor proposes to place ABF QC in charge of bays to ensure conformance with Contact requirements prior to beginning repairs.
