Contract #: 04-0120F4Cty: SF/ALA Rte: 80 PM: 13.2/13.9File #: 69.25B**QUALITY ASSURANCE -- NON-CONFORMANCE REPORT****Location:** Changxing Island, Shanghai, P.R. China**Report No:** NCR-000641**Prime Contractor:** American Bridge/Fluor Enterprises, a JV**Date:** 18-Jan-2010**Submitting Contractor:** Zhenhua Port Machinery Company, Ltd (ZPMC), Changxing Island**NCR #:** ZPMC-0613**Type of problem:**

Reference Description: 1 Missed MT Transverse Indication by QC on T-Stiffener to Bottom Panel Weld in Segment 5CE

Dear: Mr. Charles Kanapicki
Job Name: SAS Superstructure

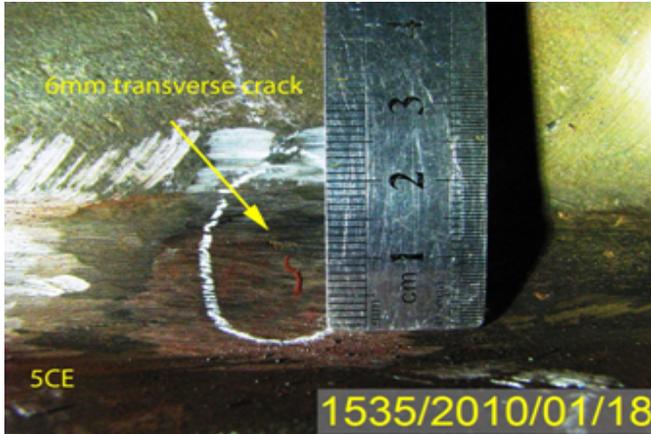
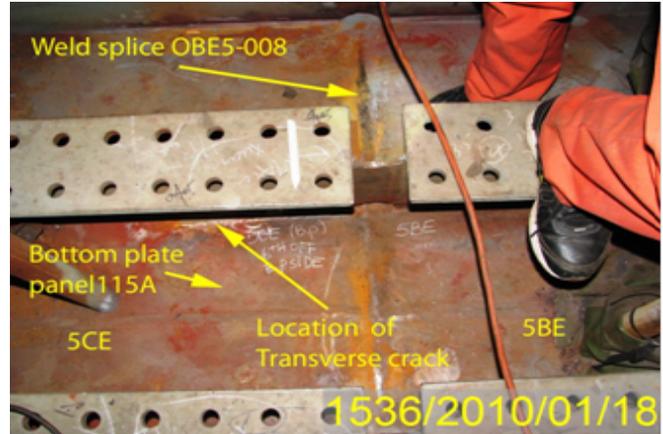
During the Quality Assurance Magnetic Particle Testing (MT) review of welds located on Segment 5BE+5CE hold back welds, this Quality Assurance Inspector (QA) discovered the following issues:

- 1 transverse crack indication measuring approximately 6mm in length.
- The weld is identified as BP112-001-001.
- The weld is a fillet weld.
- The weld is joining a T-Stiffener to bottom panel identified as BP115A.
- 6th T-stiffener off the bike path side of segment (@ E3 line).
- Y location of the transverse crack is noted to be 140mm off 5BE+5CE weld splice OBE5A-008.
- Lift 5 East is located in the OGB Trial Assembly Area.

The Notice of Witness Inspection Number (NWIT) is 005076. The indication is located inside the area that has been previously tested and accepted by ZPMC Quality Control (QC) personnel. ZPMC's QC personnel are required to perform one hundred (100%) percent MT inspection of this weld.

AWS D1.5-2002 Section 6.26.2; "Welds that are subject to RT or MT in addition to visual inspection shall have no cracks and shall be unacceptable if the RT or MT shows any of the types of discontinuities described in 6.26.2.1, 6.26.2.2, 6.26.2.3, or 6.26.2.4".

Repair said indication and perform NDT required to verify weld quality.

Contractor submitted post repair NDT report verifying the weld is now in conformance with Contract specifications.

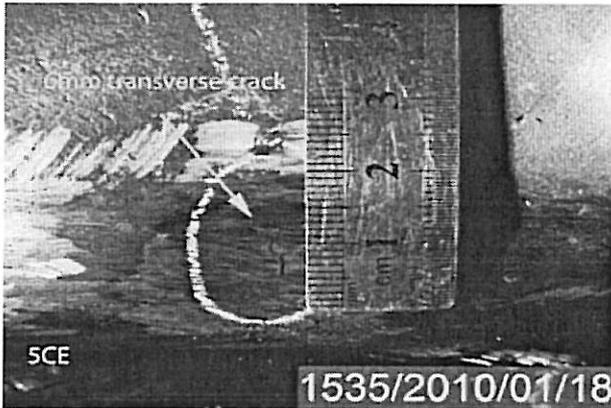
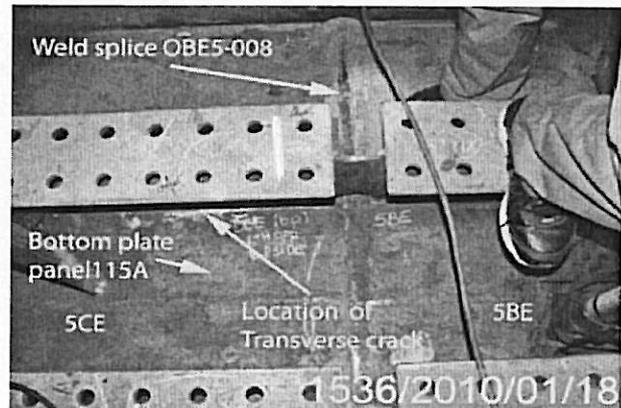
During the Quality Assurance Magnetic Particle Testing (MT) review of welds located on Segment 5BE+5CE hold back welds, this Quality Assurance Inspector (QA) discovered the following issues:

- 1 transverse crack indication measuring approximately 6mm in length.
- The weld is identified as BP112-001-001.
- The weld is a fillet weld.
- The weld is joining a T-Stiffener to bottom panel identified as BP115A.
- 6th T-stiffener off the bike path side of segment (@ E3 line).
- Y location of the transverse crack is noted to be 140mm off 5BE+5CE weld splice OBE5A-008.
- Lift 5 East is located in the OGB Trial Assembly Area.

The Notice of Witness Inspection Number (NWIT) is 005076. The indication is located inside the area that has been previously tested and accepted by ZPMC Quality Control (QC) personnel. ZPMC's QC personnel are required to perform one hundred (100%) percent MT inspection of this weld.

AWS D1.5-2002 Section 6.26.2; "Welds that are subject to RT or MT in addition to visual inspection shall have no cracks and shall be unacceptable if the RT or MT shows any of the types of discontinuities described in 6.26.2.1, 6.26.2.2, 6.26.2.3, or 6.26.2.4".
