DEPARTMENT OF TRANSPORTATION
 DIVISION OF ENGINEERING SERVICES
 Office of Structural Materials
 Quality Assurance and Source Inspection

Contract #: 04-0120F4
 Cty: SF/ALA Rte: 80 PM: 13.2/13.9
 File #: 69.25B

QUALITY ASSURANCE -- NON-CONFORMANCE REPORT

Location: Changxing Island, Shanghai, P.R. China **Report No:** NCR-000644
Prime Contractor: American Bridge/Fluor Enterprises, a JV **Date:** 20-Jan-2010
Submitting Contractor: Zhenhua Port Machinery Company, Ltd (ZPMC), Changxing Island **NCR #:** ZPMC-0615

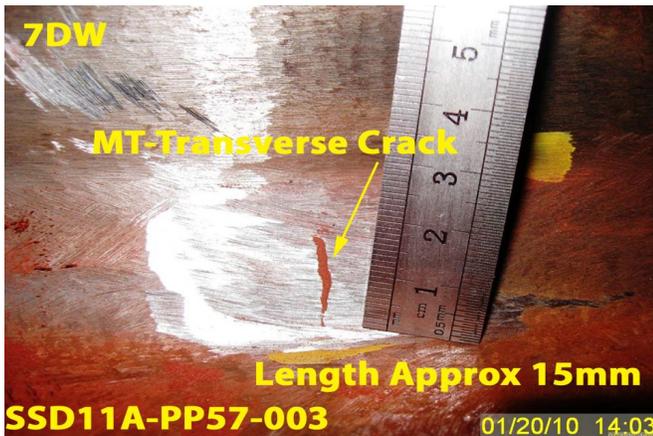
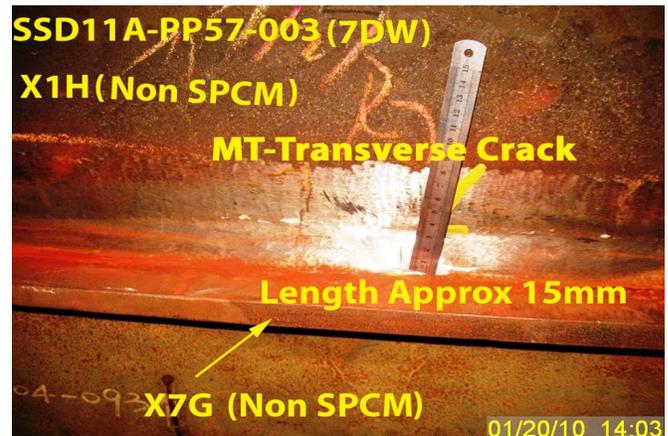
- One (1) Transverse linear crack measuring approximately 15mm in length.
- The Y location is 4500mm from corner of the Panel Point PP57 at Cross Beam side.
- The indication is clearly marked on the material near the weld.
- The weld is identified as: SSD11A-PP57-003.
- This weld is a Complete Joint Penetration (CJP) weld joining the Deck Panel Diaphragm (X1H) to Floor Beam Flange (X7G).
- The Deck Panel Diaphragm (X1H) is identified as Non-Seismic Performance Critical Member (SPCM).
- The Floor Beam Flange (X7G) is identified as Non-SPCM.
- OBG segment 7DW is located outside North side of Bay 13.

The Notice of Witness Inspection Number (NWIT) is 005086. The indication is located inside an area that has been previously tested 100% and accepted by ZPMC Quality Control (QC) personnel.

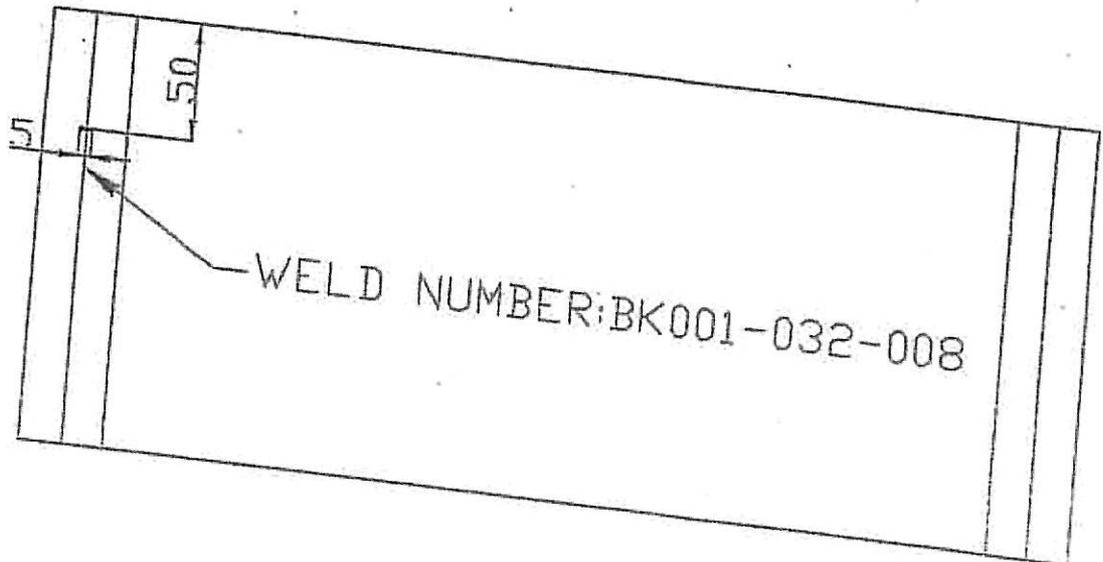
Draft of Welding Discontinuity:

在对BK001-032-008检测时, 发现1处横向裂纹, L1=5mm

One transverse crack was found by use of MT on BK001-032-008.

1. 火焰加热时, 水汽没有完全的去除或者这个区域预热不够;
1. Moisture wasn't completely removed during drying operation (preheating) or the area wasn't preheated sufficiently.

1. QC and a Lead CWI shall be present, direct and supervise all grinding and welding operations during this repair to ensure the repair is per the disposition requirements

2. QC and a Lead CWI shall have an approved copy of the CWR in hand prior to the repair.
3. Remove paint ≥ 25 mm in all direction of HAZ prior to MT.
4. Clean the excavation area of all loose debris including MT powder. Preheat to 65° C before removing cracks by grinding, repair area shall extend a minimum of 50mm beyond each end of single crack repairs.

5. If base metal is damaged by grinding, the damaged area shall be ground clean prior to performing weld repair. If gap > 5 mm is found during or after grinding, comply with the notification on changing fillet weld to CJP which is submitted for Engineer's review and approval form.

6. Prepare excavation in accordance with the New Repair Procedure prior to welding.
7. Before this repair, Verify with VT and MT repair areas are defects free, and also MT shall be performed on the base metal laying abroad cracks to ensure that no cracks were propagated to the base metal. Separate CWR approval is needed if cracks are found in the base metal, and only after this new CWR's approval can continue the repair.

8. Clean excavation area of all loose debris including MT powder after excavation. Preheat and weld according to repair WPS, the preheat shall between 160° C-230° C.

9. Perform post weld heating according to repair WPS, the postheat shall between 230° C-315° C and for one hour minimum.
10. Allow the weld to cool to ambient temperature gradually. Control cooling rate after PWHT to no more than 50° C per hour.

11. Grind the repaired area flush with base metal or the adjacent weld after post weld heating.
12. Wait 48 hours at least after the repair area has cooled to ambient temperature before performing NDT.

13. Perform MT inspection to all repair area according to Contract Drawings along with all additional NDT required by the applicable noise Special Provision Section 10-1.59 "Steel Structure", subsection "Inspection testing". NDT include VT, MT and UT if it is a CJP weld.

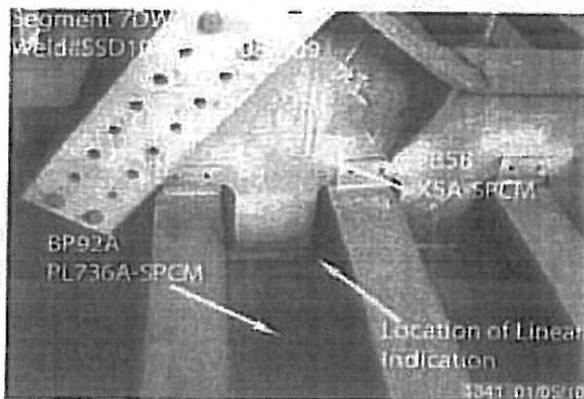
-The OBG segment 7DW is located outside in the Trial Assembly area.

The Notice of Witness Inspection Number (NWIT) is 004993. The indication is located inside the area that has been previously tested and accepted by ZPMC Quality Control (QC) personnel. ZPMC's QC personnel are required to perform twenty five (25%) percent MT inspection of this weld.

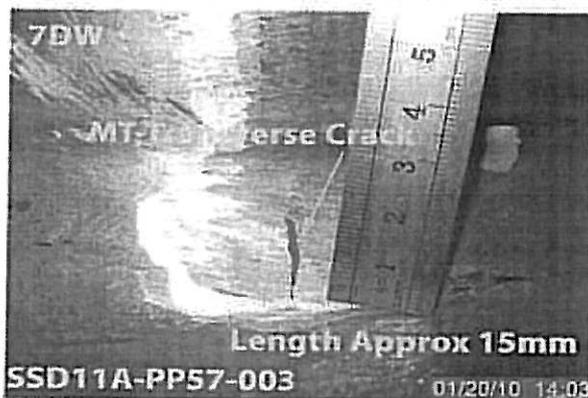
- One (1) Transverse linear crack measuring approximately 15mm in length.
- The Y location is 4500mm from corner of the Panel Point PP57 at Cross Beam side.
- The indication is clearly marked on the material near the weld.
- The weld is identified as: SSD11A-PP57-003.
- This weld is a Complete Joint Penetration (CJP) weld joining the Deck Panel Diaphragm (X1H) to Floor Beam Flange (X7G).
- The Deck Panel Diaphragm (X1H) is identified as Non-Seismic Performance Critical Member (SPCM).
- The Floor Beam Flange (X7G) is identified as Non-SPCM.
- OBG segment 7DW is located outside North side of Bay 13.

The Notice of Witness Inspection Number (NWIT) is 005086. The indication is located inside an area that has been previously tested 100% and accepted by ZPMC Quality Control (QC) personnel.

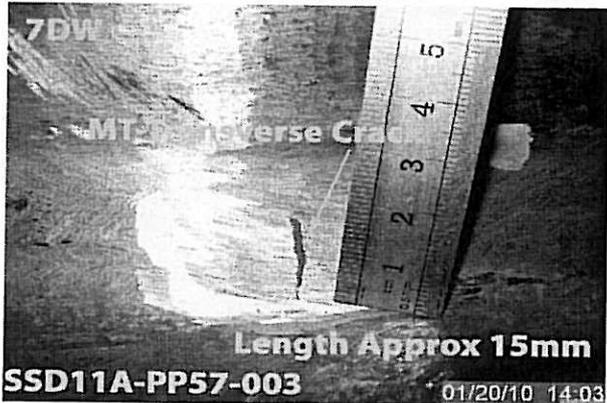
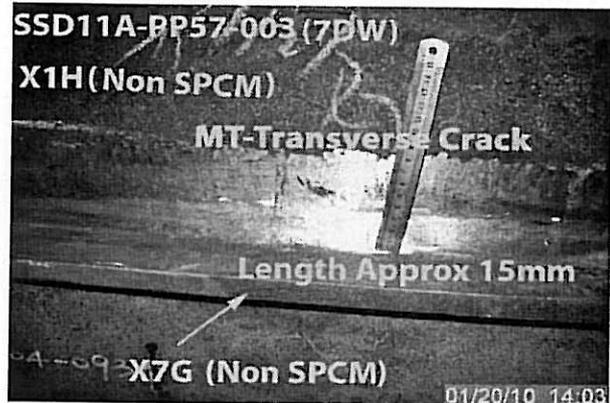
- One (1) Transverse linear crack measuring approximately 15mm in length.
- The Y location is 4500mm from corner of the Panel Point PP57 at Cross Beam side.
- The indication is clearly marked on the material near the weld.
- The weld is identified as: SSD11A-PP57-003.
- This weld is a Complete Joint Penetration (CJP) weld joining the Deck Panel Diaphragm (X1H) to Floor Beam Flange (X7G).
- The Deck Panel Diaphragm (X1H) is identified as Non-Seismic Performance Critical Member (SPCM).
- The Floor Beam Flange (X7G) is identified as Non-SPCM.
- OBG segment 7DW is located outside North side of Bay 13.

The Notice of Witness Inspection Number (NWIT) is 005086. The indication is located inside an area that has been previously tested 100% and accepted by ZPMC Quality Control (QC) personnel.
