**DEPARTMENT OF TRANSPORTATION**

Contract #: 04-0120F4Cty: SF/ALA Rte: 80 PM: 13.2/13.9File #: 69.25B**QUALITY ASSURANCE -- NON-CONFORMANCE REPORT****Location:** Changxing Island, Shanghai, P.R. China**Report No:** NCR-000646**Prime Contractor:** American Bridge/Fluor Enterprises, a JV**Date:** 23-Jan-2010**Submitting Contractor:** Zhenhua Port Machinery Company, Ltd (ZPMC), Changxing Island**NCR #:** ZPMC-0617**Type of problem:**

| <b>Procedural</b> | <b>Procedural</b> | <b>Description:</b> Unapproved Buttering of Side Panel Splice Welds | |

**Reference Description:** ZPMC performed unapproved buttering to correct root opening size on side panels for OBG Segment 12CE

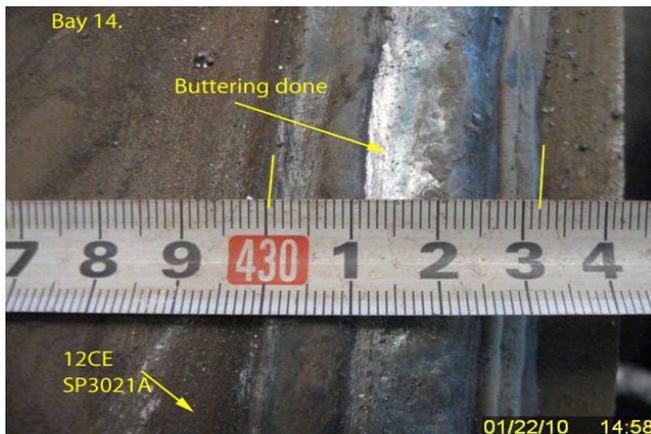
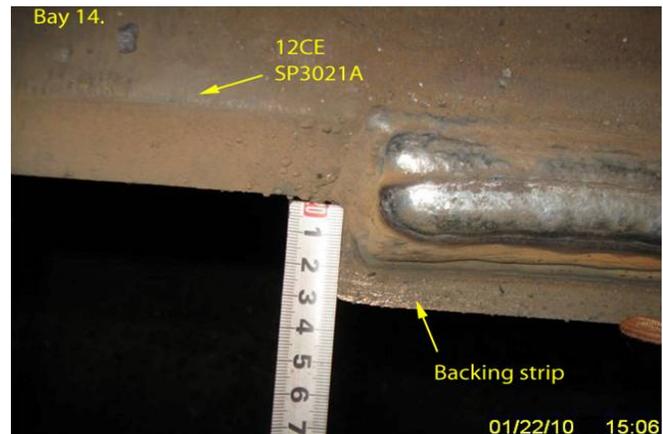
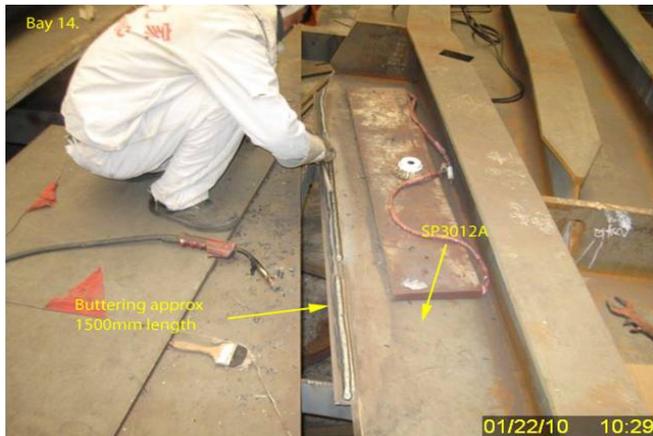
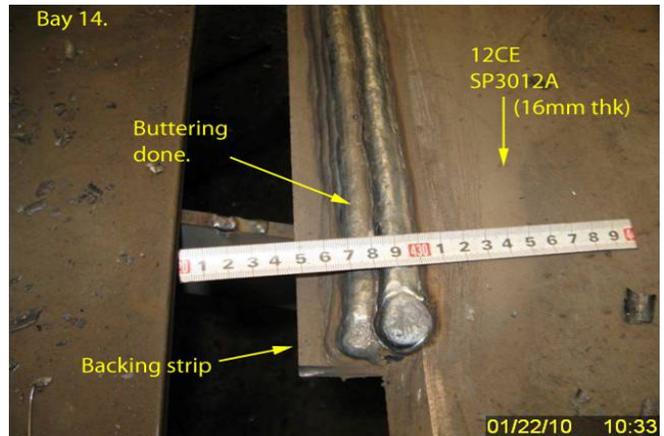
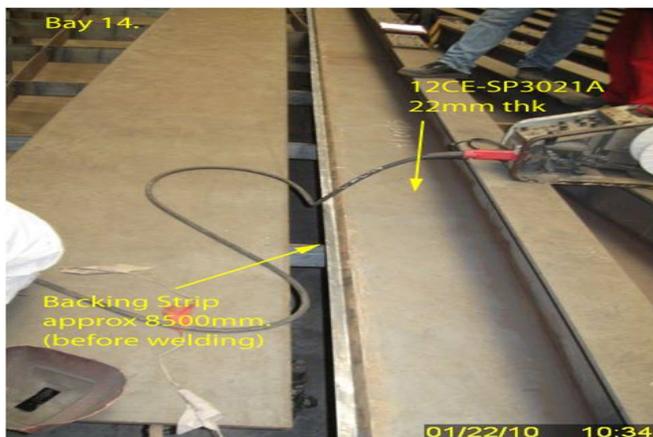
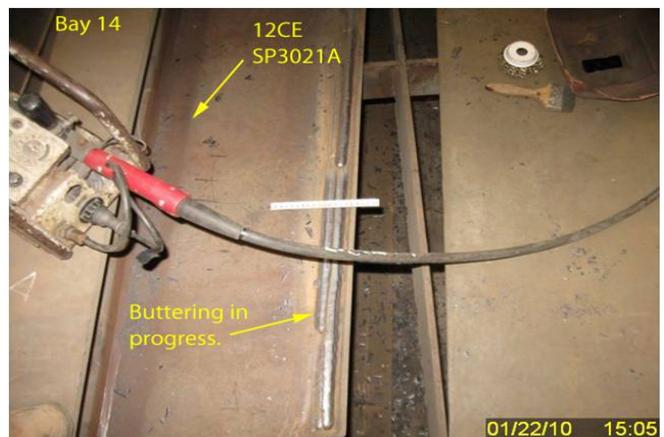
During random In-process Visual Inspection of OBG Segment 12CE, this Quality Assurance Inspector (QA) discovered the following issues:

- Deposition of weld metal (buttering/build up) of up to 21mm measured horizontally from the groove face to correct excessive root opening by Flux Cored Arc Welding (FCAW) without the prior approval of the engineer.
- Buttering was performed on Side Panel SP3012A (38mm x L=1500mm) and SP3021A (30mm x L=2000mm)
- ZPMC onsite Quality Control Inspector (QC), Mr. Guo Xing Hui, produced Welding Repair Report (WRR)-B-WR-10076 Dated January 9th, 2010 for the work being performed.
- The material being welded is Non SPCM.
- The Side Panel components are located in Bay 14.

AWS D1.5 (02) Section 3.3.4.2 – “Root openings larger than those allowed in 3.3.4.1 may be corrected by welding only with the approval of the Engineer”.

Propose a resolution for the identified non-conformance with revised procedures to prevent future occurrences. A response for the resolution of this issue is expected within 14 days.

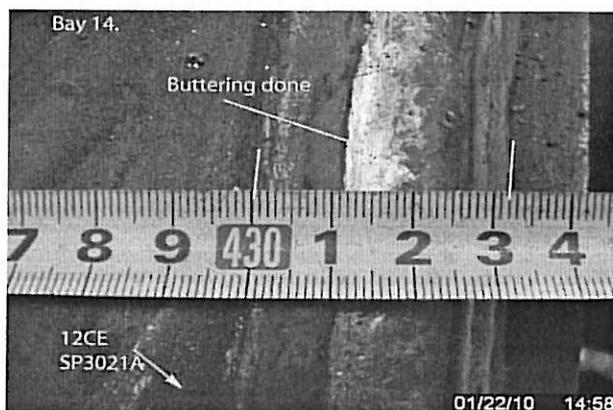
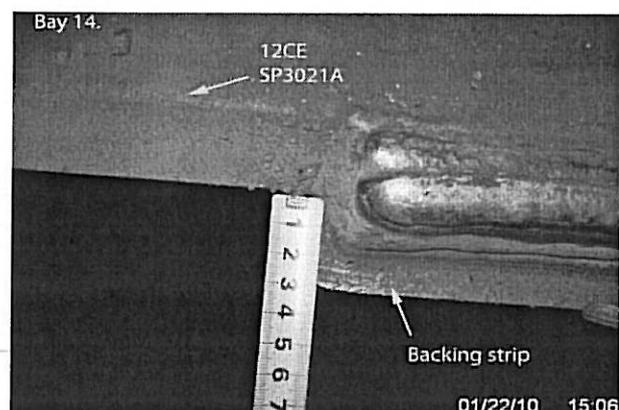
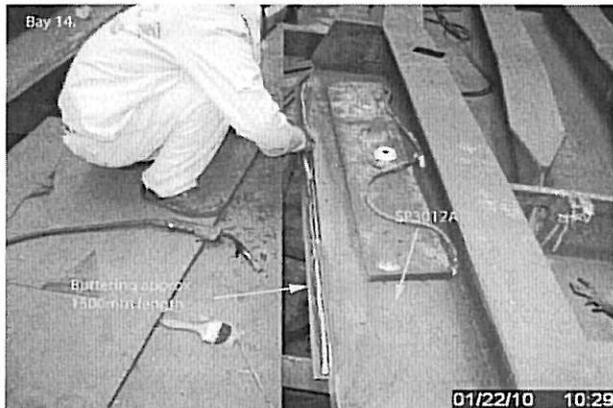
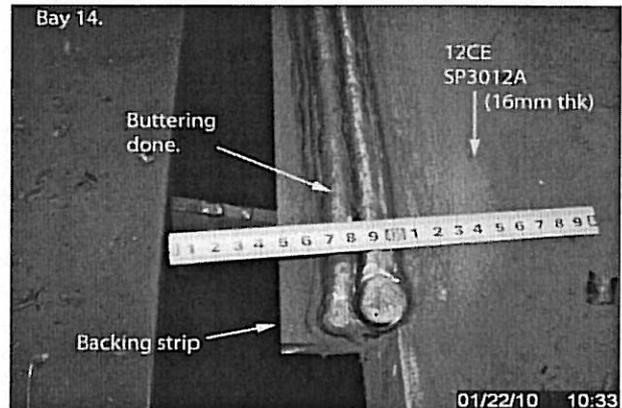
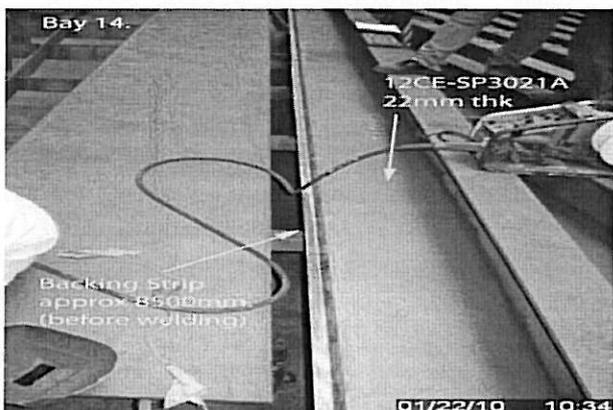
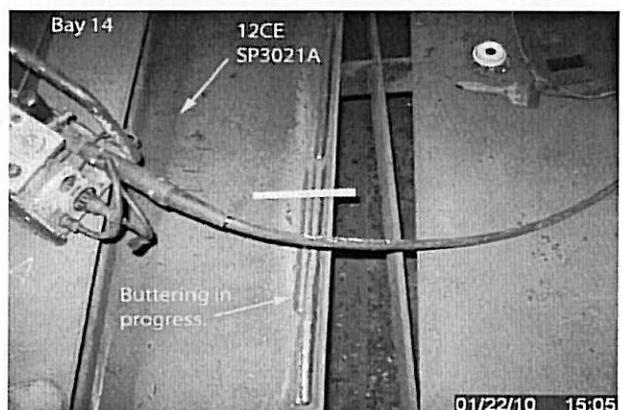
During random In-process Visual Inspection of OBG Segment 12CE, this Quality Assurance Inspector (QA) discovered the following issues:

- Deposition of weld metal (buttering/build up) of up to 21mm measured horizontally from the groove face to correct excessive root opening by Flux Cored Arc Welding (FCAW) without the prior approval of the engineer.
- Buttering was performed on Side Panel SP3012A (38mm x L=1500mm) and SP3021A (30mm x L=2000mm)
- ZPMC onsite Quality Control Inspector (QC), Mr. Guo Xing Hui, produced Welding Repair Report (WRR)-B-WR-10076 Dated January 9th, 2010 for the work being performed.
- The material being welded is Non SPCM.
- The Side Panel components are located in Bay 14.

AWS D1.5 (02) Section 3.3.4.2 – “Root openings larger than those allowed in 3.3.4.1 may be corrected by welding only with the approval of the Engineer”.

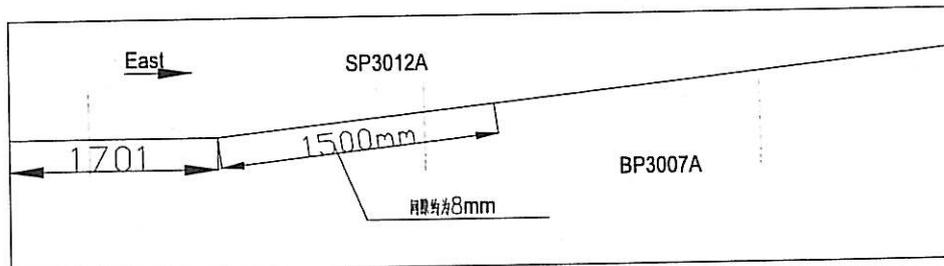
VIEW A

检查发现12CE的底板BP3007A与SP3012A的拼缝间隙超标, 最大8mm, 长度约为1500mm, 底板BP3009A与SP3021A的拼缝间隙超标, 最大15mm, 长度约为5000mm, 具体如下图所示  
After inspection 12CE bottom plate gap at BP3007A and SP3012A, the gap was maximum 8mm, 1500m in length, maximum 15mm at BP3009A and SP3021A, the detail sees the following draft.

Weld distortion and fabricate error.

1. Grind the edge of the repair area cleanly;
2. Prepare an right joint according to the approved WPS;
3. Perform VT to the repair area to ensure no impurity exist;
4. Add steel backing according to the attached drawing 1;
5. Preheat and weld according to the relevant repaired WPS;
6. Remove the steel backing and grind the weld flush with around metal;
7. Perform post NDT (VT MT UT) of repaired area to insure sound weld metal has been de posited.
8. Prepare excavation again according to the shop drawings

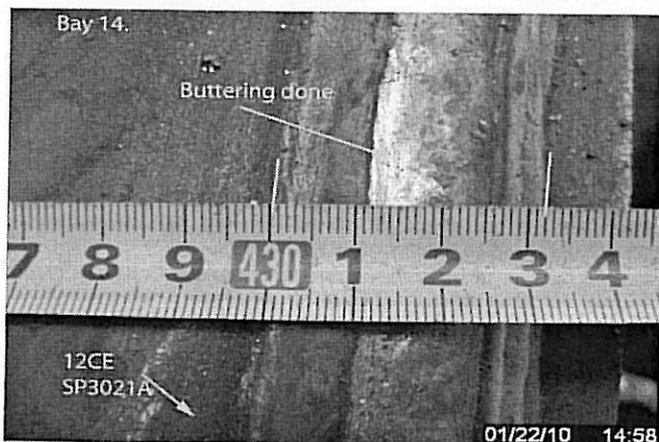
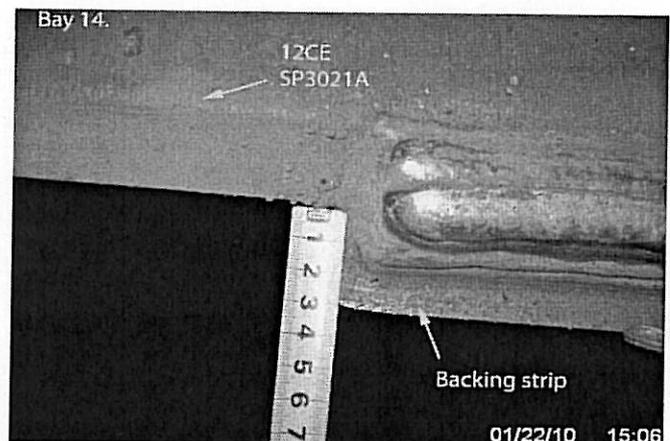
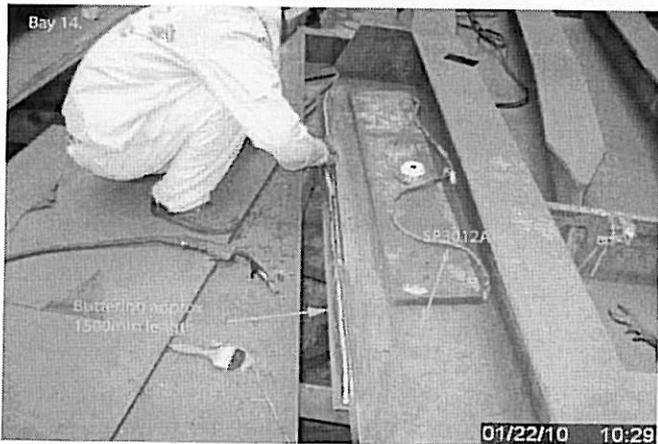
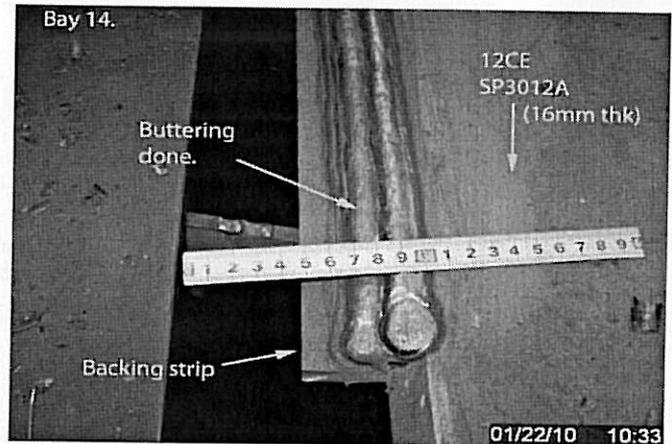
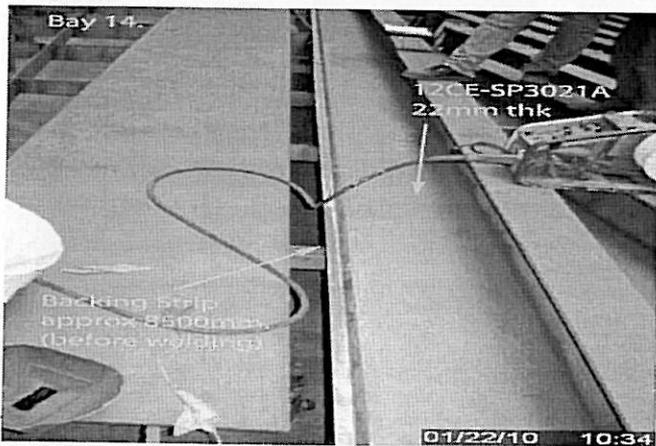
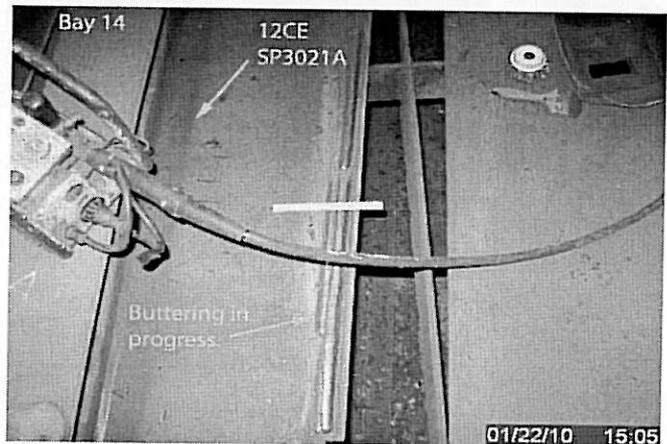
- Deposition of weld metal (buttering/build up) of up to 21mm measured horizontally from the groove face to correct excessive root opening by Flux Cored Arc Welding (FCAW) without the prior approval of the engineer.
- Buttering was performed on Side Panel SP3012A (38mm x L=1500mm) and SP3021A (30mm x L=2000mm)
- ZPMC onsite Quality Control Inspector (QC), Mr. Guo Xing Hui, produced Welding Repair Report (WRR)-B-WR-10076 Dated January 9th, 2010 for the work being performed.
- The material being welded is Non SPCM.
- The Side Panel components are located in Bay 14.

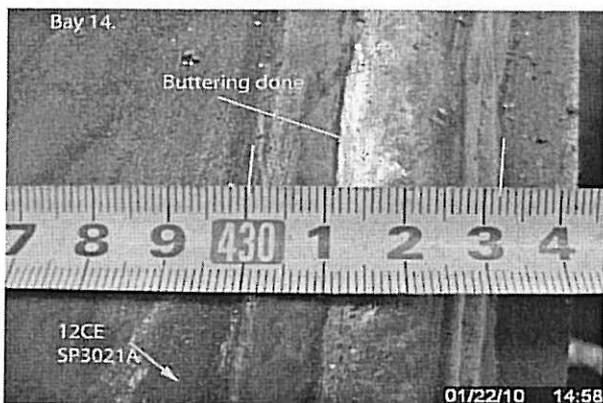
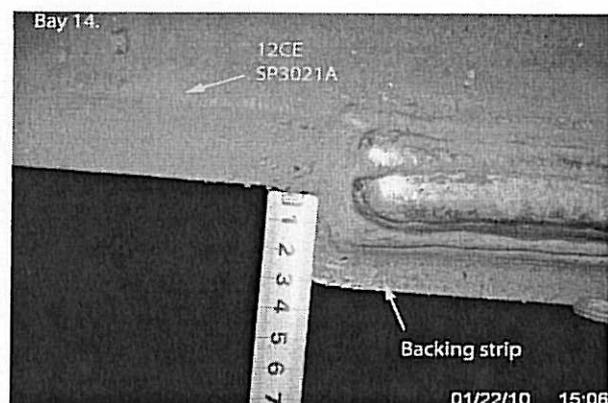
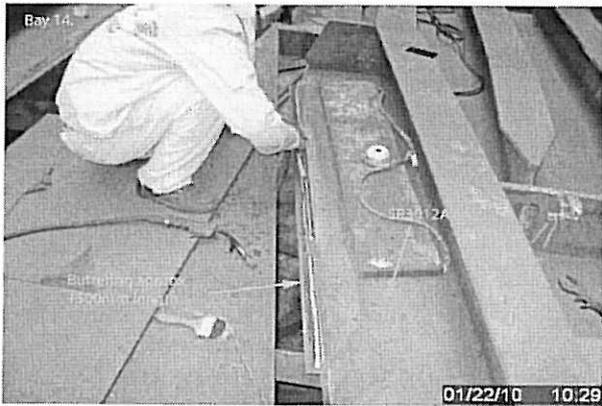
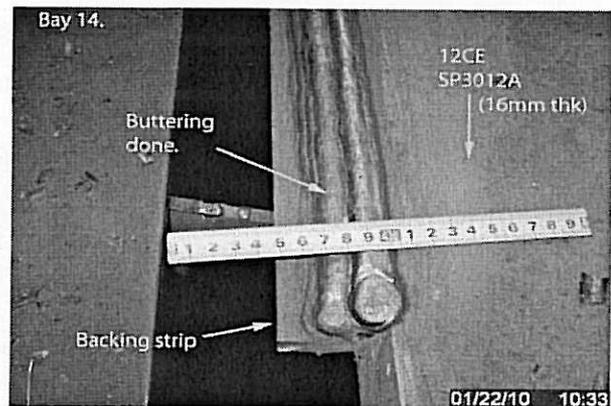
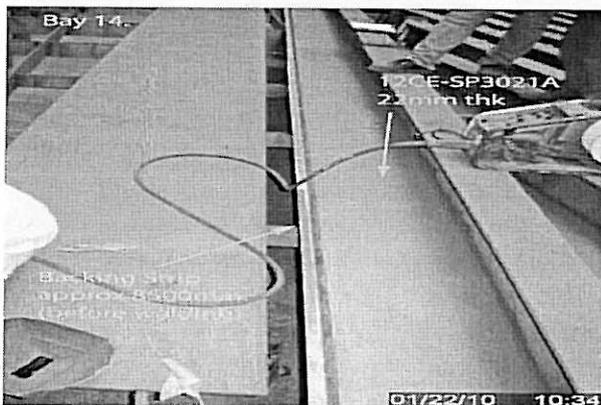
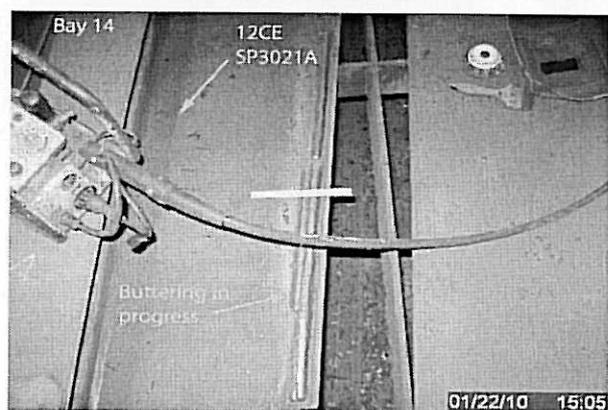
- Deposition of weld metal (buttering/build up) of up to 21mm measured horizontally from the groove face to correct excessive root opening by Flux Cored Arc Welding (FCAW) without the prior approval of the engineer.
- Buttering was performed on Side Panel SP3012A (38mm x L=1500mm) and SP3021A (30mm x L=2000mm)
- ZPMC onsite Quality Control Inspector (QC), Mr. Guo Xing Hui, produced Welding Repair Report (WRR)-B-WR-10076 Dated January 9th, 2010 for the work being performed.
- The material being welded is Non SPCM.
- The Side Panel components are located in Bay 14.

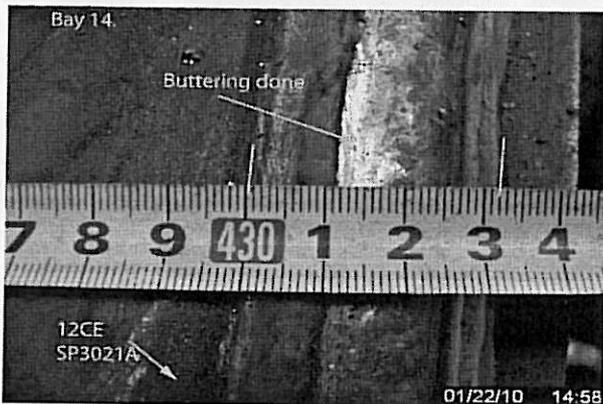
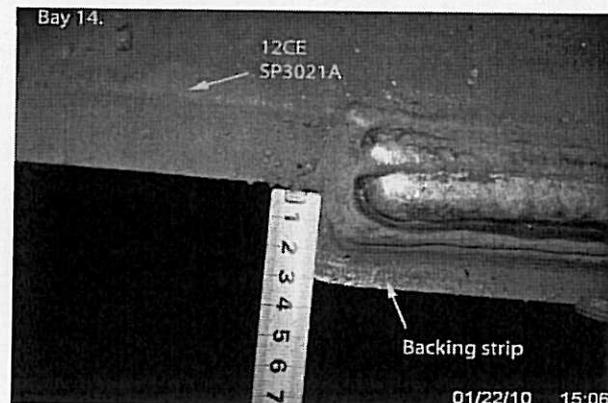
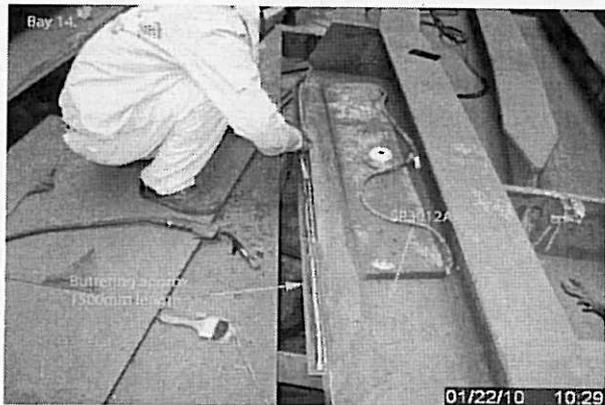
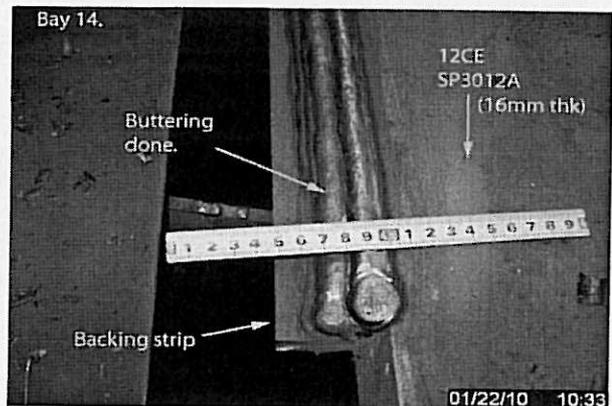
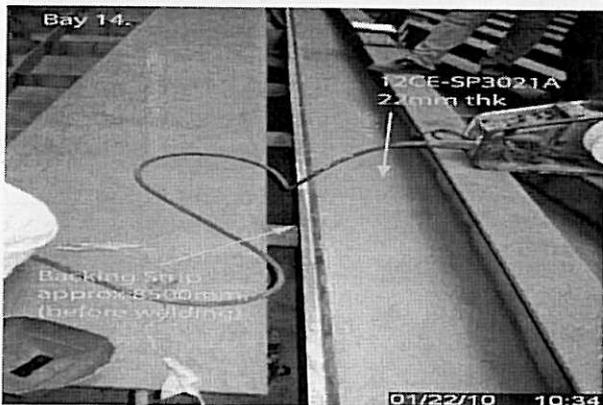
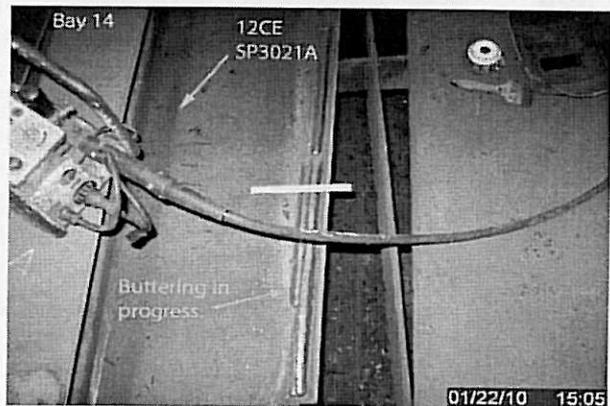
- Deposition of weld metal (buttering/build up) of up to 21mm measured horizontally from the groove face to correct excessive root opening by Flux Cored Arc Welding (FCAW) without the prior approval of the engineer.
- Buttering was performed on Side Panel SP3012A (38mm x L=1500mm) and SP3021A (30mm x L=2000mm)
- ZPMC onsite Quality Control Inspector (QC), Mr. Guo Xing Hui, produced Welding Repair Report (WRR)-B-WR-10076 Dated January 9th, 2010 for the work being performed.
- The material being welded is Non SPCM.
- The Side Panel components are located in Bay 14.

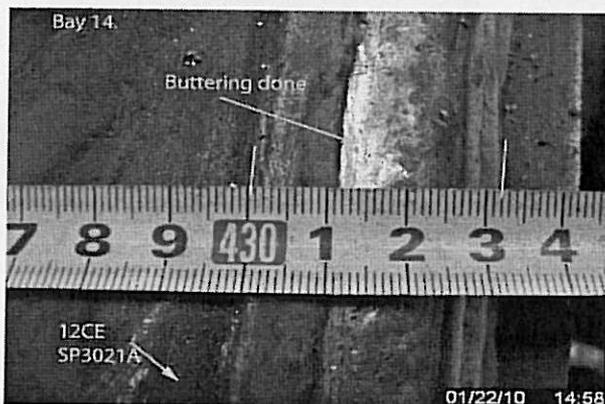
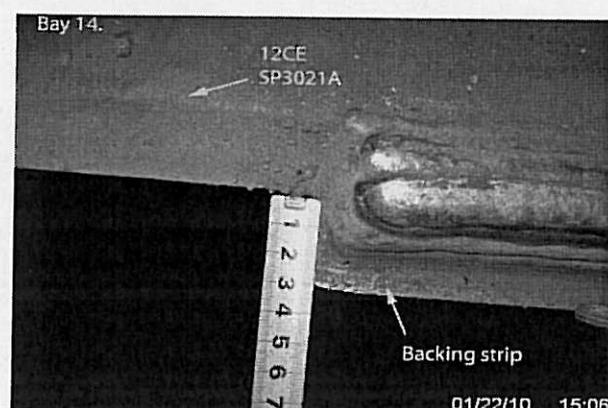
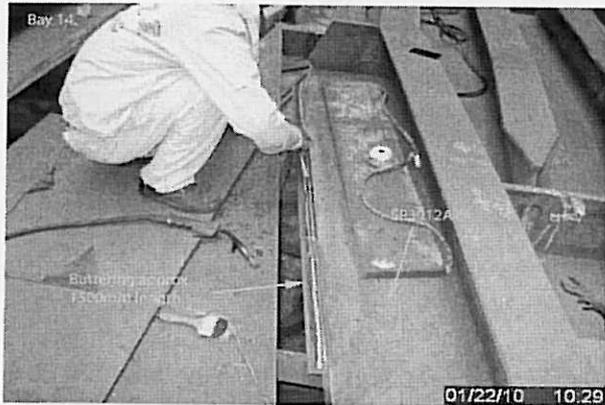
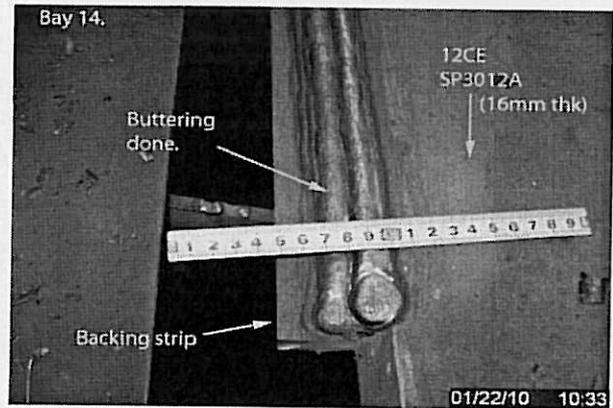
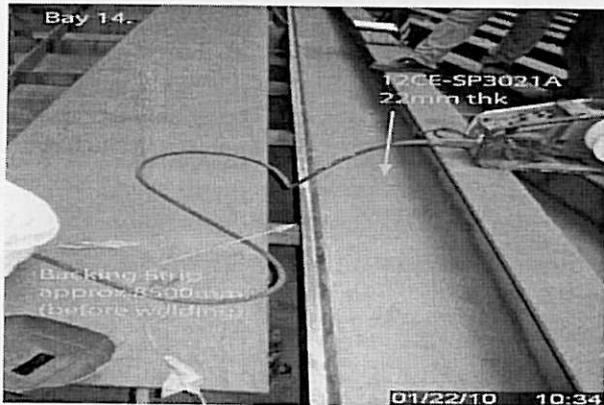
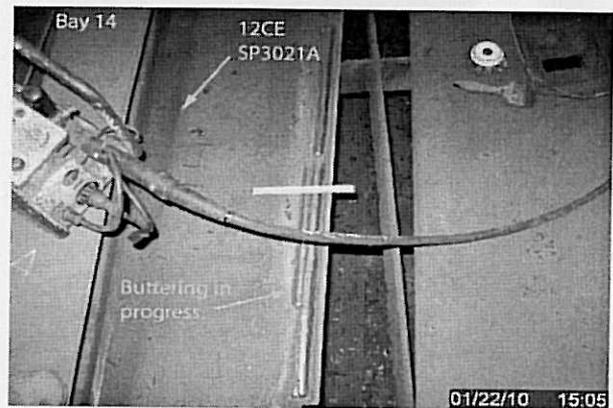
- Deposition of weld metal (buttering/build up) of up to 21mm measured horizontally from the groove face to correct excessive root opening by Flux Cored Arc Welding (FCAW) without the prior approval of the engineer.
- Buttering was performed on Side Panel SP3012A (38mm x L=1500mm) and SP3021A (30mm x L=2000mm)
- ZPMC onsite Quality Control Inspector (QC), Mr. Guo Xing Hui, produced Welding Repair Report (WRR)—B-WR-10076 Dated January 9th, 2010 for the work being performed.
- The material being welded is Non SPCM.
- The Side Panel components are located in Bay 14.
