Contract #: 04-0120F4Cty: SF/ALA Rte: 80 PM: 13.2/13.9File #: 69.25B**QUALITY ASSURANCE -- NON-CONFORMANCE REPORT****Location:** Changxing Island, Shanghai, P.R. China**Report No:** NCR-000648**Prime Contractor:** American Bridge/Fluor Enterprises, a JV**Date:** 23-Jan-2010**Submitting Contractor:** Zhenhua Port Machinery Company, Ltd (ZPMC), Changxing Island**NCR #:** ZPMC-0618**Type of problem:**

Reference Description: Counter Weights outside of the North end of Bay 17 are stored directly on the ground and MEP mounting brackets are bent

Job Name: SAS Superstructure

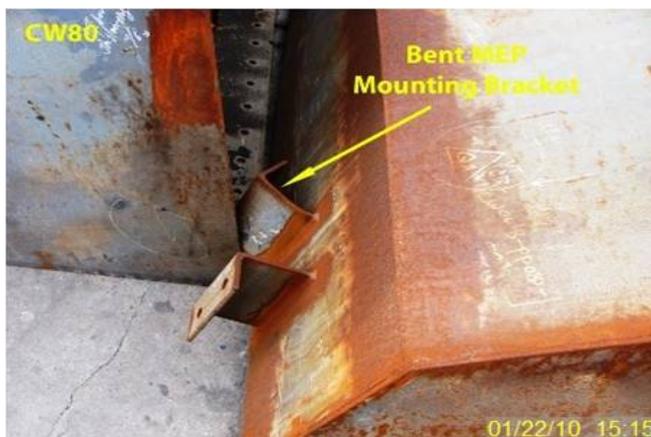
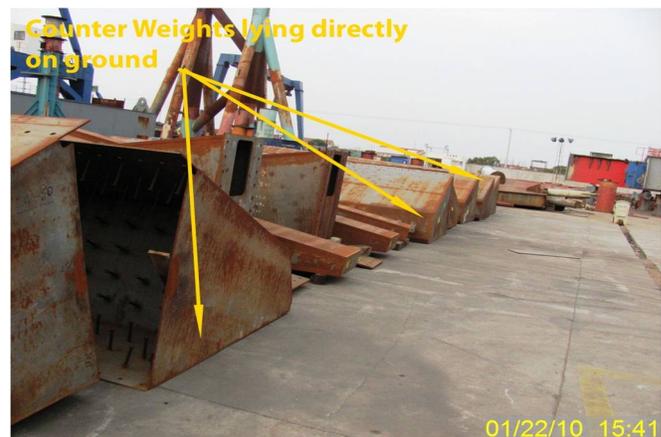
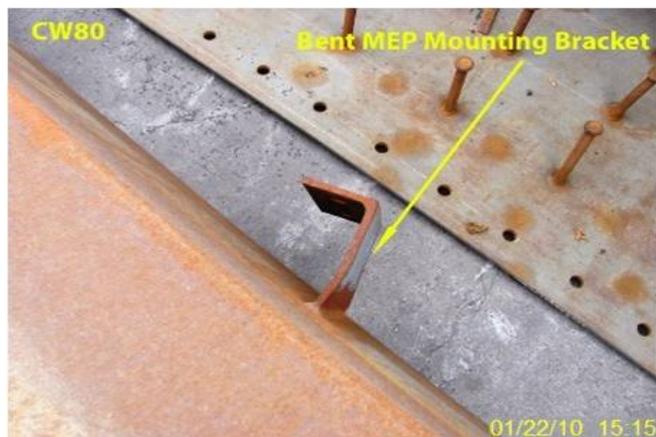
- OBG Counter Weight CW80 MEP mounting brackets (second and last) are bent.
- Nine (9) Counter Weights CW40, CW50, CW80, CW60, CW98, CW78, CW72, CW68 and CW104 were improperly stored. These Counter Weights are stored directly on the ground and are stacked unevenly on each other without the proper storage supports.
- These Counter Weights are located in the outside yard north of Bay 17.

For further information, please see the attached pictures.

Standard Specifications July, 1999 Section 6-1.03 Storage of Material; "Articles or materials to be incorporated in the work shall be stored in such a manner as to ensure the preservation of their quality and fitness for the work and to facilitate inspection".

Standard Specifications July, 1999 Section 55-1.04 Shipping, Handling and Storing Materials; "In handling and shipping of the steel work, every care shall be taken to avoid bending, scraping or overstressing the pieces. All pieces bent or otherwise injured will be rejected. Material to be stored shall be placed above the ground upon platforms, skids or other supports."

Reference Resolution: ZPMC had removed the bent angle from CW80 and will repair and MT the final weld. The other counterweights referenced in the NCR are now stored properly.

This proposed resolution is acceptable pending reattachment of the removed angle and applicable NDT results.

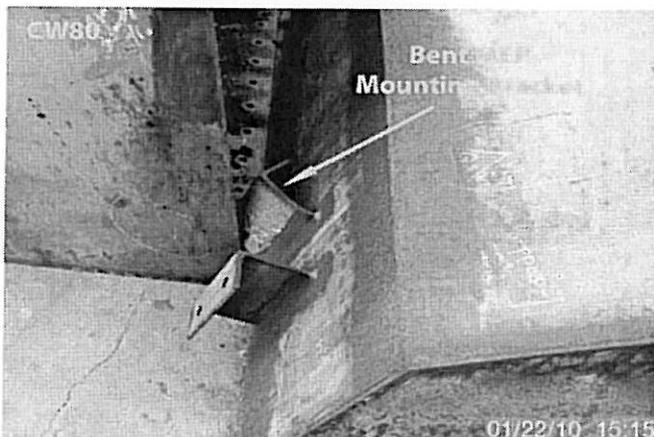
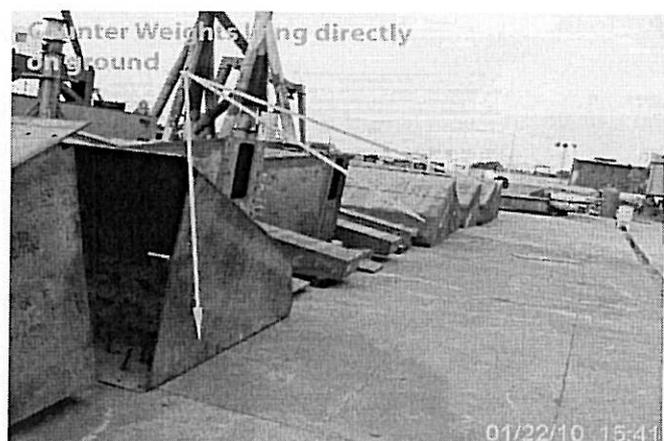
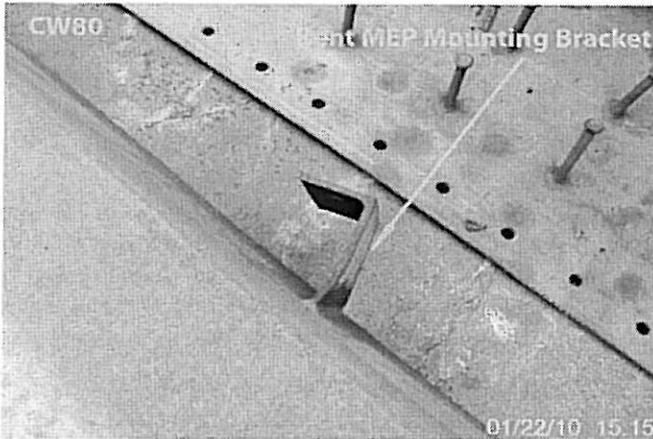
- OBG Counter Weight CW80 MEP mounting brackets (second and last) are bent.
- Nine (9) Counter Weights CW40, CW50, CW80, CW60, CW98, CW78, CW72, CW68 and CW104 were improperly stored. These Counter Weights are stored directly on the ground and are stacked unevenly on each other without the proper storage supports.
- These Counter Weights are located in the outside yard north of Bay 17.

For further information, please see the attached pictures.

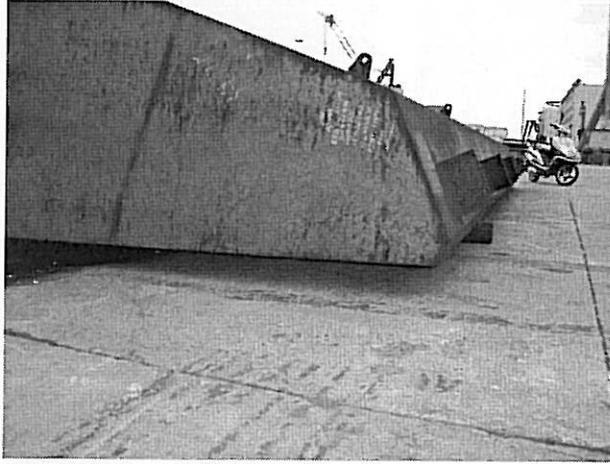
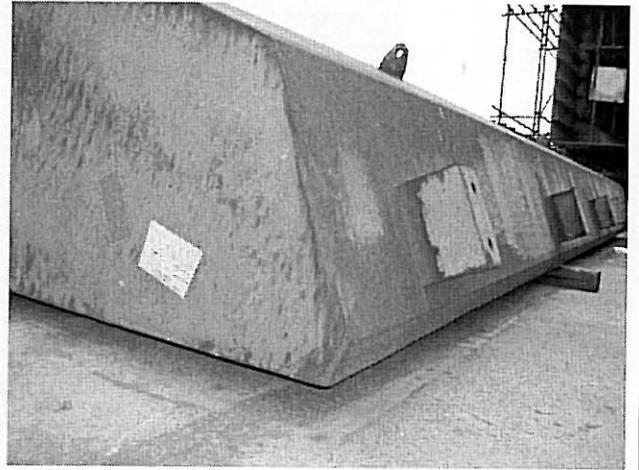
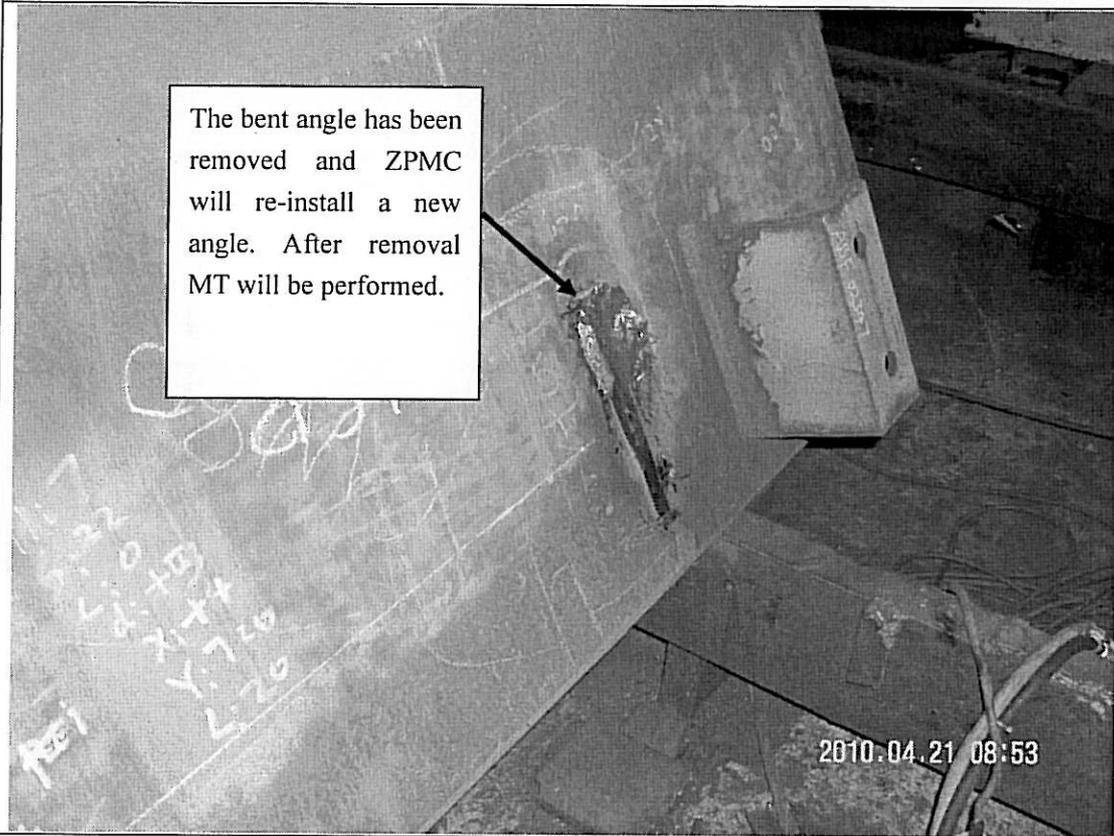
CWs have been re-stored and are acceptable now

ZPMC acknowledges this problem and has written an internal NCR regarding this issue. These CWs has been re-stored with proper storage supports now. And ZPMC will replace the bent angle on CW80. Attached photos show the storage for CWs and the removal of the bent angle. ZPMC will perform MT before re-install the new angle at the grinding area on CW80 and after the angle is replaced, CT will be notified to perform NDT. Based on this, ZPMC is requesting closure of this NCR.

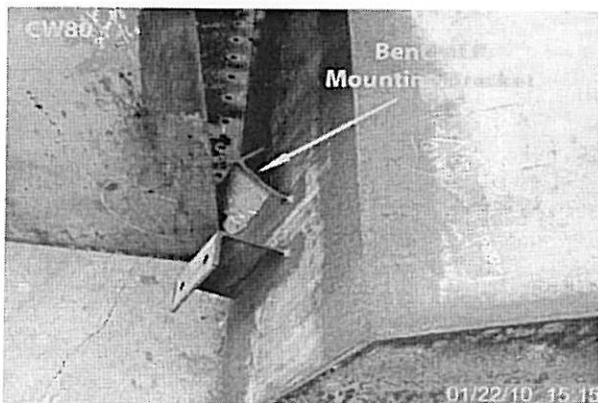
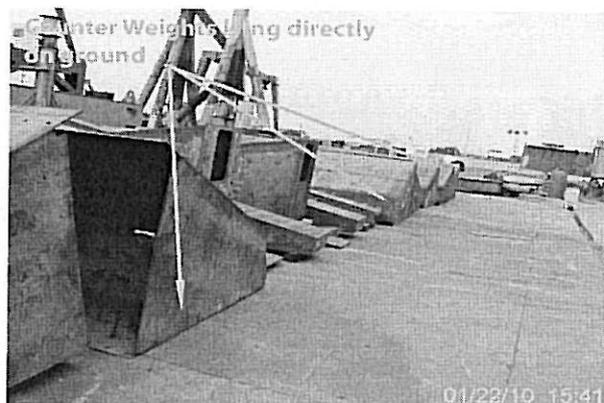
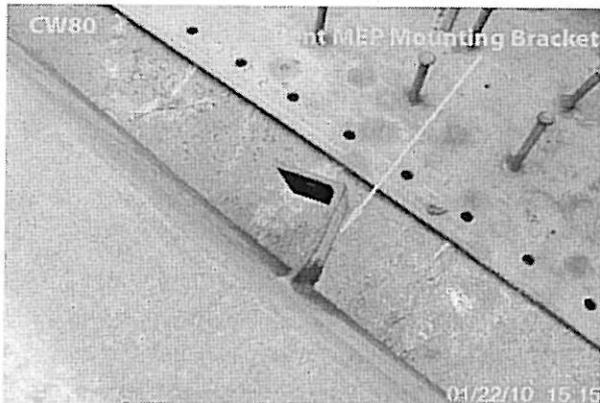
- OBG Counter Weight CW80 MEP mounting brackets (second and last) are bent.
- Nine (9) Counter Weights CW40, CW50, CW80, CW60, CW98, CW78, CW72, CW68 and CW104 were improperly stored. These Counter Weights are stored directly on the ground and are stacked unevenly on each other without the proper storage supports.
- These Counter Weights are located in the outside yard north of Bay 17.

For further information, please see the attached pictures.

Damaged members were removed and replaced. Contractor supplied post repair NDT documentation verifying weld is in conformance with Contract weld quality requirements.
