Contract #: 04-0120F4Cty: SF/ALA Rte: 80 PM: 13.2/13.9File #: 69.25B

QUALITY ASSURANCE -- NON-CONFORMANCE REPORT

Location: Changxing Island, Shanghai, P.R. China**Report No:** NCR-000649**Prime Contractor:** American Bridge/Fluor Enterprises, a JV**Date:** 24-Jan-2010**Submitting Contractor:** Zhenhua Port Machinery Company, Ltd (ZPMC), Changxing Island**NCR #:** ZPMC-0620**Type of problem:**

Reference Description: Excessive Weld Pass Width, South Tower Lift 4, Weld #SSTL4-1K/L-96**Description of Non-Conformance:**

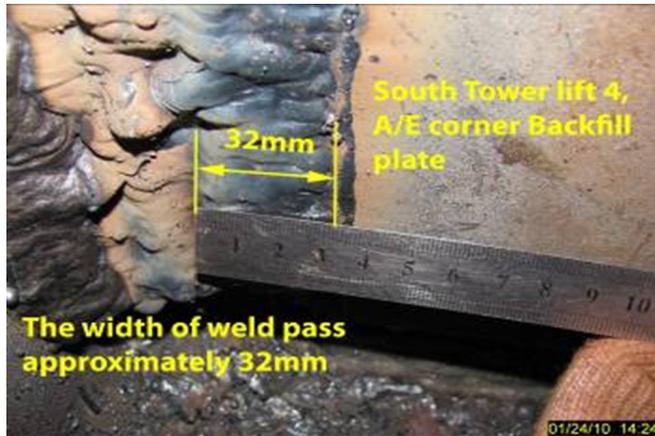
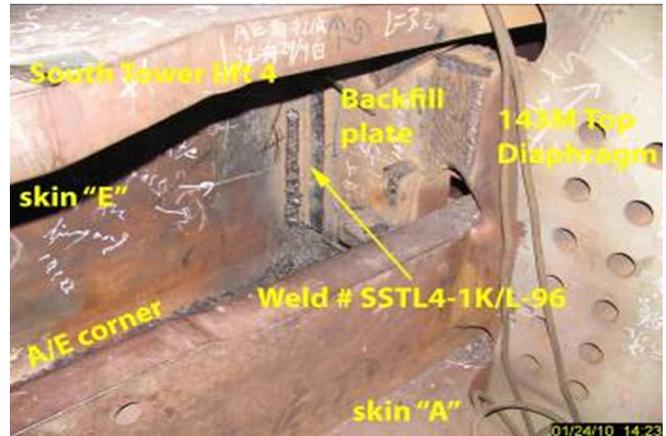
During the Quality Assurance (QA) random in-process visual inspection of South Tower Lift 4, A/E corner backfill plate at 143m top diaphragm, this QA inspector discovered the following issue:

- Excessive weld pass width.
- The width of a single weld pass measured to be approximately 32mm and the length of weld pass measured to be approximately 480mm.
- This Flux Core Arc Weld (FCAW) is a Partial Joint Penetration (PJP) groove weld performed in the vertical position.
- The maximum FCAW weld pass width allowed in vertical position for groove weld is 25mm.
- The weld is identified as: SSTL4-1K/L-96.
- The weld is joining the Backfill plate and skin E of South Tower Lift 4.
- The material is designated as non Seismic Performance Critical Member (non SPCM).
- The member is located in Bay 10

AWS D1.5 Section 4.14.1.5 FCAW: "When welding in the vertical position, a split-layer technique shall be used when the width of the layer exceeds 25 mm [1 in]."

Propose a resolution for the identified non-conformance including documentation that the welds placed are in compliance with the contract requirements. In addition to the material/workmanship non-conformance, propose a resolution that addresses the failure of Quality Control to identify the excessive weld pass width. Provide documentation of the steps taken by the Quality Control Manager to prevent future occurrences.

As soon as reminded by CT site inspector, ZPMC personnel stopped welding immediately and removed the excessive width weld pass. In order to impress and warn ZPMC site worker deeply, ZPMC had issued internal NCR-T-062. The foreman and related welder had already been inculcated to behave better in the future. As a result, the weld was checked by both ZPMC and AB/F, and finally green tagged by CT. Here attached the NDT report to show the weld is sound.

MT (T787-MT-8677) was performed and the weld was found to be acceptable.

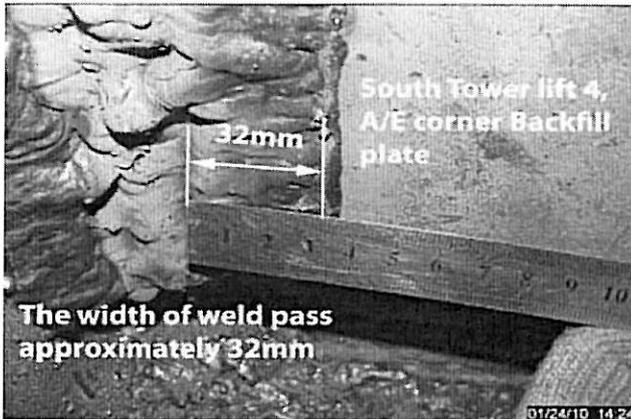
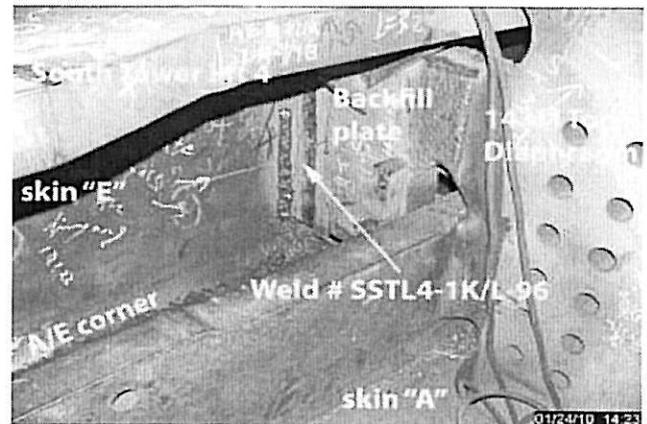
During the Quality Assurance (QA) random in-process visual inspection of South Tower Lift 4, A/E corner backfill plate at 143m top diaphragm, this QA inspector discovered the following issue:

- Excessive weld pass width.
- The width of a single weld pass measured to be approximately 32mm and the length of weld pass measured to be approximately 480mm.
- This Flux Core Arc Weld (FCAW) is a Partial Joint Penetration (PJP) groove weld performed in the vertical position.
- The maximum FCAW weld pass width allowed in vertical position for groove weld is 25mm.
- The weld is identified as: SSTL4-1K/L-96.
- The weld is joining the Backfill plate and skin E of South Tower Lift 4.
- The material is designated as non Seismic Performance Critical Member (non SPCM).
- The member is located in Bay 10

AWS D1.5 Section 4.14.1.5 FCAW: "When welding in the vertical position, a split-layer technique shall be used when the width of the layer exceeds 25 mm [1 in.]."

①针对超宽焊缝进行了打磨处理至规定范围
