**DEPARTMENT OF TRANSPORTATION**

Contract #: 04-0120F4Cty: SF/ALA Rte: 80 PM: 13.2/13.9File #: 69.25B**QUALITY ASSURANCE -- NON-CONFORMANCE REPORT****Location:** Changxing Island, Shanghai, P.R. China**Report No:** NCR-000651**Prime Contractor:** American Bridge/Fluor Enterprises, a JV**Date:** 24-Jan-2010**Submitting Contractor:** Zhenhua Port Machinery Company, Ltd (ZPMC), Changxing Island**NCR #:** ZPMC-0622**Type of problem:**

**Reference Description:** Missed MT Indication by QC for a weld joint on the Lift 12 Longitudinal Shear Plate**Description of Non-Conformance:**

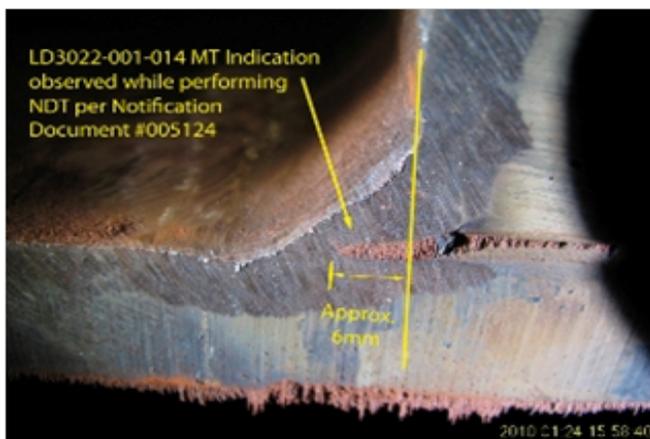
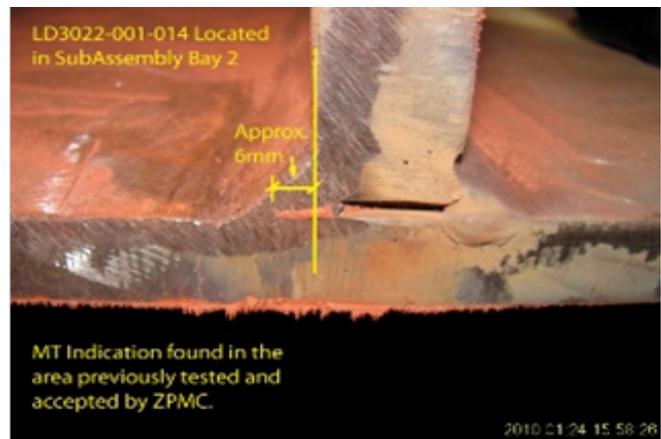
During the Quality Assurance Magnetic Particle Testing (MT) review of welds located on LD3022-001, this Quality Assurance Inspector (QA) discovered the following issues:

- One (1) linear indication measuring approximately 6mm in length.
- The weld is identified as: LD3022-001-014 for Lift 12.
- The area was previously repaired by ZPMC using Critical Weld Repair (CWR) 1151.
- The fillet weld size is 12mm.
- This Fillet Weld joins longitudinal diaphragm stiffener to longitudinal diaphragm web plate.
- This weld is designated as Non-Seismic Performance Critical Member.
- The Notice of Witness Inspection Number (NWIT) is 005124. The indication is located inside the area that has been previously tested and accepted by ZPMC Quality Control (QC) personnel. ZPMC Quality Control (QC) has performed 100% Magnetic particle Testing (MT) of this weld.

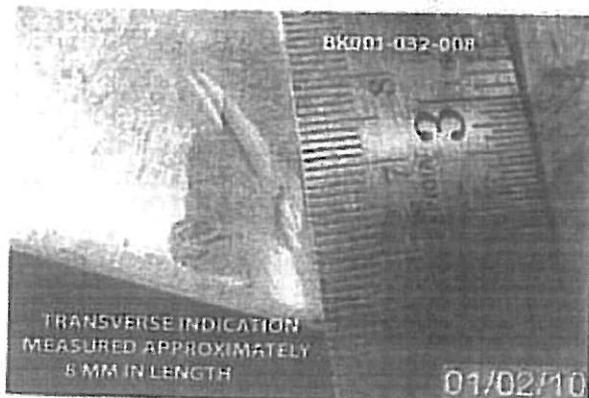
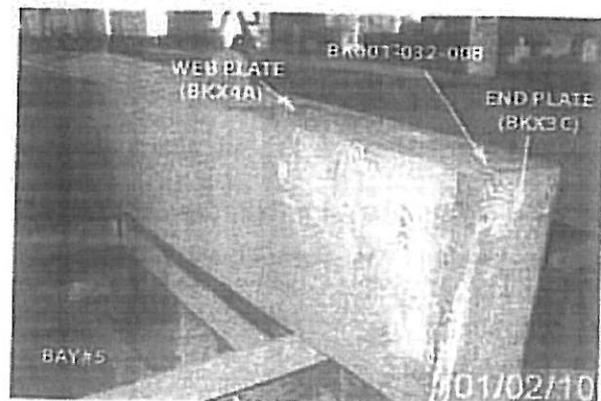
- One (1) transverse linear indication measuring approximately 8mm in length.
- The member is identified as Bike Path Cantilever Beam BK001-032.
- The weld is identified as BK001-032-008.
- The weld is a Partial Joint Penetration (PJP) T-joint joining the Web Plate (BKX4A) to the Diaphragm Flange Plate (BKX3C).
- The member is Non-Seismic Performance critical Member (SPCM).
- The member is located in OBG Bay 5.

The Notice of Witness Inspection Number (NWIT) is 004981. The indication is located inside the area that has been previously tested and accepted by ZPMC Quality Control (QC) personnel. As per the contract documents, ZPMC's QC personnel are required to perform 100% MT inspection of this weld.

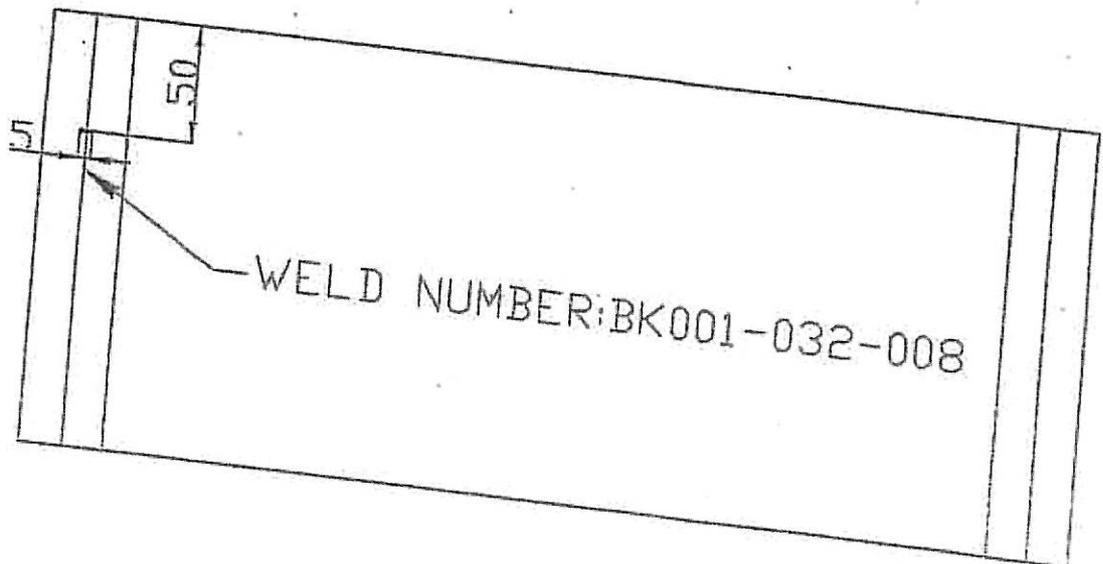
Draft of Welding Discontinuity:

One transverse crack was found by use of MT on BK001-032-008.

1. 火焰加热时, 水汽没有完全的去除或者这个区域预热不够;
1. Moisture wasn't completely removed during drying operation (preheating) or the area wasn't preheated sufficiently.

1. QC and a Lead CWI shall be present, direct and supervise all grinding and welding operations during this repair to ensure the repair is per the disposition requirements

2. QC and a Lead CWI shall have an approved copy of the CWR in hand prior to the repair.
3. Remove paint  $\geq 25$ mm in all direction of HAZ prior to MT.

4. Clean the excavation area of all loose debris including MT powder. Preheat to 65° C before removing cracks by grinding, repair area shall extend a minimum of 50mm beyond each end of single crack repairs.

5. If base metal is damaged by grinding, the damaged area shall be ground clean prior to performing weld repair. If gap  $> 5$ mm is found during or after grinding, comply with the notification on changing fillet weld to CJP which is submitted for Engineer's review and approval form.

6. Prepare excavation in accordance with the New Repair Procedure prior to welding.
7. Before this repair, Verify with VT and MT repair areas are defects free, and also MT shall be performed on the base metal laying abroad cracks to ensure that no cracks were propagated to the base metal. Separate CWR approval is needed if cracks are found in the base metal, and only after this new CWR's approval can continue the repair.

8. Clean excavation area of all loose debris including MT powder after excavation. Preheat and weld according to repair WPS, the preheat shall between 160° C-230° C.

9. Perform post weld heating according to repair WPS, the postheat shall between 230° C-315° C and for one hour minimum.
10. Allow the weld to cool to ambient temperature gradually. Control cooling rate after PWHT to no more than 50° C per hour.

11. Grind the repaired area flush with base metal or the adjacent weld after post weld heating.
12. Wait 48 hours at least after the repair area has cooled to ambient temperature before performing NDT.

13. Perform MT inspection to all repair area according to Contract Drawings along with all additional NDT required by the applicable noise Special Provision Section 10-1.59 "Steel Structure", subsection "Inspection testing". NDT include VT, MT and UT if it is a CJP weld.

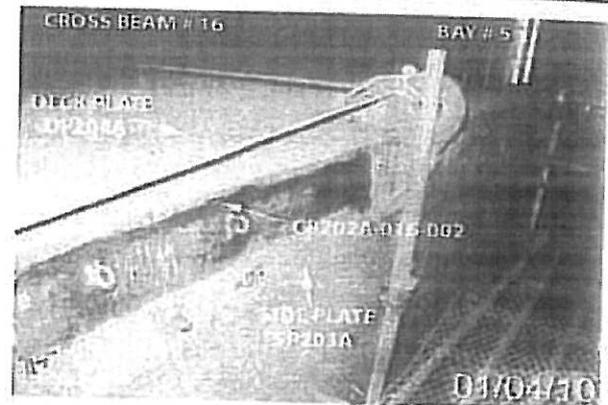
— "A" 级不符合的纵向缺陷长度将近 30mm。该焊缝是一完成的 PJP 焊缝, 连接 SP203A 至 DP204A, 编号是 CB202A-016-002。

DB 值是+3, "A" 级拒收。A 面部连续长度将近 13mm, 从联系梁北端头测量 Y 值是 1920mm。材质厚度是 18mm。该构件在 5 车间里, 该缺陷所处位置之前已经被 ZPMC QC UT 人员所检查并接受。

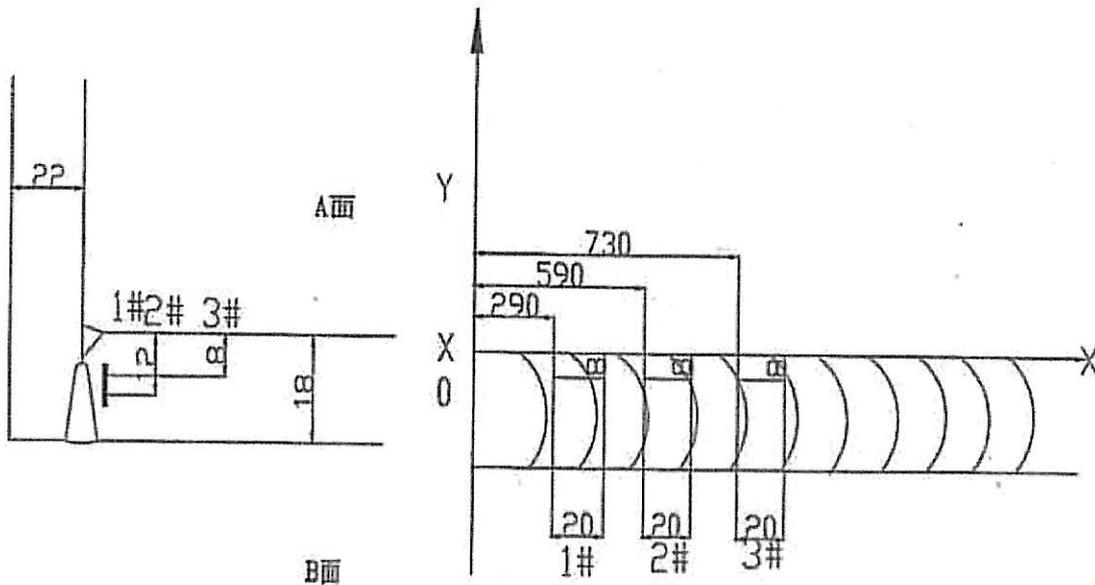
WELD NUMBER: CB202A-016-002

Rejected indication found by ultrasonic inspection is less than the maximum allowance aggregate length.

1. 从缺陷距离端面较近一侧 ( $D \leq 0.65T$ , D为缺陷深度, T为板厚) 采用碳锉或打磨的方法去除焊缝缺陷;
  2. 参照返修焊接工艺规程 (WPS) 准备正确的接头型式, 预热和焊接;
  3. 焊前对修补区域进行VT检测保证缺陷完全被清除;
  4. 将修补区域打磨到与母材或邻近焊缝平齐;
  5. 根据批准的车间图纸检查焊缝.
- 
1. Gouge or grind from nearer side from metal edge ( $D \leq 0.65T$ , "D" is depth of defects, "T" is thickness of metal) to remove all defects;
  2. Follow repair WPS for joint preparation, preheat, and weld deposit;
  3. Verify with VT no defects remain in the weld joint prior to welding;
  4. Grind the repaired area flush with base metal or the adjacent weld;
  5. Check the welds according to the working drawings;

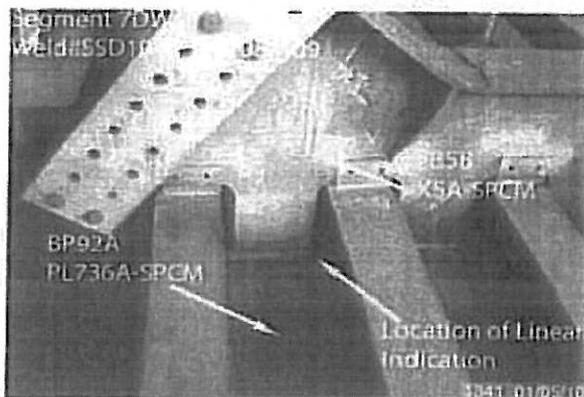
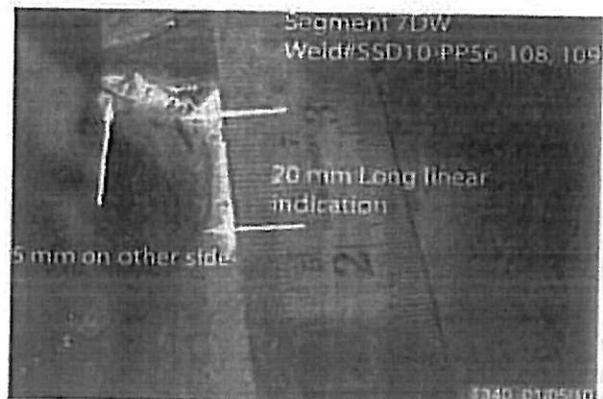
- The OBG segment 7DW is located outside in the Trial Assembly area.

The Notice of Witness Inspection Number (NWIT) is 004993. The indication is located inside the area that has been previously tested and accepted by ZPMC Quality Control (QC) personnel. ZPMC's QC personnel are required to perform twenty five (25%) percent MT inspection of this weld.

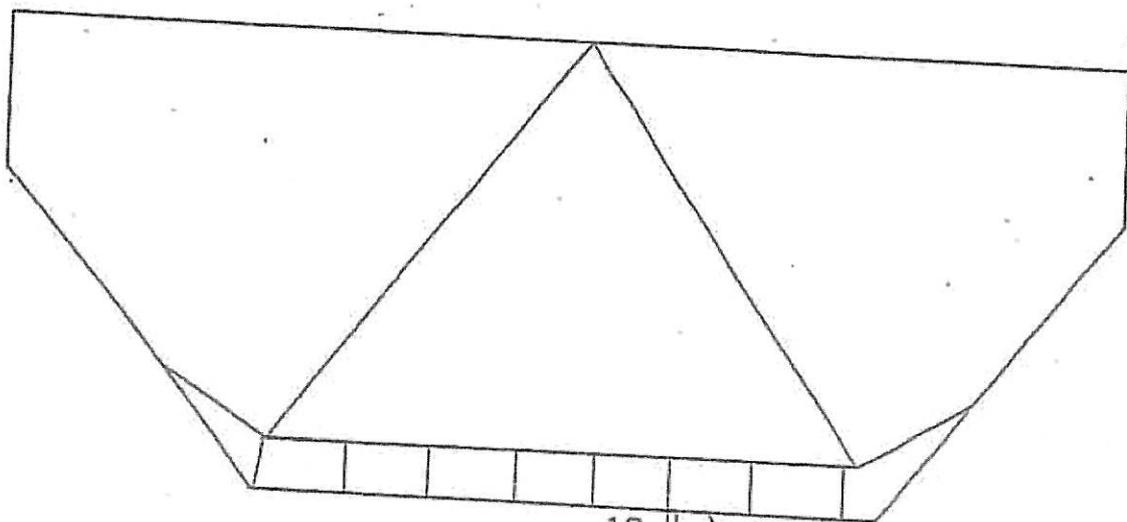
WELD NUMBER:SSD10-PP56-108

One longitudinal crack was found by use of MT on SSD10-PP56-108.

1. 火焰加热时, 水汽没有完全的去掉或者这个区域预热不够;
1. Moisture wasn't completely removed during drying operation (preheating) or the area wa sn't preheated sufficiently.

1. QC and a Lead CWI shall be present, direct and supervise all grinding and welding operations during this repair to ensure the repair is per the disposition requirements

2. QC and a Lead CWI shall have an approved copy of the CWR in hand prior to the repair.
3. Remove paint ≥25mm in all direction of HAZ prior to MT.
4. Clean the excavation area of all loose debris including MT powder. Preheat to 65° C before removing cracks by grinding, repair area shall extend a minimum of 50mm beyond each end of single crack repairs.

5. If base metal is damaged by grinding, the damaged area shall be ground clean prior to performing weld repair. If gap > 5mm is found during or after grinding, comply with the notification on changing fillet weld to CJP which is submitted for Engineer's review and approval form.

6. Prepare excavation in accordance with the New Repair Procedure prior to welding.
7. Before this repair, Verify with VT and MT repair areas are defects free, and also MT shall be performed on the base metal laying abroad cracks to ensure that no cracks were propagated to the base metal. Separate CWR approval is needed if cracks are found in the base metal, and only after this new CWR's approval can continue the repair.

8. Clean excavation area of all loose debris including MT powder after excavation. Preheat and weld according to repair WPS, the preheat shall between 160° C-230° C.

9. Perform post weld heating according to repair WPS, the postheat shall between 230° C-315° C and for on a hour minimum.
10. Allow the weld to cool to ambient temperature gradually. Control cooling rate after PWHT to no more than 50° C per hour.

11. Grind the repaired area flush with base metal or the adjacent weld after post weld heating.
12. Wait 48 hours at least after the repair area has cooled to ambient temperature before performing NDT.

13. Perform MT inspection to all repair area according to Contract Drawings along with all additional NDT required by the applicable notes Special Provision Section 10-1.59 'Steel Structure', subsection 'Inspection testing'. NDT include VT, MT and UT if it is a CJP weld.

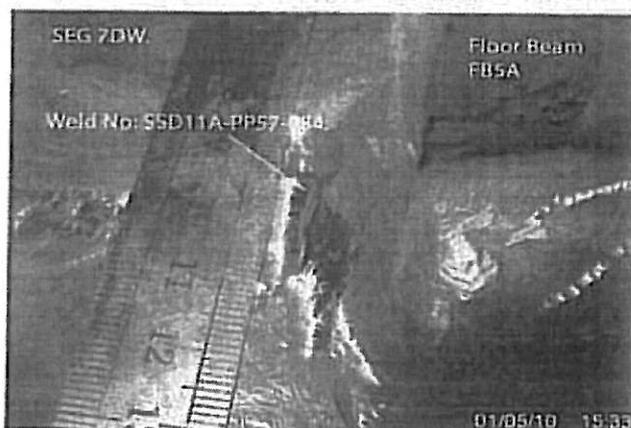
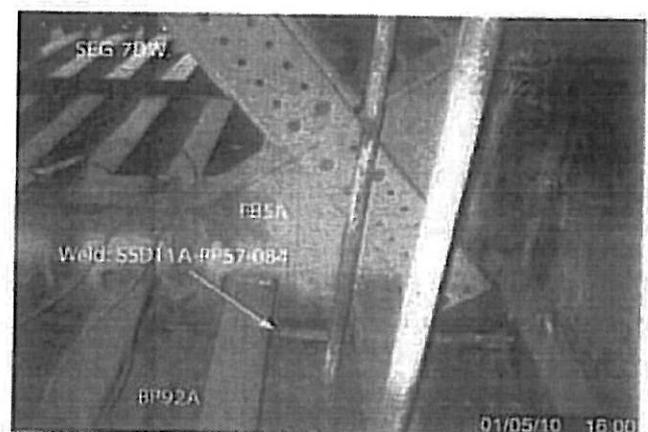
-The approved shop drawings, detail this weld as a Fracture Critical Weld (FCW).

-Segment 7DW is located at outside yard, north end of bays 13 and 14.

The Notice of Witness Inspection Number (NWIT) is 004993. The indication is located within the area that has been previously tested and accepted by ZPMC Quality Control (QC) personnel. ZPMC's QC personnel are required to perform twenty five (25%) percent MT inspection of this weld.

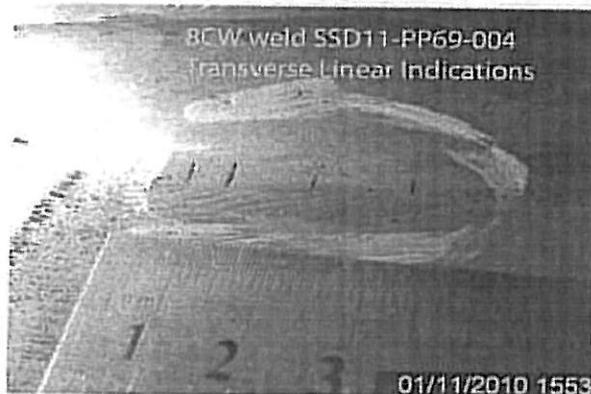
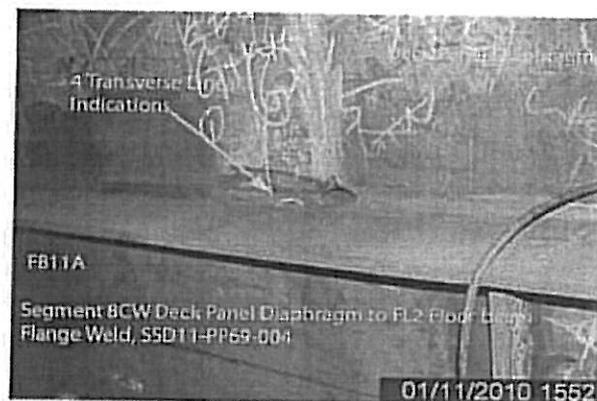
During the Quality Assurance Magnetic Particle Testing (MT) review of welds located on Segment 8CW, this Quality Assurance Inspector (QA) discovered the following issues:

- Four (4) Transverse linear indications measuring approximately from 2 mm to 6 mm in length.
- The weld is identified as: SSD11-PP69-004 @ Panel Point 069.
- This weld was turned into a Complete Joint Penetration (CJP) T-joint weld joining the upper floor beam flange to the deck panel diaphragm previously.
- This OBG Segment is located at outside yard.
- The Notice of Witness Inspection Number (NWIT) is 005037.
- The indication is located in an area that has been previously tested and accepted by ZPMC Quality Control (QC) personnel. According to the contract documents ZPMC Quality Control (QC) is required to perform 100% Magnetic particle Testing (MT) of this weld.

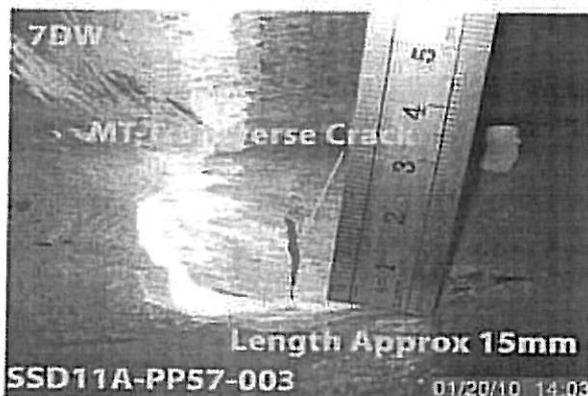
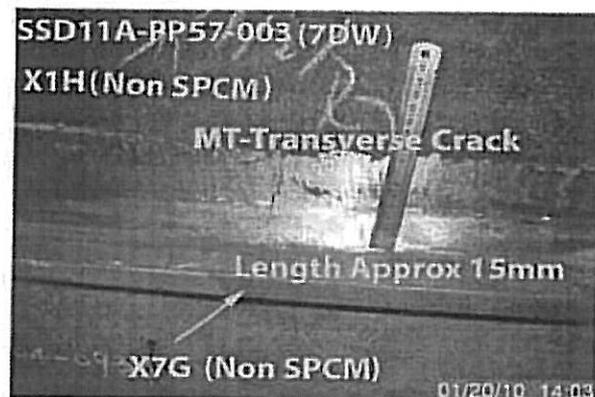
- One (1) Transverse linear crack measuring approximately 15mm in length.
- The Y location is 4500mm from corner of the Panel Point PP57 at Cross Beam side.
- The indication is clearly marked on the material near the weld.
- The weld is identified as: SSD11A-PP57-003.
- This weld is a Complete Joint Penetration (CJP) weld joining the Deck Panel Diaphragm (X1H) to Floor Beam Flange (X7G).
- The Deck Panel Diaphragm (X1H) is identified as Non-Seismic Performance Critical Member (SPCM).
- The Floor Beam Flange (X7G) is identified as Non-SPCM.
- OBG segment 7DW is located outside North side of Bay 13.

The Notice of Witness Inspection Number (NWIT) is 005086. The indication is located inside an area that has been previously tested 100% and accepted by ZPMC Quality Control (QC) personnel.

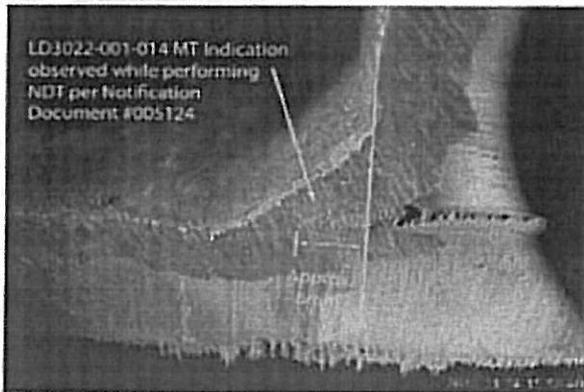
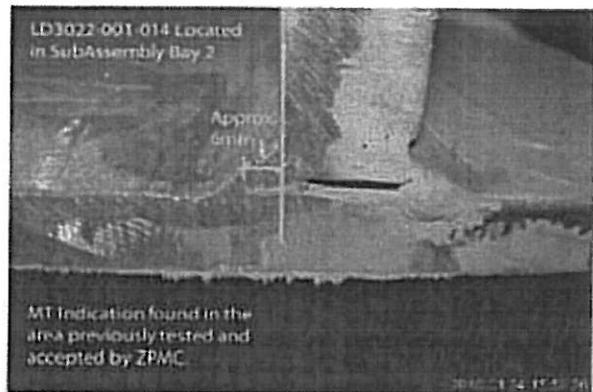
During the Quality Assurance Magnetic Particle Testing (MT) review of welds located on LD3022-001, this Quality Assurance Inspector (QA) discovered the following issues:

- One (1) linear indication measuring approximately 6mm in length.
- The weld is identified as: LD3022-001-014 for Lift 12.
- The area was previously repaired by ZPMC using Critical Weld Repair (CWR) 1151.
- The fillet weld size is 12mm.
- This Fillet Weld joins longitudinal diaphragm stiffener to longitudinal diaphragm web plate.
- This weld is designated as Non-Seismic Performance Critical Member.
- The Notice of Witness Inspection Number (NWIT) is 005124. The indication is located inside the area that has been previously tested and accepted by ZPMC Quality Control (QC) personnel. ZPMC Quality Control (QC) has performed 100% Magnetic particle Testing (MT) of this weld.

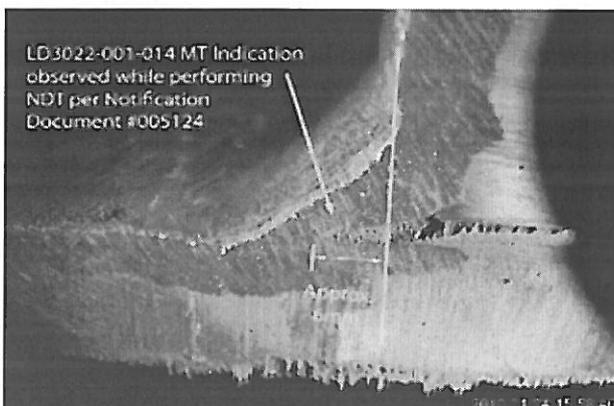
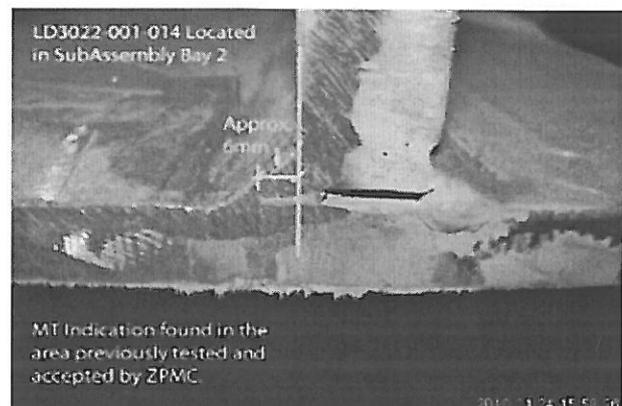
-This weld is designated as Non-Seismic Performance Critical Member.

-The Notice of Witness Inspection Number (NWIT) is 005124. The indication is located inside the area that has been previously tested and accepted by ZPMC Quality Control (QC) personnel. ZPMC Quality Control (QC) has performed 100% Magnetic particle Testing (MT) of this weld.
