QUALITY ASSURANCE -- NON-CONFORMANCE REPORT

Report No: NCR-000652

Bridge No: 34-0006

Reference Description: Base Metal Repair without Engineer's Approval, East Tower, Lift 4, Skin E

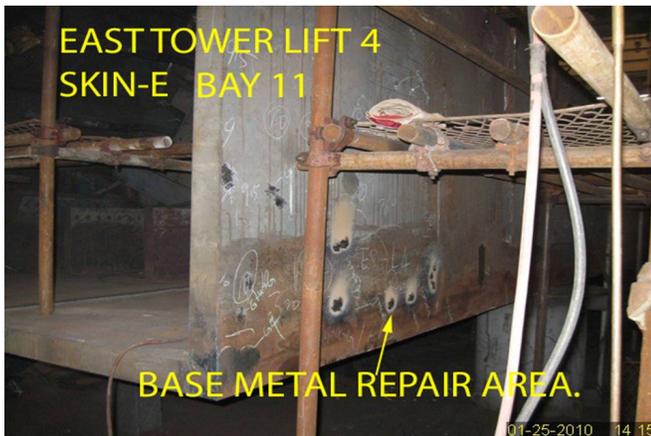
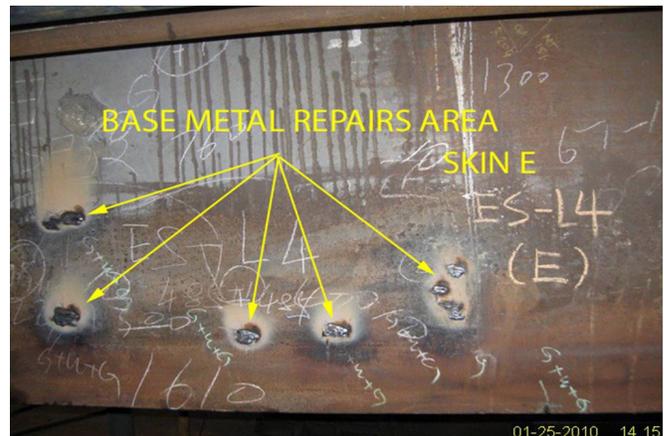
Caltrans Quality Assurance (QA) observed base metal repairs were performed without prior approval from the Engineer. These repairs were performed using the Shielded Metal Arc Welding (SMAW) process at East Tower, Lift 4, Skin E, on Seismic Performance Critical Member (SPCM) 485 grade material.

Propose a resolution for the identified non-conformance, documenting that the repaired base metal / welding repair is in compliance with the contract requirements. Documentation provided for the Engineer's review of the acceptability of the weld repair shall at a minimum include the procedure utilized/CWR and the NDT results.

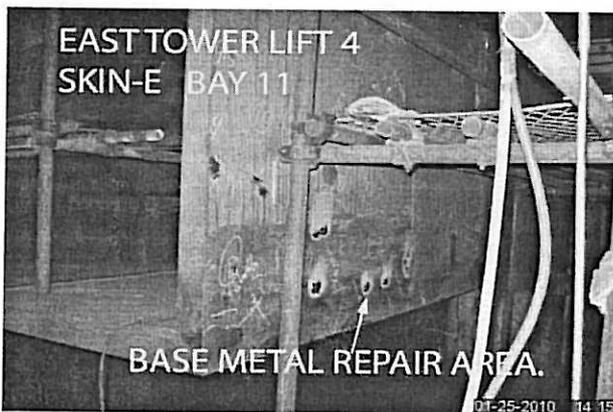
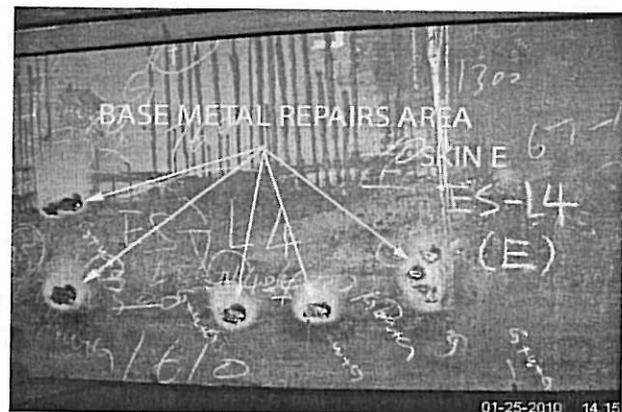
Caltrans Quality Assurance (QA) observed base metal repairs were performed without prior approval from the Engineer. These repairs were performed using the Shielded Metal Arc Welding (SMAW) process at East Tower, Lift 4, Skin E, on Seismic Performance Critical Member (SPCM) 485 grade material.

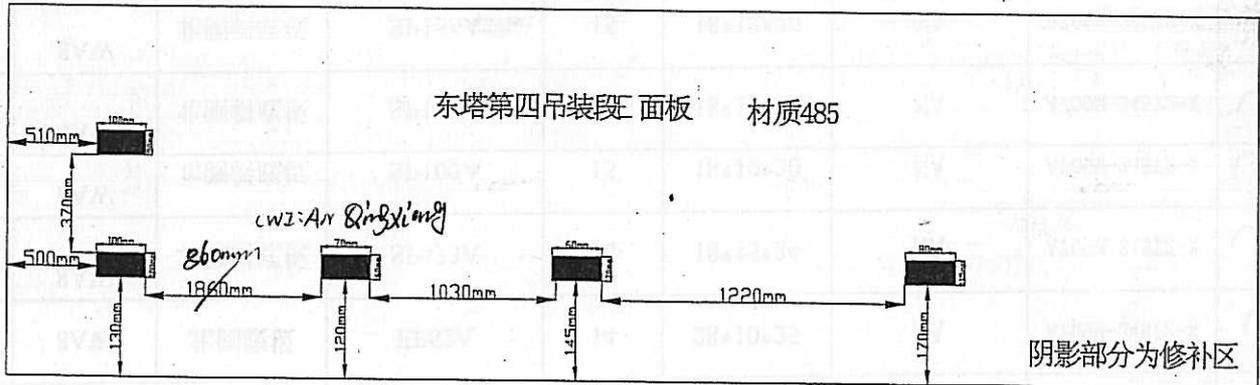
East tower fourth lifting Skin E metal degree 485

Fourth lifting east tower Skin E, the base metal was found damaged after grinding, 3-8mm in depth and needed to repair, the detail see the draft.

Repair area in shadow.

Train and educate operator to improve operation skill.
