Contract #: 04-0120F4Cty: SF/ALA Rte: 80 PM: 13.2/13.9File #: 69.25B**QUALITY ASSURANCE -- NON-CONFORMANCE REPORT****Location:** Changxing Island, Shanghai, P.R. China**Report No:** NCR-000653**Prime Contractor:** American Bridge/Fluor Enterprises, a JV**Date:** 25-Jan-2010**Submitting Contractor:** Zhenhua Port Machinery Company, Ltd (ZPMC), Changxing Island**NCR #:** ZPMC-0624**Type of problem:**

Welding	Concrete	Other	
Welding	Curing	Procedural	Bridge No: 34-0006
Joint fit-up	Coating	Other	Component: OBG Segment 7EW FB to LD Weld
Procedural	Procedural	Description: Missed UT Indication by QC

Reference Description: An UT indication (in 7EW FB to LD Weld) found by QA verification at the location where the contractor has tested and accepted

To:	AMERICAN BRIDGE/FLUOR, A JV 375 BURMA ROAD OAKLAND CA 95607	Date:	26-Jan-2010
Dear:	Mr. Charles Kanapicki	Contract No:	04-0120F4 04-SF-80-13.2 / 13.9
Attention:	Mr. Thomas Nilsson Project/Fabrication Manager	Job Name:	SAS Superstructure
Subject:	NCR No. ZPMC-0624	Document No:	05.03.06-000612

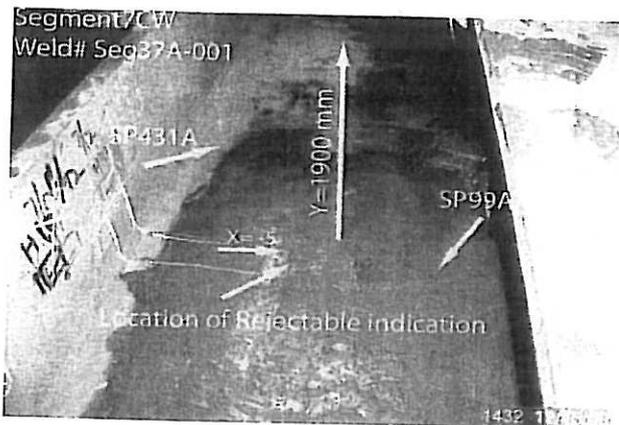
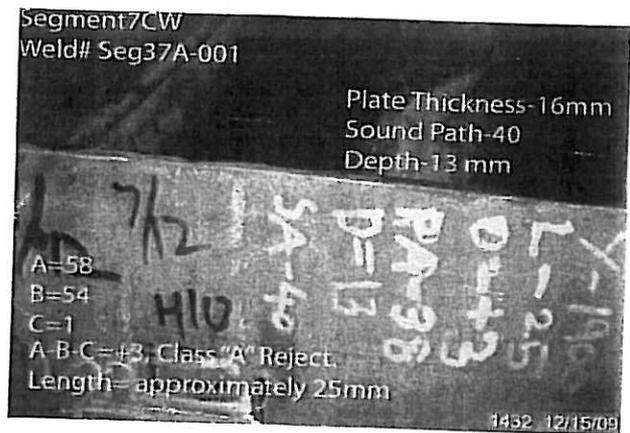
During the Quality Assurance Ultrasonic Testing (UT) review of weld located on OBG Segment 7CW, this Quality Assurance Inspector (QA) discovered the following issue:

- A total of one (1) rejectable Class "A" indication measuring approximately 25mm in length.
 - The Weld is a complete joint penetration (CJP) Butt Weld joining Side Plate SP99A to SP431A and is identified as SEG37A-001.
 - The Segment is located in the repair yard north of the blast shop.
- The Notice of Witness Inspection Number (NWIT) is 004866. The indication is located inside the area that has been previously tested and accepted by ZPMC Quality Control (QC) personnel. As per the contract documents, ZPMC's QC personnel are required to perform 100% (UT) inspection of this splice weld.

Submit a repair plan to the engineer for approval. A response for the resolution of this issue is expected within 7 days.

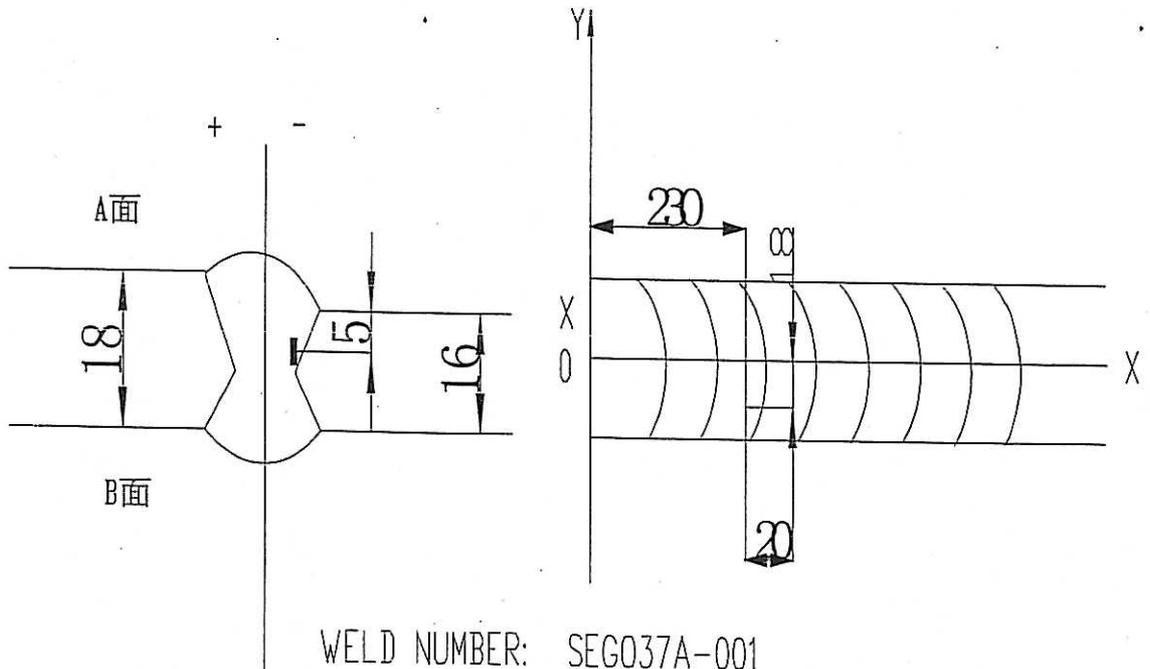
(UT探伤发现的缺陷总长度小于最大允许长度。) SEG037A-001

Rejected indication found by ultrasonic inspection is less than the maximum allowance aggregate length.

1. Gouge or grind from nearer side from metal edge ($D \leq 0.65T$, " D " is depth of defects, " T " is thickness of metal) to remove all defects;

2. Follow repair WPS for joint preparation, preheat, and weld deposit;

3. Verify with VT no defects remain in the weld joint prior to welding;

4. Grind the repaired area flush with base metal or the adjacent weld;

5. Perform UT inspection to the weld along with 50mm on each end of the repair area;

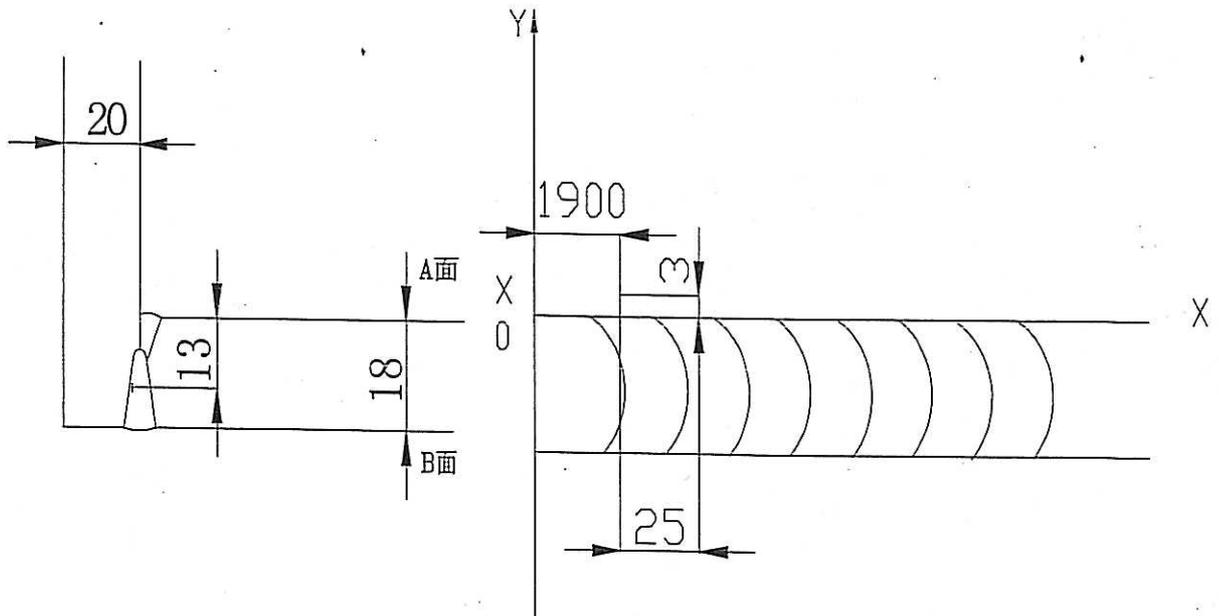
WELD NUMBER: SEG041C-013

Rejected indication found by ultrasonic inspection is less than the maximum allowance aggregate length.

1. Gouge or grind from nearer side from metal edge ($D \leq 0.65T$, "D" is depth of defects, "T" is thickness of metal) to remove all defects;

2. Follow repair WPS for joint preparation, preheat, and weld deposit;

3. Verify with VT no defects remain in the weld joint prior to welding;

4. Grind the repaired area flush with base metal or the adjacent weld;

5. Perform UT inspection to the weld along with 50mm on each end of the repair area;

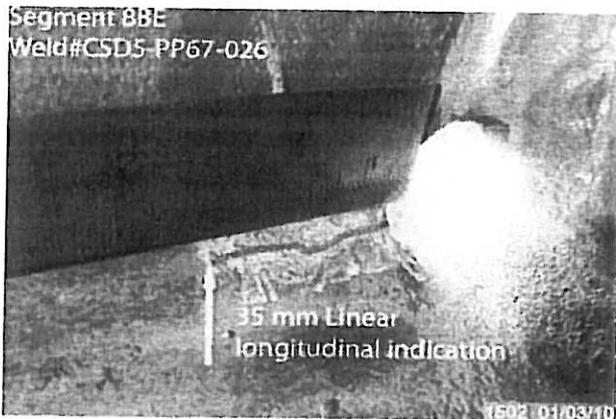
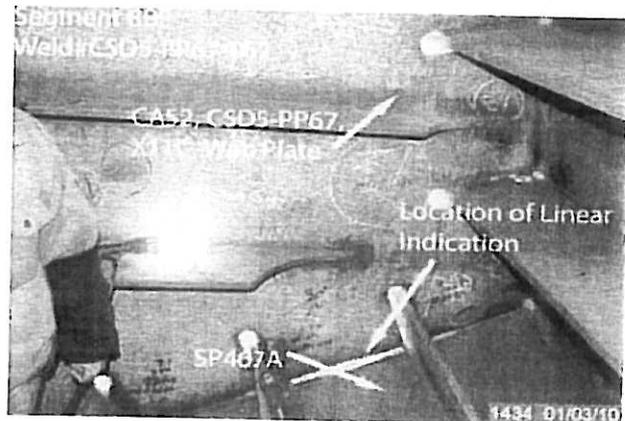
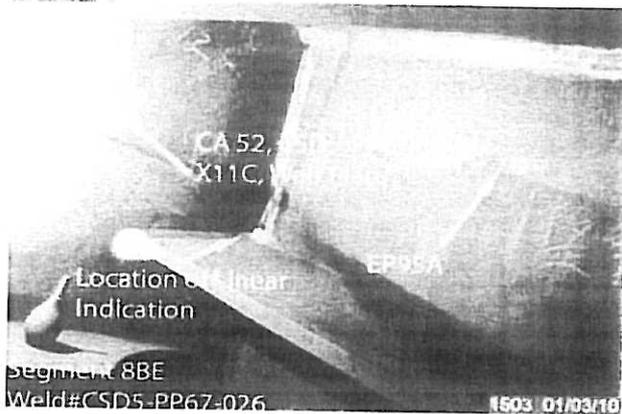
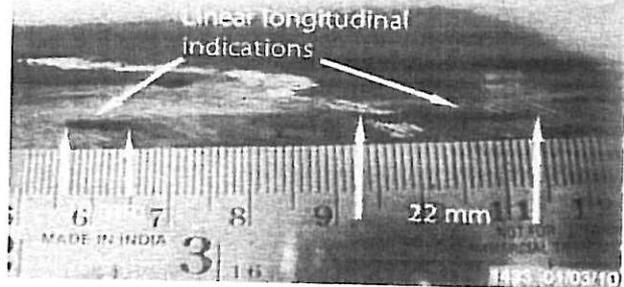
- Two (2) Longitudinal linear indication measuring approximately 22mm and 35mm in length.
- The welds are identified as: CSD5-PP67-052 (22 mm) and CSD5-PP67-026 (35 mm).
- The welds are a Fillet Weld type joining the Side Plate (SP467A) and Edge Plate (EP95A) stiffeners to Corner Assembly (CA52A) web plates.
- The OBG 8BE segment is located outside in front of the Blast Shop.

The Notice of Witness Inspection Number (NWIT) is 004978. The indication is located inside the area that has been previously tested and accepted by ZPMC Quality Control (QC) personnel. ZPMC's QC personnel are required to perform twenty five (25%) percent MT inspection of this weld.

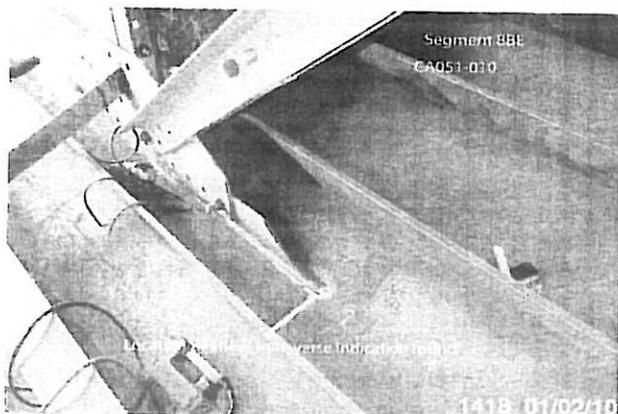
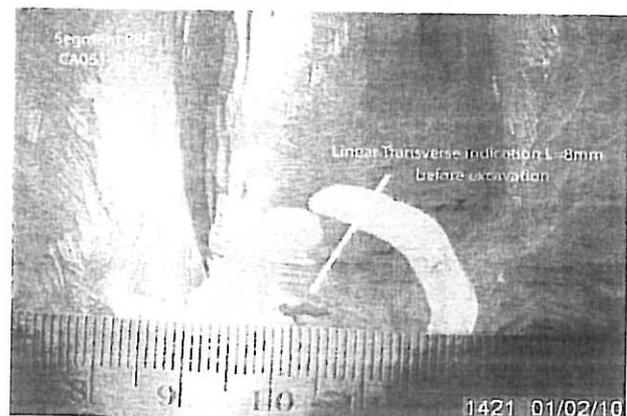
- One (1) Transverse linear indication that measured approximately 8mm in length.
- The weld is identified as CA051-010 at panel point (PP64.5 in Segment 8BE).
- The weld is a fillet weld joining the Vertical Longitudinal Truss (X74H) to the Side Plate (SP458A)
- The Side Panel plate is identified as: PL1353A.
- The OBG Corner Assembly is located in the outside repair yard, south side of the Bay14.

The Notice of Witness Inspection Number (NWIT) is 004978. The indication is located inside the area that has been previously tested and accepted by ZPMC Quality Control (QC) personnel. As per the contract documents, ZPMC's QC personnel are required to perform 100% Magnetic Particle inspection of this weld.

Repair said indication and perform NDT required to verify weld quality.
