Contract #: 04-0120F4Cty: SF/ALA Rte: 80 PM: 13.2/13.9File #: 69.25B**QUALITY ASSURANCE -- NON-CONFORMANCE REPORT****Location:** Changxing Island, Shanghai, P.R. China**Report No:** NCR-000654**Prime Contractor:** American Bridge/Fluor Enterprises, a JV**Date:** 25-Jan-2010**Submitting Contractor:** Zhenhua Port Machinery Company, Ltd (ZPMC), Changxing Island**NCR #:** ZPMC-0625**Type of problem:**

Reference Description: MT indications found in the weld and the weld near the base metal in CB4 Deck and Side Panel

Job Name: SAS Superstructure

Report No: NCR-000654

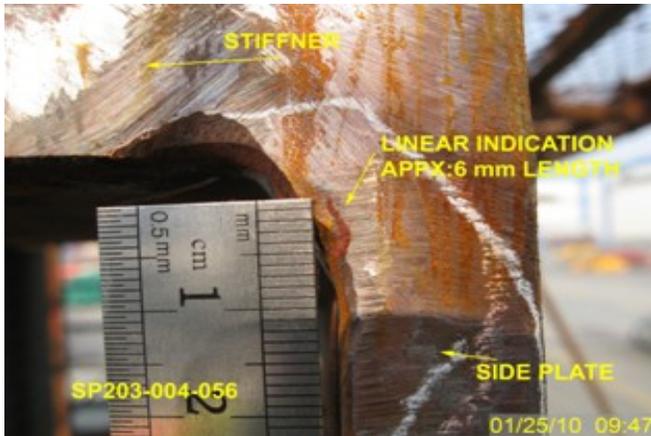
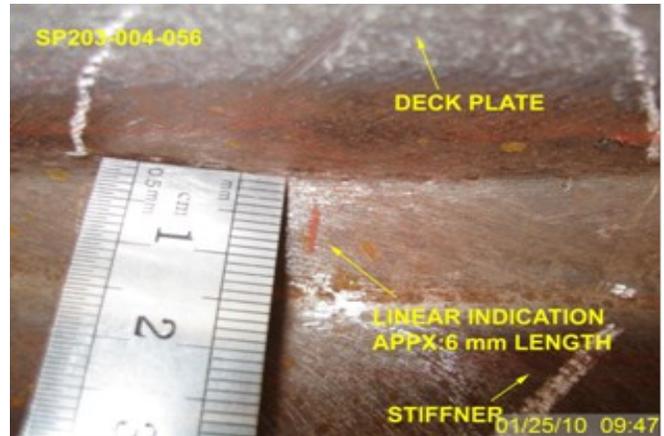
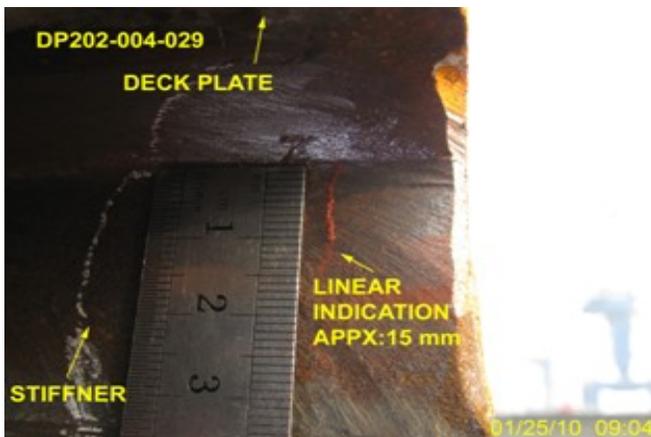
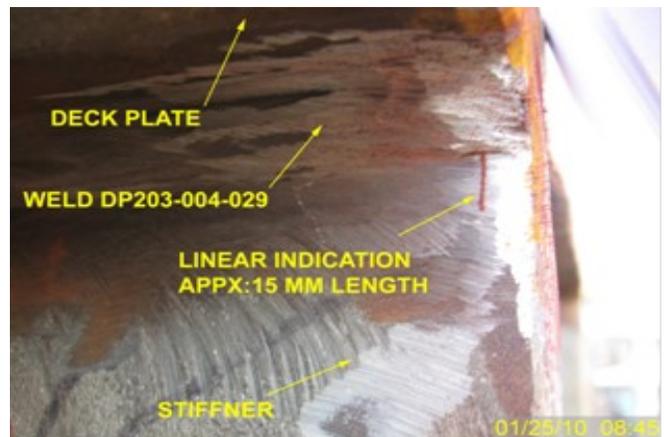
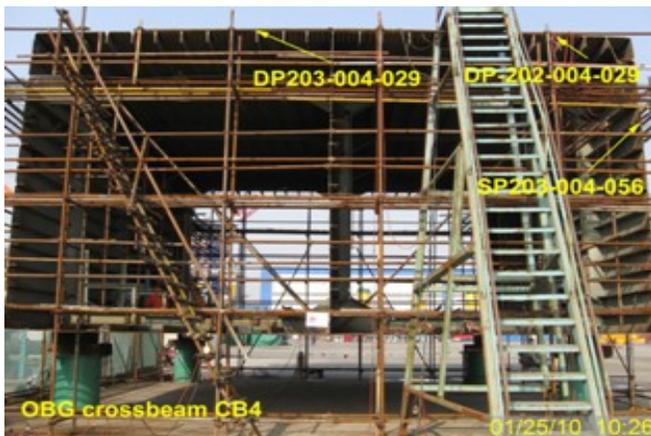
During Quality Assurance (QA) Magnetic Particle Testing (MT) review of welds located on Cross Beam CB4, this QA Inspector discovered the following issues:

- One (1) Transverse Linear indication measuring approximately 15 mm in length.
- The indication is on the base metal near the weld is identified as: DP202-004-029.
- The weld is a fillet weld joining deck plate to stiffener plate.

- One (1) Transverse Linear indication measuring approximately 15 mm in length.
- The indication is on the base metal near the weld is identified as: DP203-004-029.
- The weld is a fillet weld joining deck plate to stiffener plate.

- Two (2) Transverse Linear indications measuring approximately each indication 6 mm in length.
- The weld is identified as: SP203-004-056.
- The weld is a fillet weld joining deck plate to stiffener plate.

- The Notice of Witness Inspection Number (NWIT) is 005123. The indications are located outside the area that has been previously tested and accepted by ZPMC Quality Control (QC) personnel by performing 25% MT inspection of these welds.

-AWS D1.5 (02) Section 6.26.2 – “Welds that are subject to MT in addition to visual inspection shall have no cracks”.

Repair said indications and perform NDT required to verify weld quality.

Contractor submitted NDT data verifying the welds were repaired in accordance with approved CWRs and are in conformance with Contract specifications. Additional training was provided to NDT Technicians and an internal NCR was also issued by the Contractor in regards to this issue.

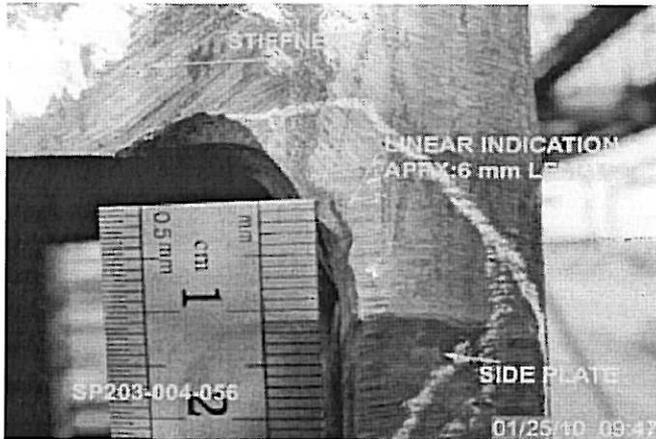
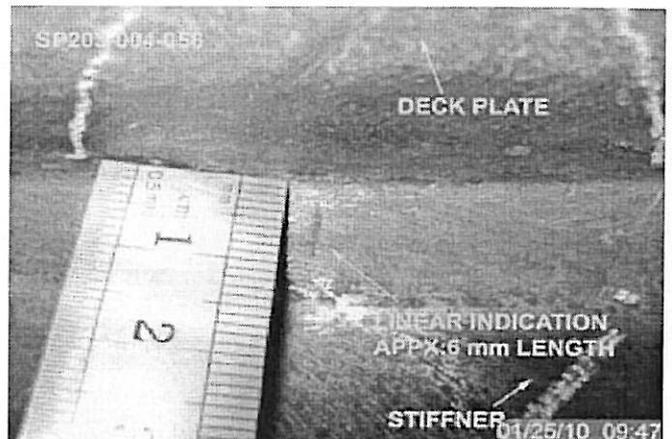
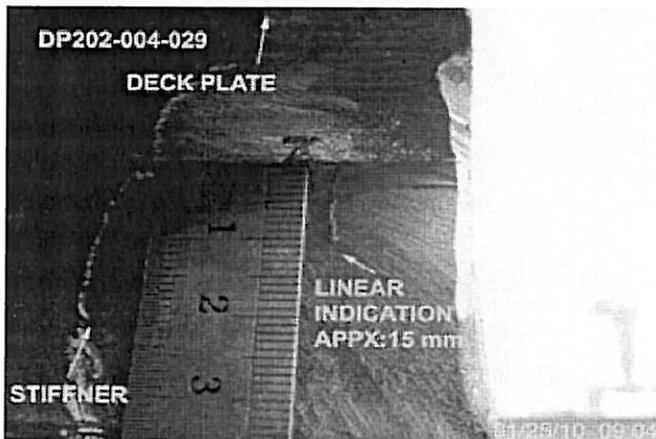
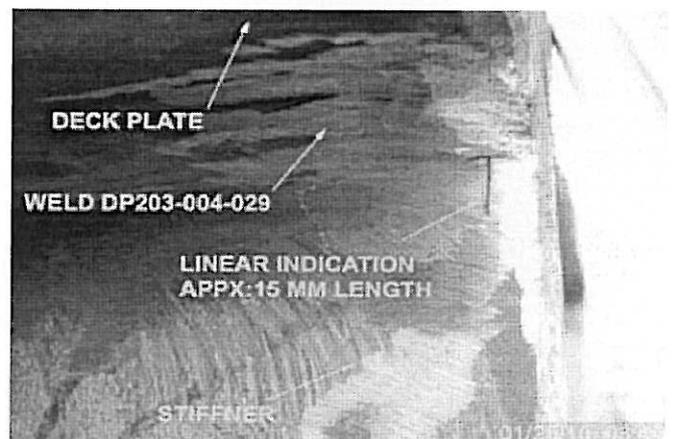
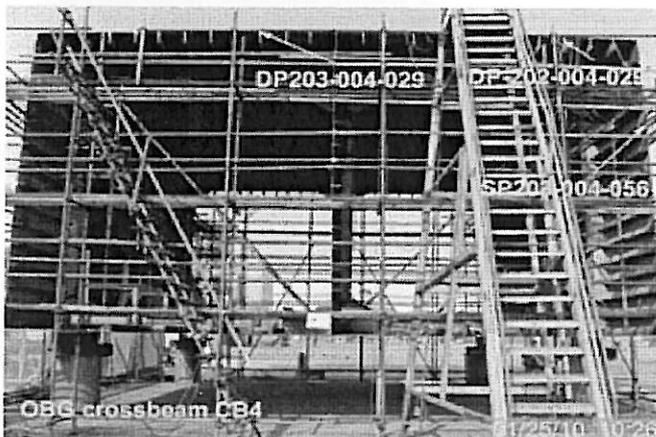
During Quality Assurance (QA) Magnetic Particle Testing (MT) review of welds located on Cross Beam CB4, this QA Inspector discovered the following issues:

- One (1) Transverse Linear indication measuring approximately 15 mm in length.
- The indication is on the base metal near the weld is identified as: DP202-004-029.
- The weld is a fillet weld joining deck plate to stiffener plate.

- One (1) Transverse Linear indication measuring approximately 15 mm in length.
- The indication is on the base metal near the weld is identified as: DP203-004-029.
- The weld is a fillet weld joining deck plate to stiffener plate.

- Two (2) Transverse Linear indications measuring approximately each indication 6 mm in length.
- The weld is identified as: SP203-004-056.
- The weld is a fillet weld joining deck plate to stiffener plate.

- The Notice of Witness Inspection Number (NWIT) is 005123. The indications are located outside the area that has been previously tested and accepted by ZPMC Quality Control (QC) personnel by performing 25% MT inspection of these welds.

-AWS D1.5 (02) Section 6.26.2 – “Welds that are subject to MT in addition to visual inspection shall have no cracks”.
