Contract #: 04-0120F4Cty: SF/ALA Rte: 80 PM: 13.2/13.9File #: 69.25B**QUALITY ASSURANCE -- NON-CONFORMANCE REPORT****Location:** Changxing Island, Shanghai, P.R. China**Report No:** NCR-000655**Prime Contractor:** American Bridge/Fluor Enterprises, a JV**Date:** 26-Jan-2010**Submitting Contractor:** Zhenhua Port Machinery Company, Ltd (ZPMC), Changxing Island**NCR #:** ZPMC-0626**Type of problem:**

Reference Description: Missed UT indication by QC on Side Plate to Bottom Plate Joint on Segment 12BE**Description of Non-Conformance:**

QUALITY ASSURANCE -- NON-CONFORMANCE REPORT

Job Name: SAS Superstructure

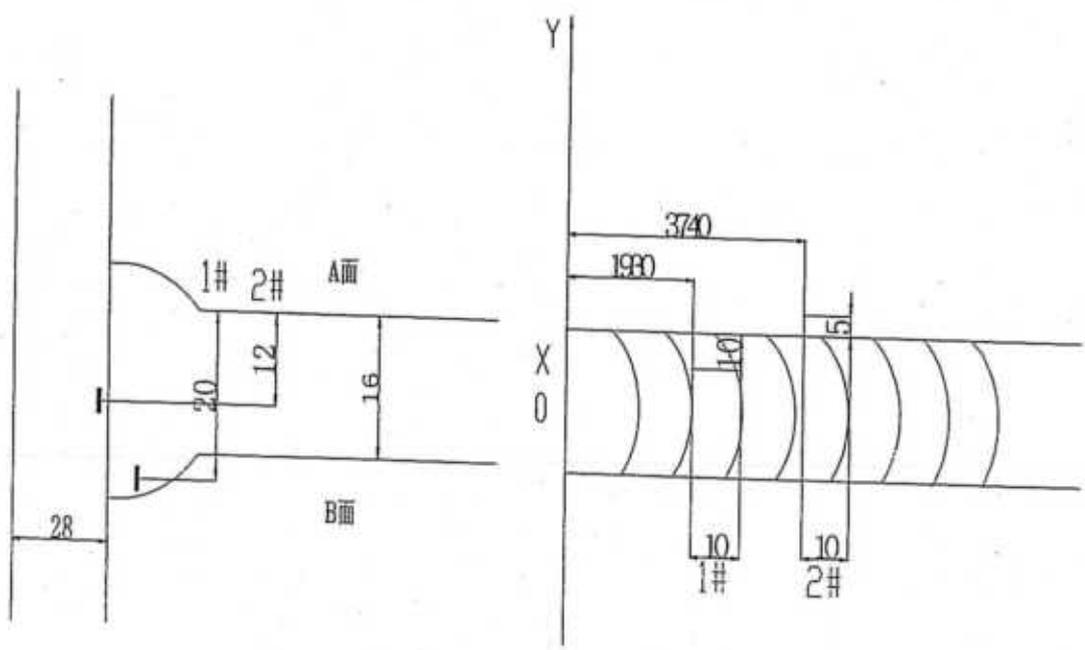
WELD NUMBER: SEG3002A-001

在对 OBG 12BE 进行 UT 检验的过程中, 加州工程师发现以下问题:
 一条纵向线性缺陷长度将近 10mm。dB 值是+6, 深度是接近 18mm。焊缝号是 SEG3002A-001 在联系梁侧。Y 值是从 PP113 起 1160mm 位置。该焊缝 CJP 焊缝, 连接 PL3056A(非 SPCM)至 PL3043A (非 SPCM), 12BE 在十四车间中。缺陷所在位置之前已经被 ZPMC UT 检验人员所检验并接受。

Rejected indication found by ultrasonic inspection is less than the maximum allowance aggregate length.

(UT探伤发现的缺陷总长度小于最大允许长度。) SEG3002A-001

1. Gouge or grind from nearer side from metal edge ($D \leq 0.65T$, "D" is depth of defects, "T" is thickness of metal) to remove all defects;

2. Follow repair WPS for joint preparation, preheat, and weld deposit;

3. Verify with VT no defects remain in the weld joint prior to welding;

4. Grind the repaired area flush with base metal or the adjacent weld;

5. Perform UT inspection to the weld along with 50mm on each end of the repair area;

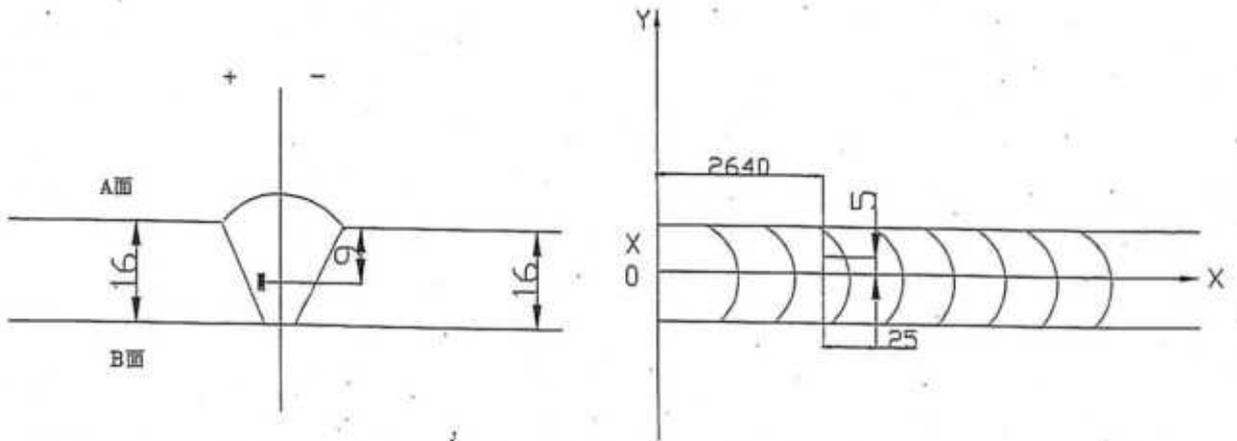
WELD NUMBER: SEG050A-003

Rejected indication found by ultrasonic inspection is less than the maximum allowance aggregate length.

(UT探伤发现的缺陷总长度小于最大允许长度。) SEG050A-003

1. Gouge or grind from nearer side from metal edge ($D \leq 0.65T$, "D" is depth of defects, "T" is thickness of metal) to remove all defects;
2. Follow repair WPS for joint preparation, preheat, and weld deposit;
3. Verify with VT no defects remain in the weld joint prior to welding;
4. Grind the repaired area flush with base metal or the adjacent weld;
5. Check the welds according to the working drawings;
