**QUALITY ASSURANCE -- NON-CONFORMANCE REPORT**

**Location:** Changxing Island, Shanghai, P.R. China**Report No:** NCR-000656**Prime Contractor:** American Bridge/Fluor Enterprises, a JV**Date:** 27-Jan-2010**Submitting Contractor:** Zhenhua Port Machinery Company, Ltd (ZPMC), Changxing Island**NCR #:** ZPMC-0627**Type of problem:**

**Reference Description:** Fabrication not according to the approved shop drawings in Segment 6CE vertical floorbeam flange

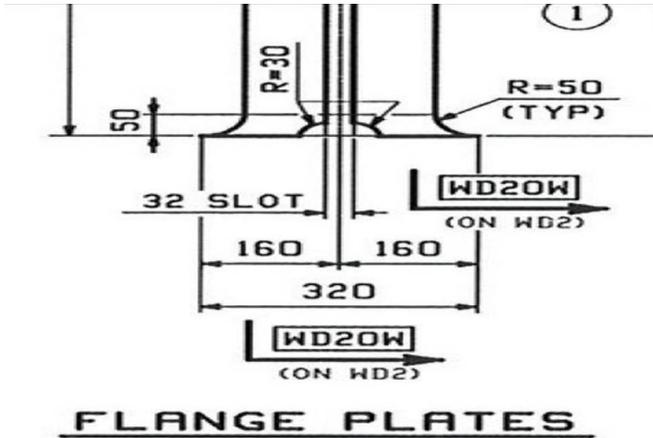
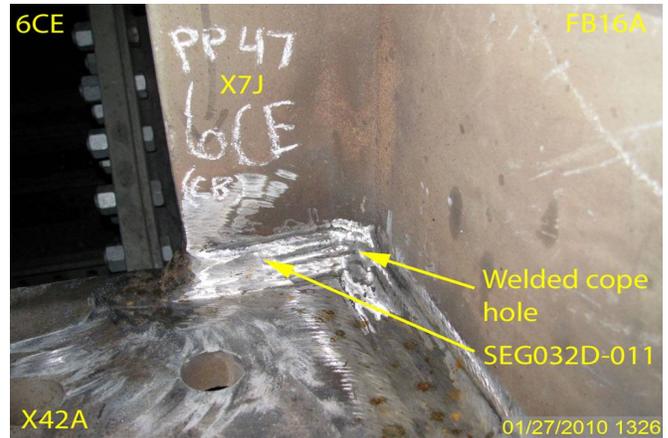
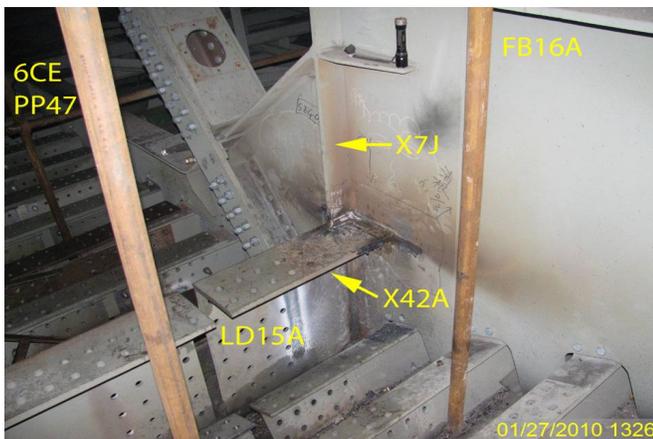
During the Quality Assurance (QA) random in-process visual inspection of the OBG segments in the Trial Assembly area, this QA inspector discovered the following issues:

- Cope Hole R=30mm has been welded (on X7J)
- The R=50mm portion at the transition end of the X7J flange has been trimmed

- At panel point 47, Segment 6CE, Floor Beam FB16A
- The PJP weld joint connecting the vertical floorbeam flange (stiffener) X7J to the Longitudinal Diaphragm LD15A flange plate X42A
- Weld number SEG032D-011

AWS D1.5 2002 Section 3.2.5: Radii of beam copes and weld access holes shall provide a smooth transition, free of notches or cutting past the points of tangency between adjacent surfaces.

AWS D1.5 2002 Section 3.2.5: Reentrant corners of base-metal cut edges shall be formed to provide a smooth transition with a radius of not less than 25 mm [1 in.] that meets the adjacent edges without offset or cutting past the point of tangency. The reentrant corners may be formed by thermal cutting, followed by grinding to meet the surface requirements of 3.2.2.

Propose a resolution for the identified non-conformance with revised procedures to prevent future occurrences and provide documentation to show that the non-conformance has been corrected according to the approved shop drawings. A response for the resolution of this issue is expected within 14 days.

**Reference Resolution:** ZPMC has excavated the cope hole so it is now in conformance with AWS D1.5 and the approved shop drawings. Attached is the NDT to show that base metal was not damaged during this repair.

Contractor removed weld, installed cope hole in conformance with approved Shop Drawings, and submitted subsequent NDT report verifying the weld and base material in the vicinity of the repair were not affected.

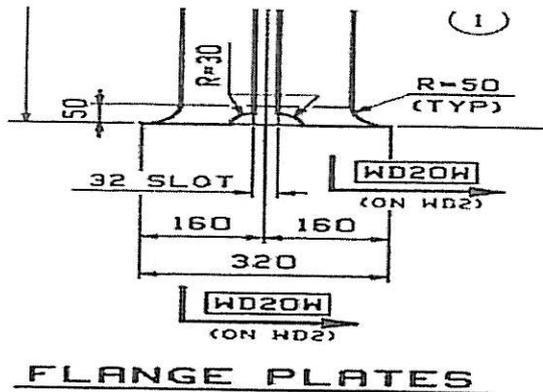
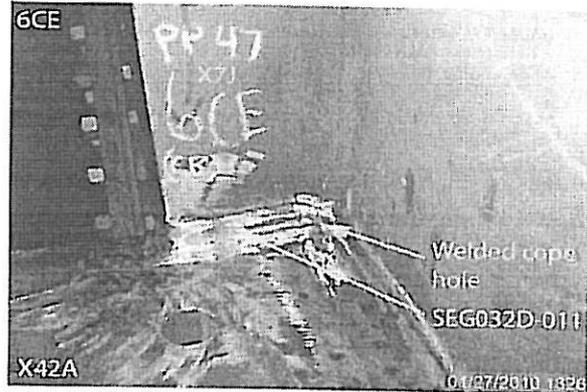
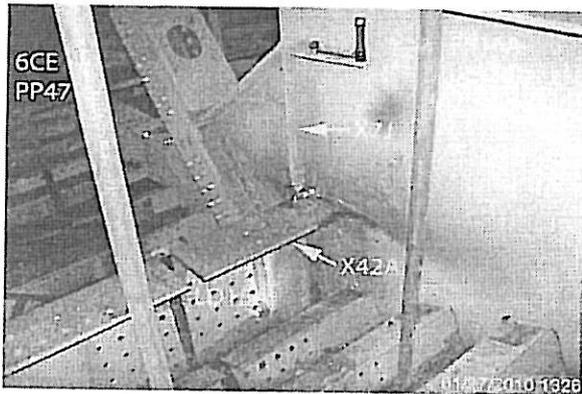
AWS D1.5 2002 Section 3.2.5: Reentrant corners of base-metal cut edges shall be formed to provide a smooth transition with a radius of not less than 25 mm [1 in.] that meets the adjacent edges without offset or cutting past the point of tangency. The reentrant corners may be formed by thermal cutting, followed by grinding to meet the surface requirements of 3.2.2.

AWS D1.5 2002 Section 3.2.5: Radii of beam copes and weld access holes shall provide a smooth transition, free of notches or cutting past the points of tangency between adjacent surfaces.

- Weld number SEG032D-011
- LD15A flange plate X42A
- The PJP weld joint connecting the vertical floorbeam flange (stiffener) X7J to the Longitudinal Diaphragm
- At panel point 47, Segment 6CE, Floor Beam FB16A

-The R=50mm portion at the transition end of the X7J flange has been trimmed

-Cope Hole R=30mm has been welded (on X7J)

Replace cope hole and perform NDT required to verify weld quality.
