Contract #: 04-0120F4Cty: SF/ALA Rte: 80 PM: 13.2/13.9File #: 69.25B**QUALITY ASSURANCE -- NON-CONFORMANCE REPORT****Location:** Changxing Island, Shanghai, P.R. China**Report No:** NCR-000657**Prime Contractor:** American Bridge/Fluor Enterprises, a JV**Date:** 27-Jan-2010**Submitting Contractor:** Zhenhua Port Machinery Company, Ltd (ZPMC), Changxing Island**NCR #:** ZPMC-0628**Type of problem:**

Reference Description: UT Indication discovered after ZPMC had tested and accepted this weld in Segment 8CE Side Panel to Side Panel

Job Name: SAS Superstructure

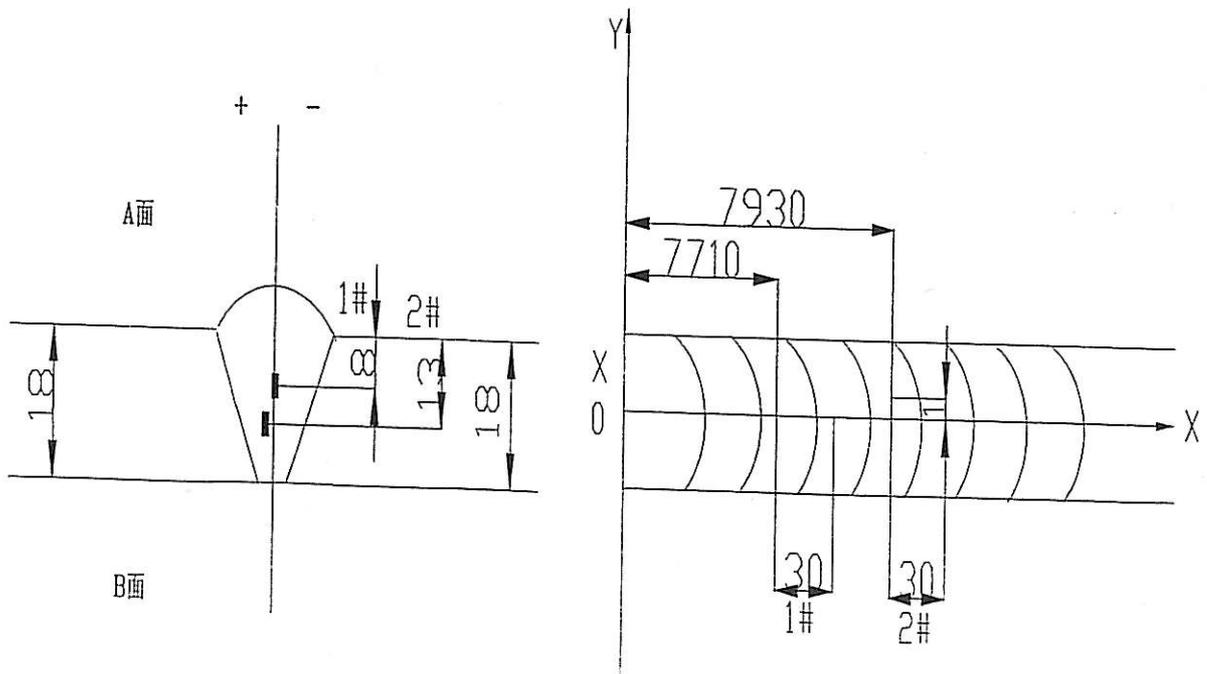
WELD NUMBER: SEG048B-032

Description of welding discontinuity:

Rejected indication found by ultrasonic inspection is less than the maximum allowance aggregate length.

(UT探伤发现的缺陷总长度小于最大允许长度。) SEG048B-032

Caused:

1、焊道未及时处理干净。

1. Did not clear the weld pass completely in time.

1. Gouge or grind from nearer side from metal edge ($D \leq 0.65T$, "D" is depth of defects, "T" is thickness of metal) to remove all defects;

2. Follow repair WPS for joint preparation, preheat, and weld deposit;

3. Verify with VT no defects remain in the weld joint prior to welding;

4. Grind the repaired area flush with base metal or the adjacent weld;

5. Perform UT inspection to the weld along with 50mm on each end of the repair area;
