Contract #: 04-0120F4  
 Cty: SF/ALA Rte: 80 PM: 13.2/13.9  
 File #: 69.25B

## QUALITY ASSURANCE -- NON-CONFORMANCE REPORT

**Report No:** NCR-000658

**Reference Description:** Welder was not qualified to weld in 4F position for 6CW counterweight connection plate

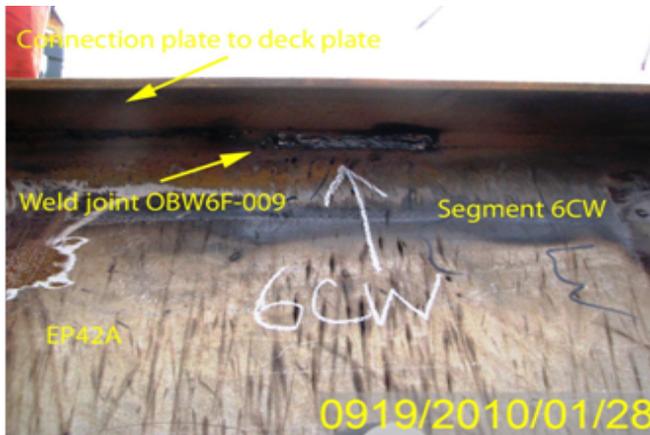
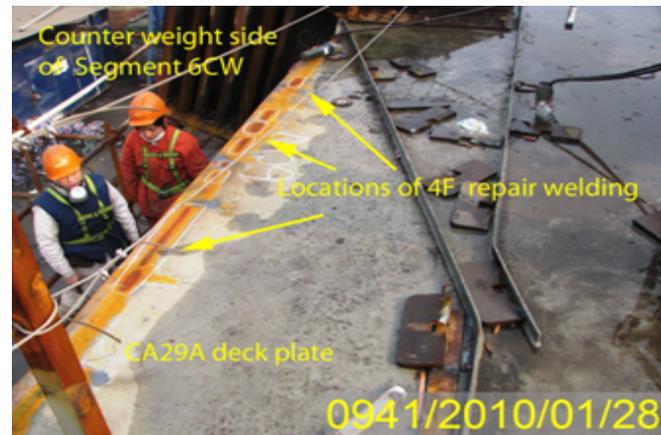
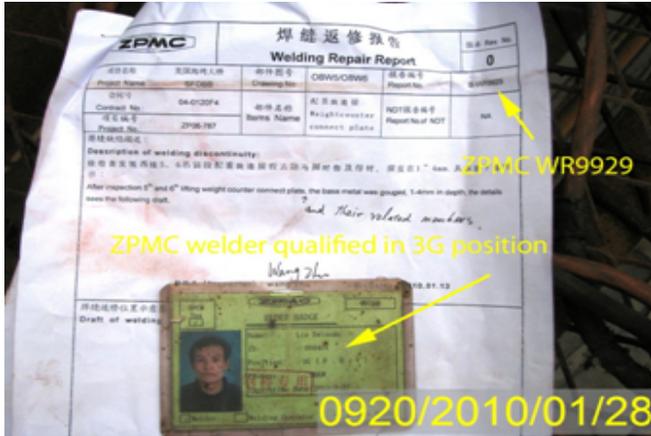
- ZPMC welder Xiao Di # 066401 was observed welding in the 4F overhead welding position, which he is only qualified in 3F vertical position.
- Welding was performed on the Connection Plate to Deck Plate.
- The Deck Plate is identified as CA29A.
- The weld is identified as OBW6F-009.
- This weld is a Complete Joint Penetration (CJP).
- A total of eight (8) repairs were performed on the bottom side of weld joint OBW6F-009.
- These repairs are located on the Counter Weight side of segment 6CW at the W3 line.
- Lift 6W is located in the OGB Trial Assembly Area.

Propose a resolution for the identified non-conformance with revised procedures to prevent future occurrences and also provide documentation to show that the weld quality conforms to contract requirements.

**Reference Resolution:** The welder in question for this non conformance report has been qualified in the 4F position. Attached is documentation of the test results of the welder qualifications which are acceptable.

This proposed resolution is acceptable. The documentation received for ZPMC Welder Liu Daiquan is sufficient and the Department concurs that Non-Conformance ZPMC-0629 is closed.

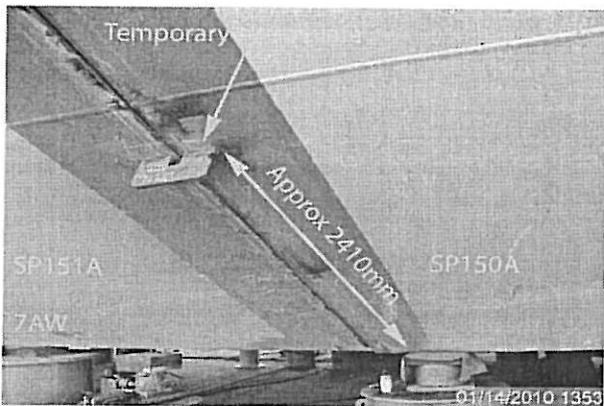
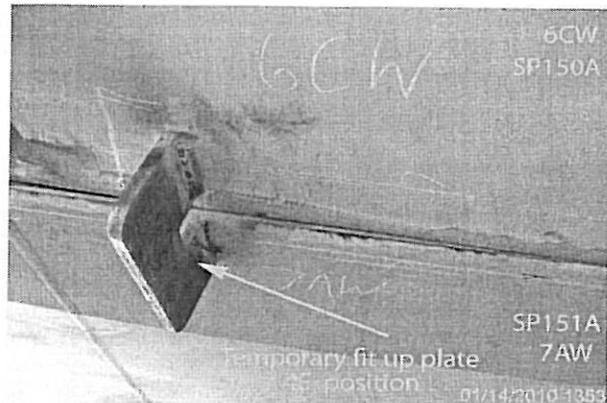
**Reference Description:** ZPMC welder was observed welding outside of his qualified position on 6CW to 7AW Side Panel temporary attachments

- Welder Xiao Di #203204 (2F) welding in the 4F position which he is not qualified.
- Welding was performed on temporary fit up plates SP150A (6CW) to SP151A (7AW) at the Side Plate Segment field splice, Counter Weight side.
- Fit up plate was welded approximately 2410mm from the Side Plate to Bottom plate splice weld.
- The material for 6CW SP150A (PL524A) is designated as Seismic Performance Critical Member (SPCM).
- The material for 7AW SP151A (PL527A) is designated as Non-Seismic Performance Critical Member (Non-SPCM).
- Segment 6CW/7AW is located outside in the Trial Assembly area.

AWS D1.5 (2002) Section 5.22.2.2 2F (horizontal) – “Qualification in the 2F (horizontal) position shall qualify for flat and horizontal position fillet welding of plate and structural shapes”.

Ensure the welder Xiao Di welds in the positions for which he is approved. A response for the resolution of this issue is expected within 7 days.

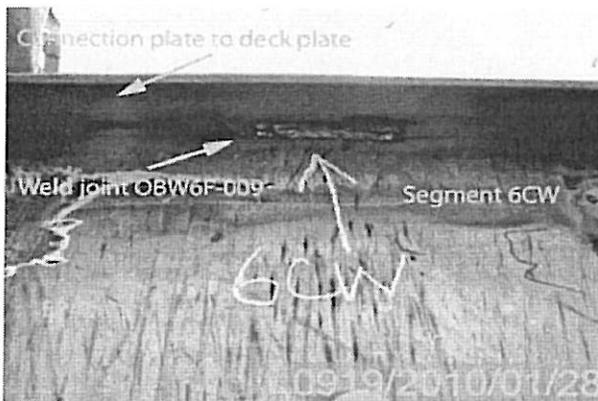
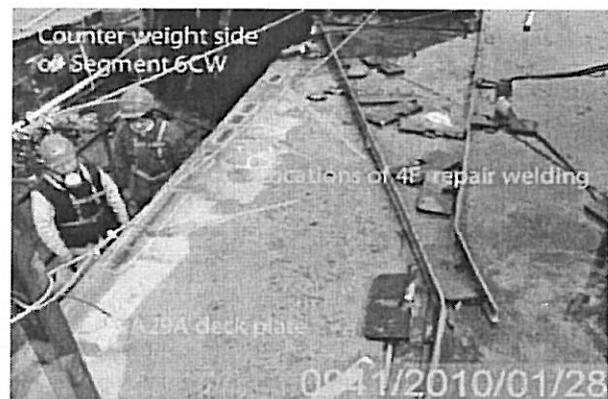
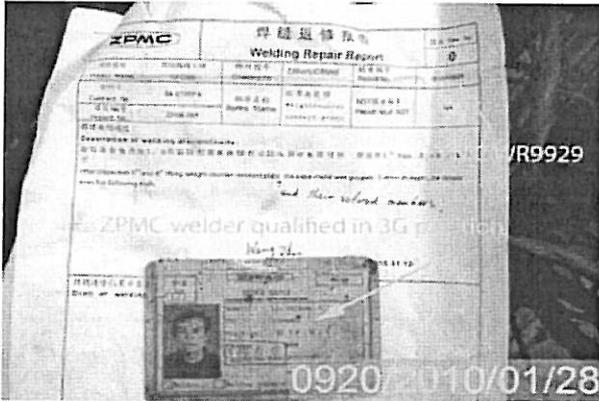
Reference Description: Welder was not qualified to weld in 4F position for 6CW counterweight connection plate

- ZPMC welder Xiao Di # 066401 was observed welding in the 4F overhead welding position, which he is only qualified in 3F vertical position.
- Welding was performed on the Connection Plate to Deck Plate.
- The Deck Plate is identified as CA29A.
- The weld is identified as OBW6F-009.
- This weld is a Complete Joint Penetration (CJP).
- A total of eight (8) repairs were performed on the bottom side of weld joint OBW6F-009.
- These repairs are located on the Counter Weight side of segment 6CW at the W3 line.
- Lift 6W is located in the OGB Trial Assembly Area.

AWS D1.5 (2002) 5.22.2.3; 3F (Vertical). Qualification in the 3F (vertical) position shall qualify for flat, horizontal, and vertical position fillet welding of plate and structural shapes.

Qualify welder for welding in the 4G position.

Welder Liu Dai Quan, ID 066401, was qualified to weld in said position on March 29, 2010. NOTE: Incorrect welder name mentioned in the NCR, however, the correct welder ID was provided.
