QUALITY ASSURANCE -- NON-CONFORMANCE REPORT

Location: Changxing Island, Shanghai, P.R. China**Report No:** NCR-000660**Prime Contractor:** American Bridge/Fluor Enterprises, a JV**Date:** 28-Jan-2010**Submitting Contractor:** Zhenhua Port Machinery Company, Ltd (ZPMC), Changxing Island**NCR #:** ZPMC-0631**Type of problem:**

Reference Description: Missed UT indication by QC on Segment 8CE Floorbeam to Deck Stiffener**Description of Non-Conformance:**

Job Name: SAS Superstructure

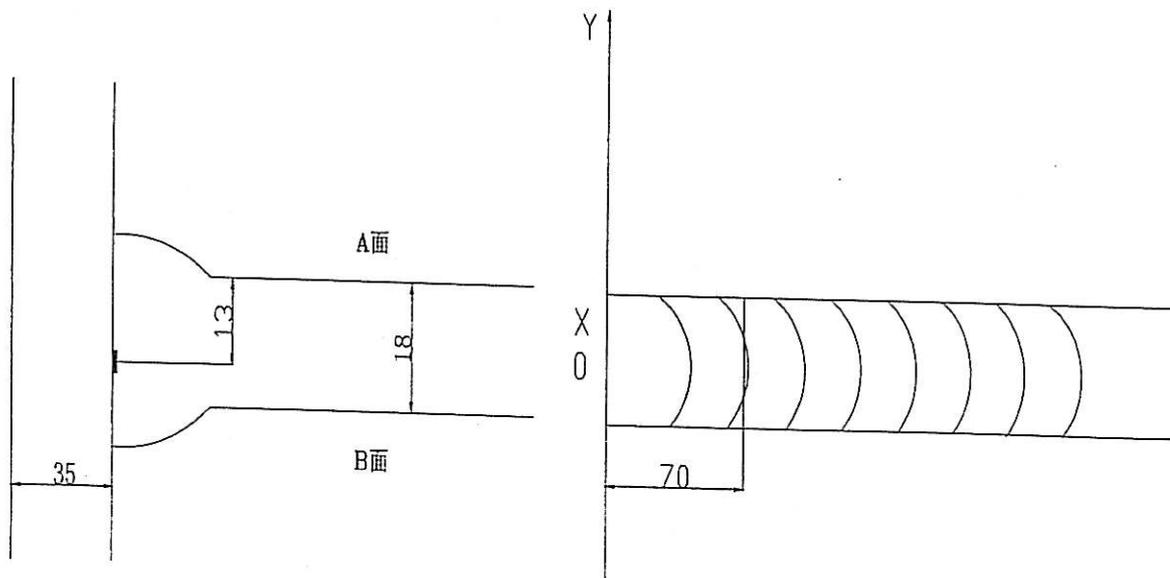
WELD NUMBER: SSD18-PP70-144

- Two (2) Class "A" longitudinal indications measuring approximately 70mm and 220mm in length.
- The indication dB ratings are +4 and -3 respectively.
- Material thickness is 18mm.

- The depth of the indications are approximately 14mm and 11mm.
- The 1st weld is identified as SSD18-PP70-144 at Panel Point PP70 Crossbeam Side.
- The 2nd weld is identified as SSD17-PP69-136 at Panel Point PP69 Crossbeam Side.

Rejected indication found by ultrasonic inspection is less than the maximum allowance aggregate length.

(UT探伤发现的缺陷总长度小于最大允许长度。) SSD18-PP70-144

1. 从缺陷距离端面较近一侧 ($D \leq 0.65T$, D 为缺陷深度, T 为板厚) 采用碳刨或打磨的方法去除焊缝缺陷;
 2. 参照返修焊接工艺规程 (WPS) 准备正确的接头型式, 预热和焊接;
 3. 焊前对修补区域进行VT检测保证缺陷完全被清除;
 4. 将修补区域打磨到与母材或邻近焊缝平齐;
 5. 对焊缝进行UT检测, 检测范围为返修区域以及其两端各延长50mm。
-
1. Gouge or grind from nearer side from metal edge ($D \leq 0.65T$, "D" is depth of defects, "T" is thickness of metal) to remove all defects;
 2. Follow repair WPS for joint preparation, preheat, and weld deposit;
 3. Verify with VT no defects remain in the weld joint prior to welding;
 4. Grind the repaired area flush with base metal or the adjacent weld;
 5. Perform UT inspection to the weld along with 50mm on each end of the repair area;

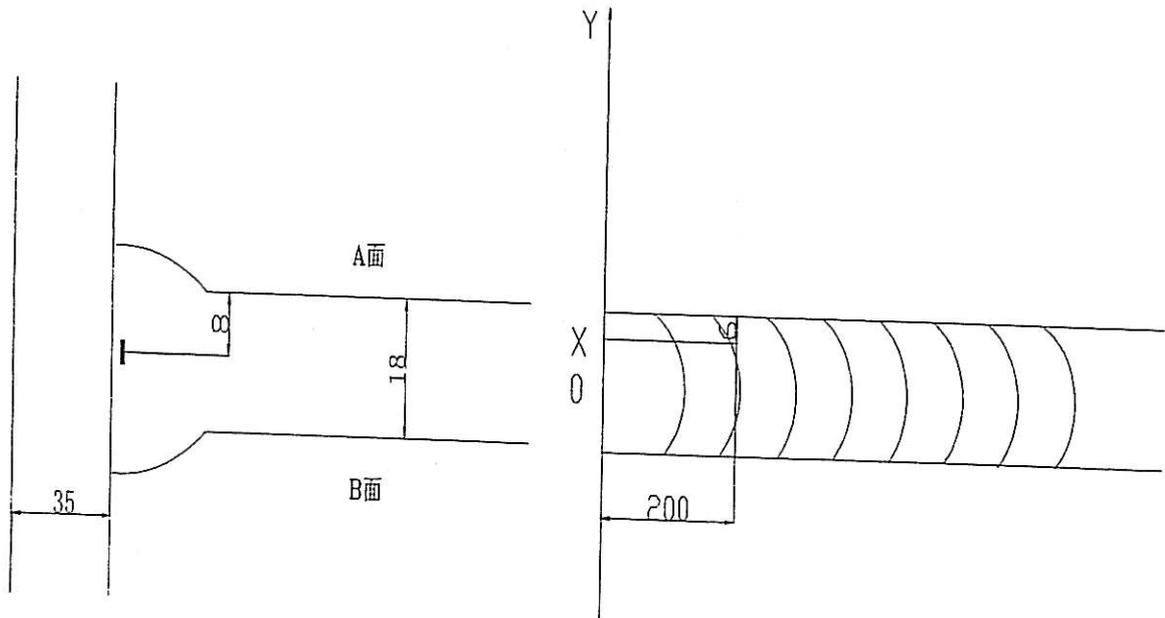
WELD NUMBER: SSD17-PP69-136

Rejected indication found by ultrasonic inspection is less than the maximum allowance aggregate length.

(UT探伤发现的缺陷总长度小于最大允许长度。) SSD17-PP69-136

1. 从缺陷距离端面较近一侧 ($D \leq 0.65T$, D 为缺陷深度, T 为板厚) 采用碳刨或打磨的方法去除焊缝缺陷;
 2. 参照返修焊接工艺规程 (WPS) 准备正确的接头型式, 预热和焊接;
 3. 焊前对修补区域进行VT检测保证缺陷完全被清除;
 4. 将修补区域打磨到与母材或邻近焊缝平齐;
 5. 对焊缝进行UT检测, 检测范围为返修区域以及其两端各延长50mm。
-
1. Gouge or grind from nearer side from metal edge ($D \leq 0.65T$, "D" is depth of defects, "T" is thickness of metal) to remove all defects;
 2. Follow repair WPS for joint preparation, preheat, and weld deposit;
 3. Verify with VT no defects remain in the weld joint prior to welding;
 4. Grind the repaired area flush with base metal or the adjacent weld;
 5. Perform UT inspection to the weld along with 50mm on each end of the repair area;
