Contract #: 04-0120F4  
 Cty: SF/ALA Rte: 80 PM: 13.2/13.9  
 File #: 69.25B

## QUALITY ASSURANCE -- NON-CONFORMANCE REPORT

**Report No:** NCR-000663

**Reference Description:** Base Metal Repair (Buttering) without Engineer's Approval, SA3-438 Longitudinal Stiffener Splice Plate, North Tower Lift 2-3

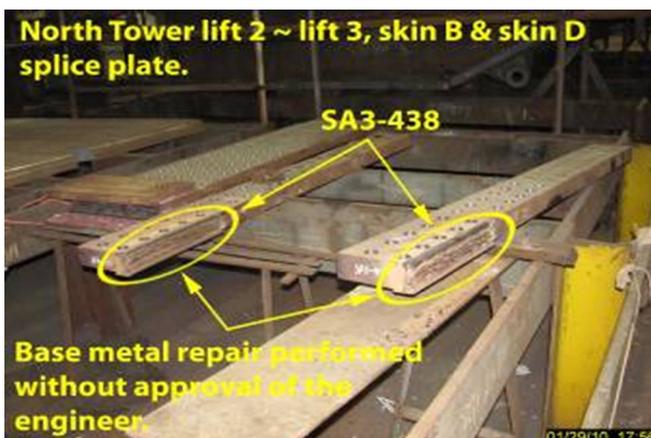
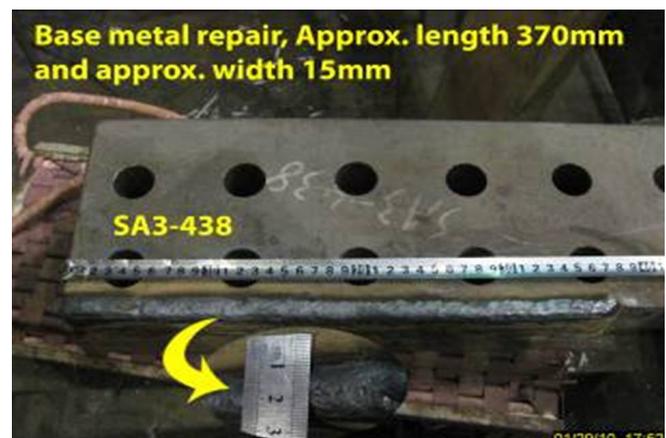
During random in-process visual inspection of North Tower lift 2 ~ lift 3, skin B & skin D splice plate, Caltrans Quality Assurance (QA) discovered the following:

- The deposition of weld metal (buttering/build-up) by Shielded Metal Arc Welding (SMAW) process on the base metal of SA3-438 splice plates.
- This build-up is measured to be approximately 15mm in width and approximately 370mm long.
- The plate thickness is 60mm.
- The material grade is A709M HPS 485 T2-Z, non-SPCM.
- This base metal repair was performed without the Engineer's approval.
- The welder is identified as 066236.
- The members are located in Bay 10.

AWS D1.5 Section: 3.7.4 "Prior approval of the Engineer shall be obtained for repairs to base metal (other than those required by 3.2), or for a revised design to compensate for deficiencies."

Propose a resolution for the identified non-conformance, documenting that the repaired base metal / welding repairs are in compliance with the contract requirements. Documentation provided for the Engineer's review of the acceptability of the weld repairs shall at a minimum include the procedure utilized/CWR and the NDT results.

**Reference Resolution:** ZPMC requests that this NCR be closed because the repairs were performed using the same procedure that was later approved.

The proposed resolution is acceptable. The Department concurs that Non-conformance ZPMC-0633 is closed.

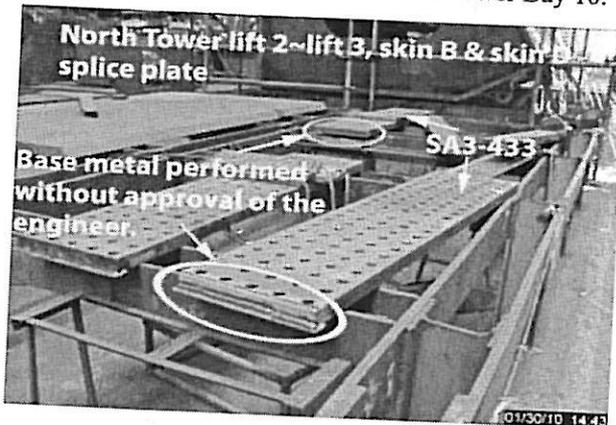
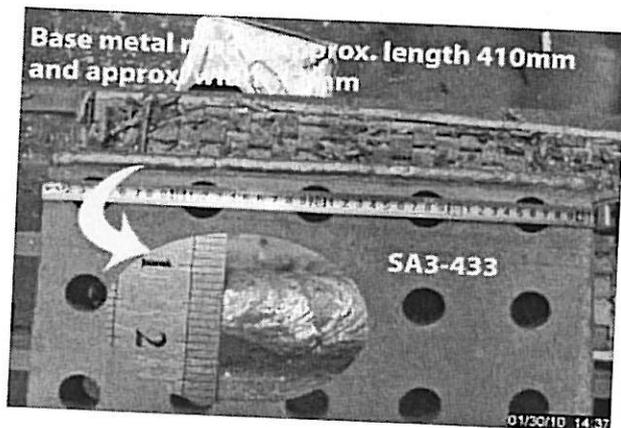
During random in-process observations of the fabrication of North Tower lift 2 ~ lift 3, skin B & skin D splice plates, Caltrans Quality Assurance (QA) observed the following issues:

- ZPMC performed deposition of weld metal (buttering/build up) by Shielded Metal Arc Welding (SMAW) process on the base metal edge of splice plates for skin B and skin D of North Tower lift 2 ~ lift 3.
- This base metal repair was performed without the approval of the Engineer.
- This build up was performed across the entire width of the edge and measured approximately 12mm thick and approximately 410mm in length.
- The material thickness is 50mm.
- The members are both identified as SA3-433.
- The plate material is designated as A709 grade 485 Non-Seismic Performance Critical Members (Non-SPCM).
- These members are located inside of Tower Bay 10.

AWS D1.5 Section: 3.7.4; "Prior approval of the Engineer shall be obtained for repairs to base metal (other than those required by 3.2), or for a revised design to compensate for deficiencies."

Propose a resolution for the identified non-conformance, documenting that the repaired base metal / welding repairs are in compliance with the contract requirements. Documentation provided for the Engineer's review of the acceptability of the weld repairs shall at a minimum include the procedure utilized/CWR and the NDT results.

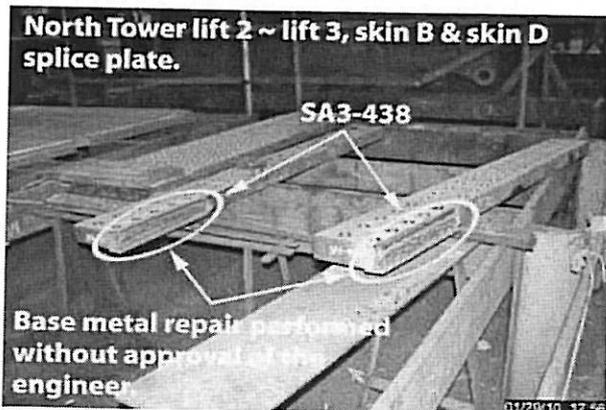
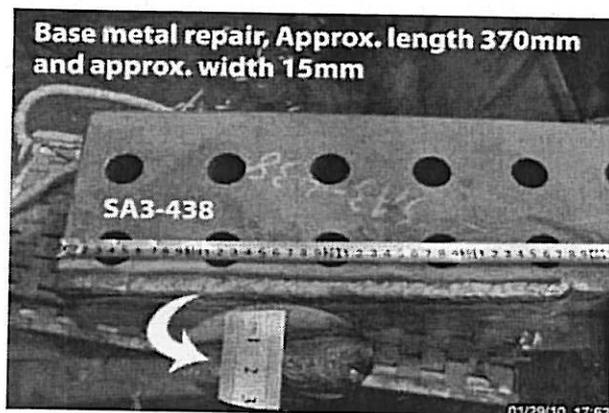
During random in-process visual inspection of North Tower lift 2 ~ lift 3, skin B & skin D splice plate, Caltrans Quality Assurance (QA) discovered the following:

- The deposition of weld metal (buttering/build-up) by Shielded Metal Arc Welding (SMAW) process on the base metal of SA3-438 splice plates.
- This build-up is measured to be approximately 15mm in width and approximately 370mm long.
- The plate thickness is 60mm.
- The material grade is A709M HPS 485 T2-Z, non-SPCM.
- This base metal repair was performed without the Engineer's approval.
- The welder is identified as 066236.
- The members are located in Bay 10.

AWS D1.5 Section: 3.7.4 "Prior approval of the Engineer shall be obtained for repairs to base metal (other than those required by 3.2), or for a revised design to compensate for deficiencies."

Accept buttering based on the presence of WRR and CT inspector witnessing repair.
