Contract #: 04-0120F4Cty: SF/ALA Rte: 80 PM: 13.2/13.9File #: 69.25B**QUALITY ASSURANCE -- NON-CONFORMANCE REPORT****Location:** Changxing Island, Shanghai, P.R. China**Report No:** NCR-000664**Prime Contractor:** American Bridge/Fluor Enterprises, a JV**Date:** 29-Jan-2010**Submitting Contractor:** Zhenhua Port Machinery Company, Ltd (ZPMC), Changxing Island**NCR #:** ZPMC-0634**Type of problem:**

Reference Description: Missed Class A UT indication on Deck Panel Splice, 8CE**Description of Non-Conformance:**

Job Name: SAS Superstructure

Subject: NCR No. ZPMC-0634

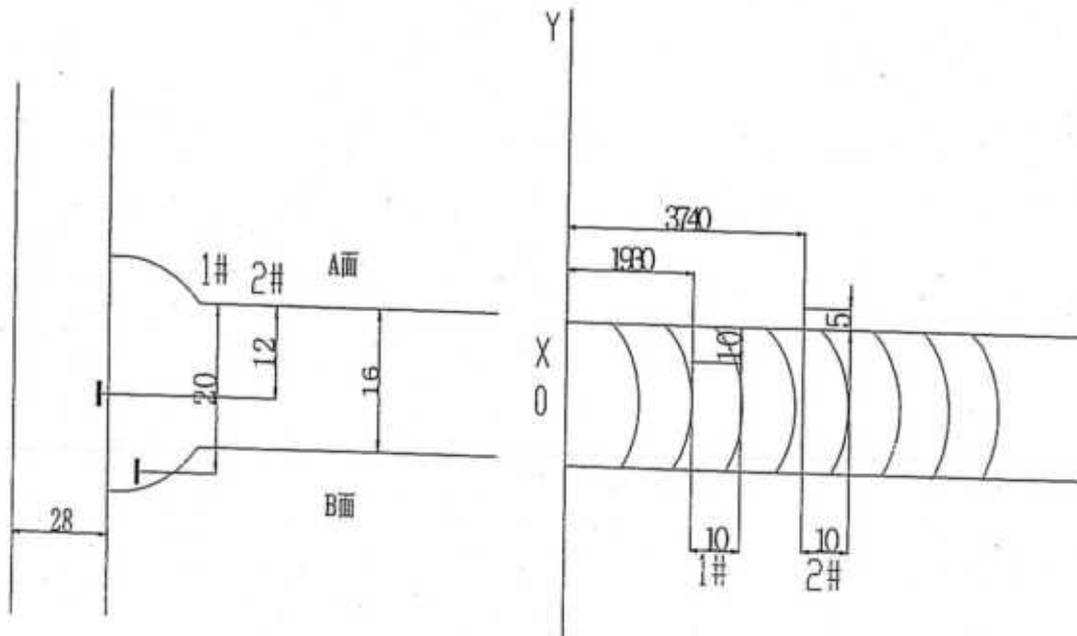
WELD NUMBER: SEG3002A-001

在对 OBG 12BE 进行 UT 检验的过程中, 加州工程师发现以下问题:
 一条纵向线性缺陷长度将近 10mm。dB 值是+6, 深度是接近 18mm。焊缝号是 SEG3002A-001 在联系梁侧。Y 值是从 PP113 起 1160mm 位置。该焊缝 CJP 焊缝, 连接 PL3056A(非 SPCM)至 PL3043A (非 SPCM), 12BE 在十四车间中。缺陷所在位置之前已经被 ZPMC UT 检验人员所检验并接收。

Rejected indication found by ultrasonic inspection is less than the maximum allowance aggregate length.

(UT探伤发现的缺陷总长度小于最大允许长度。) SEG3002A-001

1. Gouge or grind from nearer side from metal edge ($D \leq 0.65T$, "D" is depth of defects, "T" is thickness of metal) to remove all defects;

2. Follow repair WPS for joint preparation, preheat, and weld deposit;

3. Verify with VT no defects remain in the weld joint prior to welding;

4. Grind the repaired area flush with base metal or the adjacent weld;

5. Perform UT inspection to the weld along with 50mm on each end of the repair area;
