Contract #: 04-0120F4
 Cty: SF/ALA Rte: 80 PM: 13.2/13.9
 File #: 69.25B

QUALITY ASSURANCE -- NON-CONFORMANCE REPORT

Report No: NCR-000665

Reference Description: Missed MT indication on Deck Plate Diaphragm to Closed Rib weld, 8CE

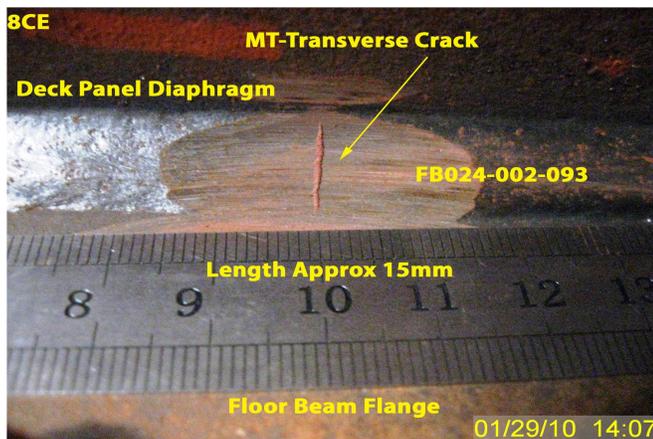
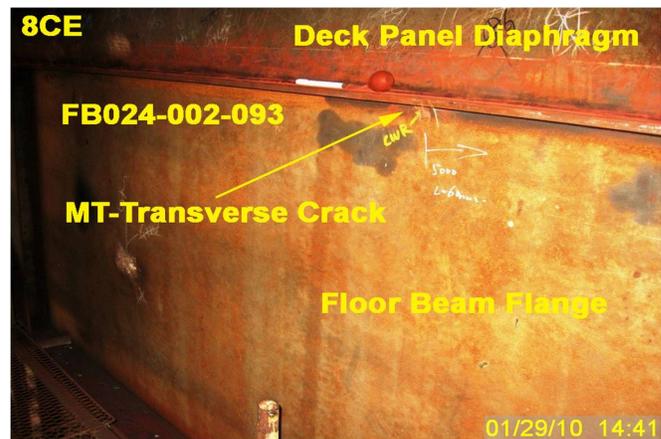
- One (1) Transverse linear indication measuring approximately 15mm in length.
- The weld is a Fillet weld joining the FL3 Floor beam Web (X20C) to Flange (X7E) at panel point 69.
- The crack is clearly marked on the material near the weld.
- The weld is identified as FB024-002-093 and Indication from "Y" location is 5000mm.
- OBG segment 8CE is located in the segment repair yard north of the blast shop.
- The indication was discovered visually and confirmed by Magnetic particle Testing (MT) by Caltrans QA.
- ZPMC Quality Control Personnel have performed 25% Magnetic Particle Testing of this weld.

AWS D1.5 (02) Section 6.26.2 – “Welds that are subject to MT in addition to visual inspection shall have no cracks.

Propose a resolution for the identified non-conformance with revised procedures to prevent future occurrences and provide documentation to show that the crack has been properly repaired to meet contract requirements. A response for the resolution of this issue is expected within 14 days.

Repair indication and perform required NDT to verify the weld is in conformance with Contract requirements.

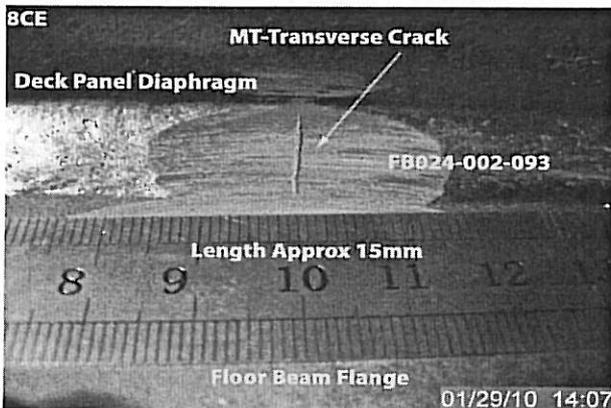
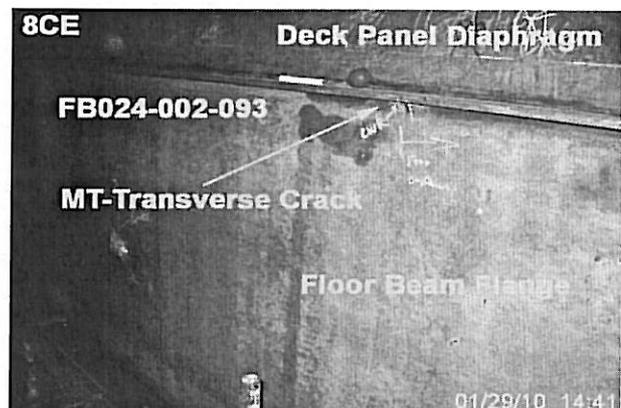
- One (1) Transverse linear indication measuring approximately 15mm in length.
- The weld is a Fillet weld joining the FL3 Floor beam Web (X20C) to Flange (X7E) at panel point 69.
- The crack is clearly marked on the material near the weld.
- The weld is identified as FB024-002-093 and Indication from "Y" location is 5000mm.
- OBG segment 8CE is located in the segment repair yard north of the blast shop.
- The indication was discovered visually and confirmed by Magnetic particle Testing (MT) by Caltrans QA.
- ZPMC Quality Control Personnel have performed 25% Magnetic Particle Testing of this weld.

AWS D1.5 (02) Section 6.26.2 – “Welds that are subject to MT in addition to visual inspection shall have no cracks.
