Contract #: 04-0120F4
 Cty: SF/ALA Rte: 80 PM: 13.2/13.9
 File #: 69.25B

QUALITY ASSURANCE -- NON-CONFORMANCE REPORT

Report No: NCR-000666

Reference Description: Base Metal Repair (buttering) without the Engineer's Approval, Longitudinal Splice Plate SA3-433

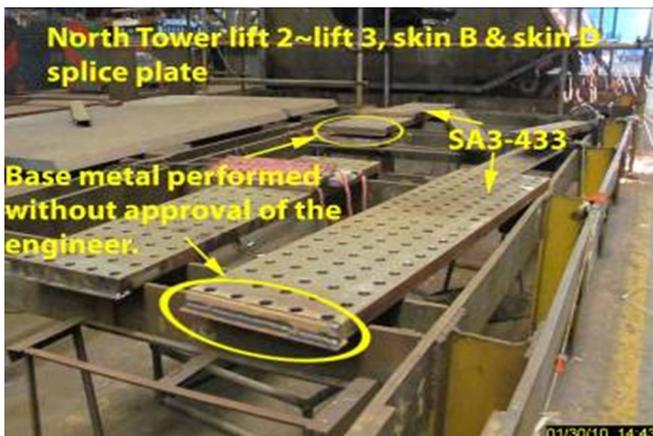
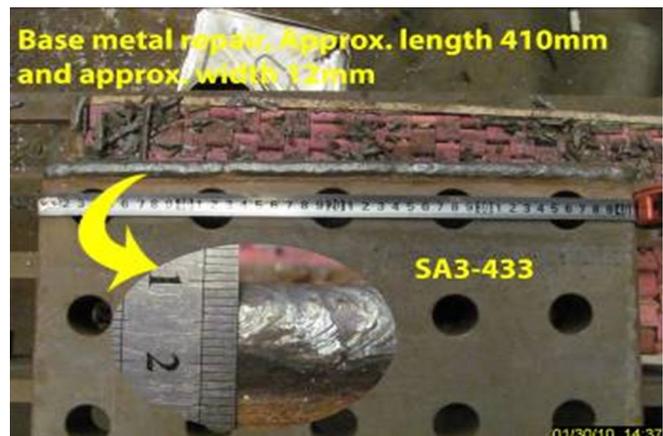
During random in-process observations of the fabrication of North Tower lift2 ~ lift 3, skin B & skin D splice plates, Caltrans Quality Assurance (QA) observed the following issues:

- ZPMC performed deposition of weld metal (buttering/build up) by Shielded Metal Arc Welding (SMAW) process on the base metal edge of splice plates for skin B and skin D of North Tower lift 2 ~ lift 3.
- This base metal repair was performed without the approval of the Engineer.
- This build up was performed across the entire width of the edge and measured approximately 12mm thick and approximately 410mm in length.
- The material thickness is 50mm.
- The members are both identified as SA3-433.
- The plate material is designated as A709 grade 485 Non-Seismic Performance Critical Members (Non-SPCM).
- These members are located inside of Tower Bay 10.

AWS D1.5 Section: 3.7.4; "Prior approval of the Engineer shall be obtained for repairs to base metal (other than those required by 3.2), or for a revised design to compensate for deficiencies."

Propose a resolution for the identified non-conformance, documenting that the repaired base metal / welding repairs are in compliance with the contract requirements. Documentation provided for the Engineer's review of the acceptability of the weld repairs shall at a minimum include the procedure utilized/CWR and the NDT results.

Reference Resolution: ZPMC requests that this NCR be closed because the repairs were performed using the same procedure that was later approved.

Based on the interpretation of SMR/METS, it is acceptable for ABF/ZPMC to proceed with protocol for the OBG temporary attachment base metal repair and to utilize the maximum build up limits for weld joint correction from AWS D1.5 Section 3.3.4.1 (the lesser of 20mm or 2t) for these elements.

The proposed resolution is acceptable. The Department concurs that Non-conformance ZPMC-0636 is closed.
