Contract #: 04-0120F4
 Cty: SF/ALA Rte: 80 PM: 13.2/13.9
 File #: 69.25B

QUALITY ASSURANCE -- NON-CONFORMANCE REPORT

Location: Changxing Island, Shanghai, P.R. China **Report No:** NCR-000667
Prime Contractor: American Bridge/Fluor Enterprises, a JV **Date:** 30-Jan-2010
Submitting Contractor: Zhenhua Port Machinery Company, Ltd (ZPMC), Changxing Island **NCR #:** ZPMC-0637

Reference Description: The radius and transition of the X7 FB vertical stiffener plates are not fabricated per the approved shop drawings

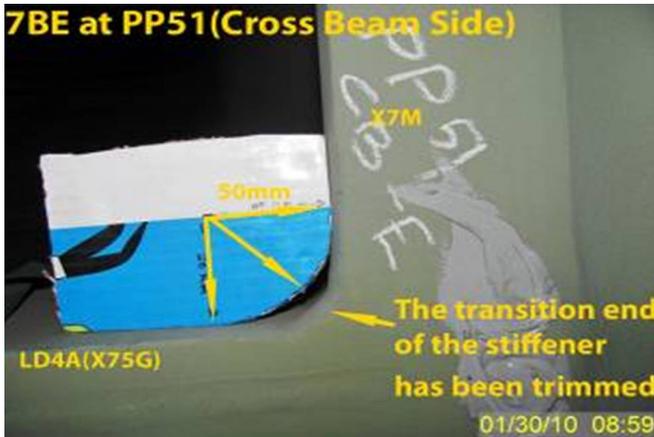
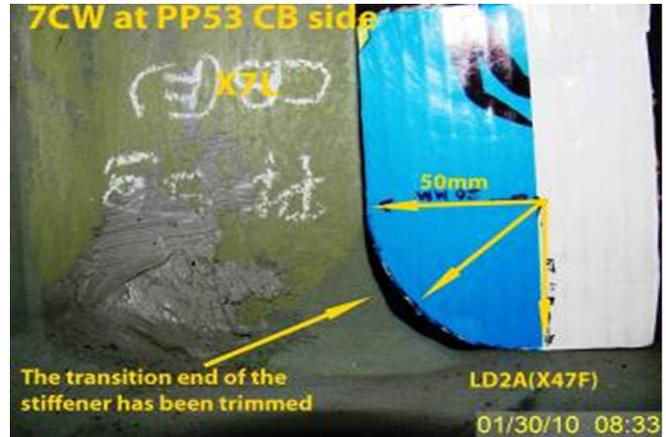
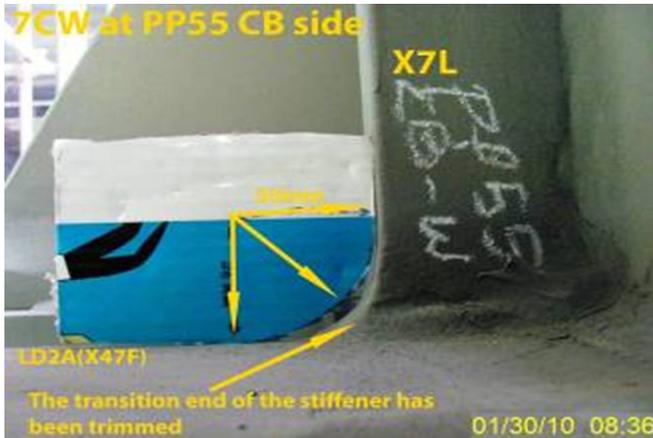
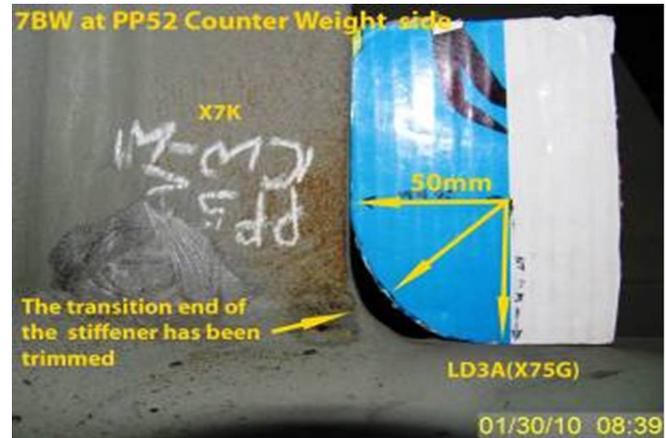
- The R=50mm portion at the transition end of the X7 floorbeam vertical flange (stiffener) to Longitudinal Diaphragm has been trimmed and found four locations that were not in compliance with the approved shop drawings (OBG Standards- Floor beam Details-X7).
- The 1st Weld joint is identified as SEG035C-032 at PP51 Crossbeam Side.
- The 2nd Weld joint is identified as SEG035B-040 at PP52 Counter weight Side.
- The 3rd Weld joint is identified as SEG037C-023 at PP53 Crossbeam Side.
- The 4th Weld joint is identified as SEG035C-008 at PP55 Crossbeam Side.
- All joints are Partial Joint Penetration (PJP) as per WD20W, weld joint connecting the vertical floorbeam flange (stiffener) X7 to the Longitudinal Diaphragm top flange plate.

AWS D1.5 2002 Section 3.2.5: Reentrant corners of base-metal cut edges shall be formed to provide a smooth transition with a radius of not less than 25 mm [1 in.] that meets the adjacent edges without offset or cutting past the point of tangency. The reentrant corners may be formed by thermal cutting, followed by grinding to meet the surface requirements of 3.2.2.

Propose a resolution for the identified non-conformance with revised procedures to prevent future occurrences and provide documentation to show that the radius and transition on the FB stiffeners have been repaired according to the approved show drawings. A response for the resolution of this issue is expected within 14 days.
