Contract #: 04-0120F4
 Cty: SF/ALA Rte: 80 PM: 13.2/13.9
 File #: 69.25B

QUALITY ASSURANCE -- NON-CONFORMANCE REPORT

Report No: NCR-000670

Reference Description: Partial Backing Bar Removal, South Tower Lift 4, A/E Corner Backfill Plate

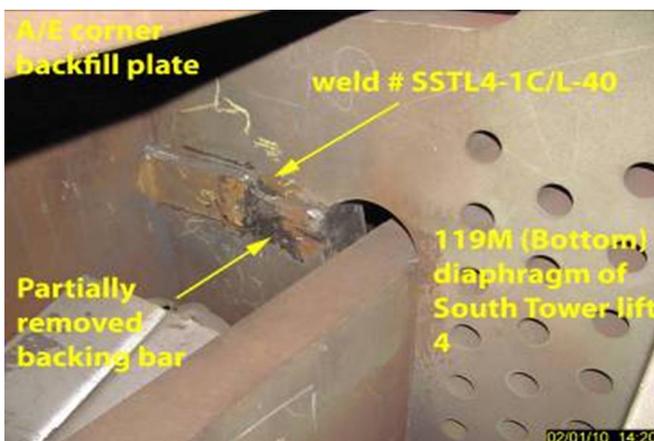
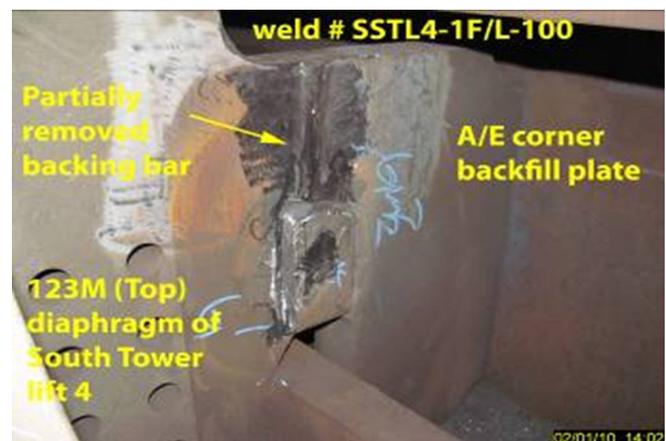
During random verification Ultrasonic Testing (UT) of A/E corner backfill plate of South Tower Lift 4, Caltrans Quality Assurance (QA) observed the following issues:

- Backing has been partially removed at two weld locations, SSSL4-1C/L-40 at 119M (bottom) diaphragm and SSSL4-1F/L-100 at 123M (top) diaphragm.
- These welds join the backfill plates and double diaphragm plates of South Tower lift 4.
- The members are located in Tower Bay 10.

AWS D1.5 (2002) Section 3.13.2: "Groove welds made with the use of steel backing shall have the weld metal thoroughly fused with the backing. Steel backing shall be continuous for the full length of each weld made with

ZPMC has removed the backing bar entirely and is providing NDT of the weld to show that it is acceptable. Discussions between the ABFJV QCM and ZPMC prompted ZPMC to remove the remaining backing bar. ZPMC requests closure of this NCR.

Backing bars were removed and UT report T787-UT-2658 was provided showing the welds are acceptable.

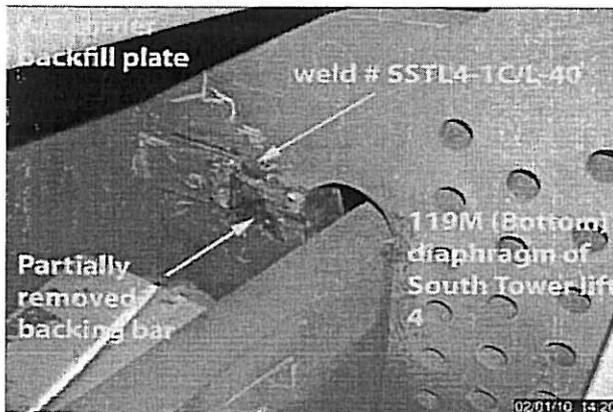
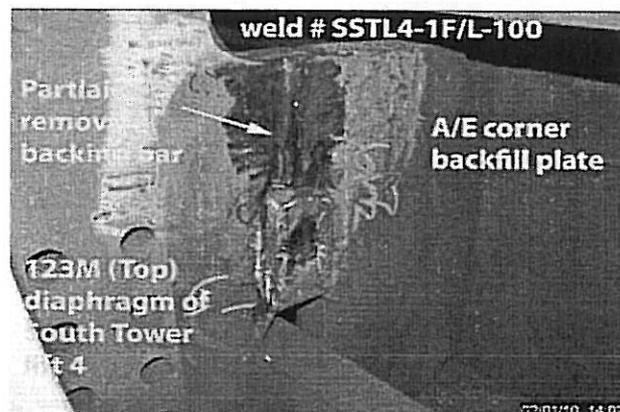
During random verification Ultrasonic Testing (UT) of A/E corner backfill plate of South Tower Lift 4, Caltrans Quality Assurance (QA) observed the following issues:

- Backing has been partially removed at two weld locations, SSSL4-1C/L-40 at 119M (bottom) diaphragm and SSSL4-1F/L-100 at 123M (top) diaphragm.
- These welds join the backfill plates and double diaphragm plates of South Tower lift 4.
- The members are located in Tower Bay 10.

AWS D1.5 (2002) Section 3.13.2: "Groove welds made with the use of steel backing shall have the weld metal thoroughly fused with the backing. Steel backing shall be continuous for the full length of each weld made with
