Contract #: 04-0120F4Cty: SF/ALA Rte: 80 PM: 13.2/13.9File #: 69.25B**QUALITY ASSURANCE -- NON-CONFORMANCE REPORT****Location:** Changxing Island, Shanghai, P.R. China**Report No:** NCR-000671**Prime Contractor:** American Bridge/Fluor Enterprises, a JV**Date:** 02-Feb-2010**Submitting Contractor:** Zhenhua Port Machinery Company, Ltd (ZPMC), Changxing Island**NCR #:** ZPMC-0639**Type of problem:**

**Reference Description:** Missed UT indication by QC on Segment 9AE, Side Panel Welds**Description of Non-Conformance:**

**REGARDING: NCR-000655(ZPMC-0626) NCR-000664(ZPMC-0634)  
NCR-000671 (ZPMC-0639)**

Reference Description: Missed UT indication by QC on Side Plate to Bottom Plate Joint on Segment 12BE

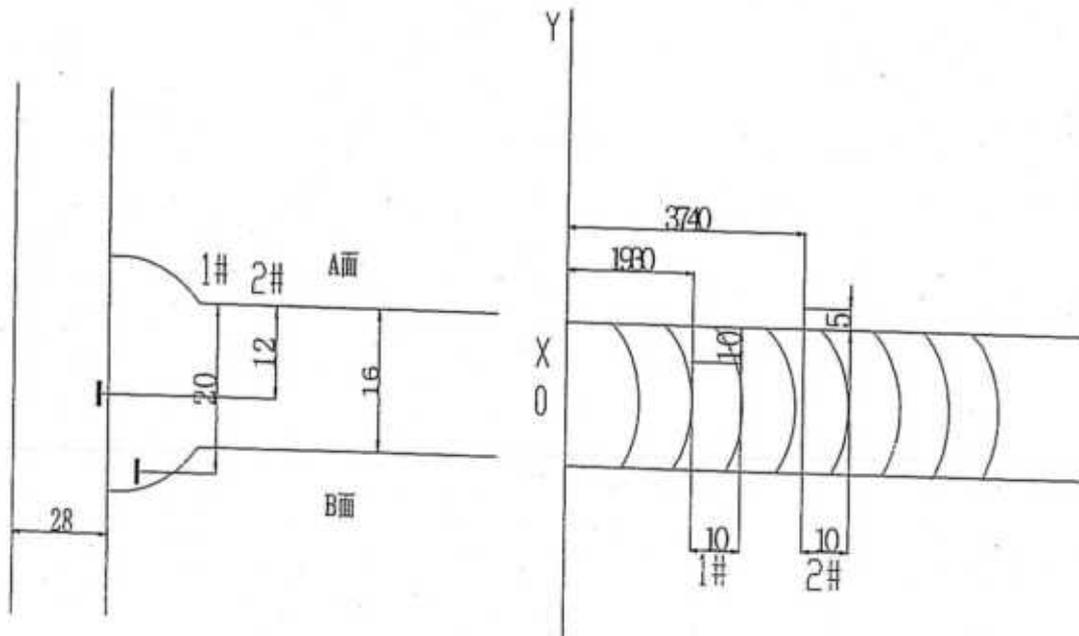
WELD NUMBER: SEG3002A-001

在对 OBG 12BE 进行 UT 检验的过程中, 加州工程师发现以下问题:  
 一条纵向线性缺陷长度将近 10mm。dB 值是+6, 深度是接近 18mm。焊缝号是 SEG3002A-001 在联系梁侧。Y 值是从 PP113 起 1160mm 位置。该焊缝 CJP 焊缝, 连接 PL3056A(非 SPCM)至 PL3043A (非 SPCM), 12BE 在十四车间中。缺陷所在位置之前已经被 ZPMC UT 检验人员所检验并接收。

Rejected indication found by ultrasonic inspection is less than the maximum allowance aggregate length.

(UT探伤发现的缺陷总长度小于最大允许长度。) SEG3002A-001

1. Gouge or grind from nearer side from metal edge ( $D \leq 0.65T$ , "D" is depth of defects, "T" is thickness of metal) to remove all defects;

2. Follow repair WPS for joint preparation, preheat, and weld deposit;

3. Verify with VT no defects remain in the weld joint prior to welding;

4. Grind the repaired area flush with base metal or the adjacent weld;

5. Perform UT inspection to the weld along with 50mm on each end of the repair area;

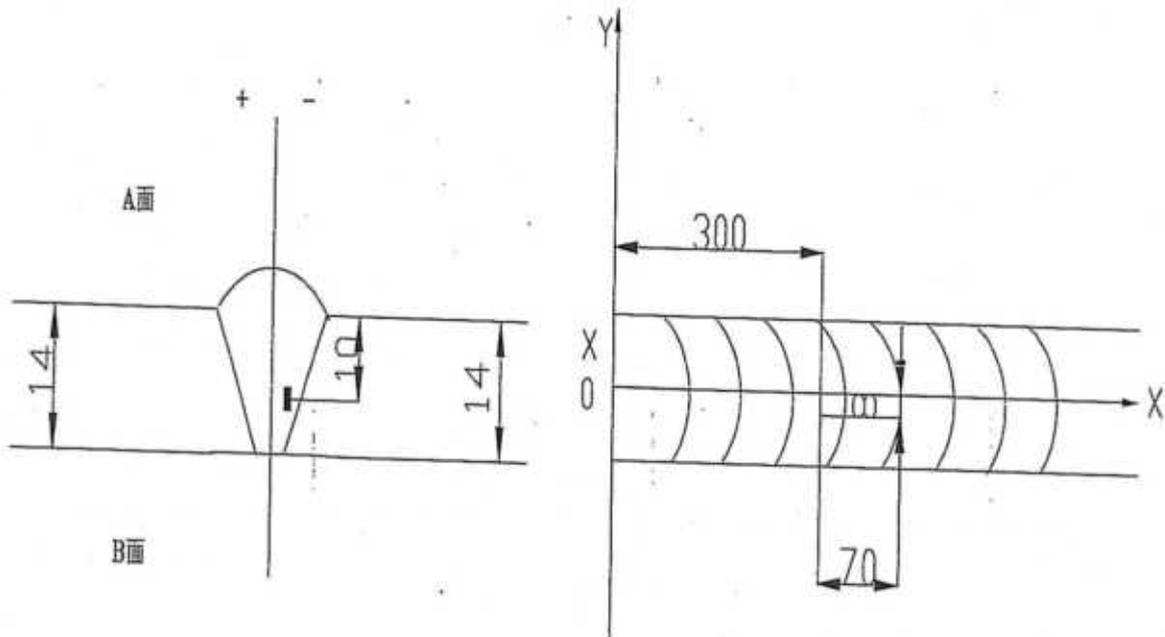
WELD NUMBER: SEG048\*-008

- One (1) Class "A" indication measuring approximately 60 mm in length.
- The decibel rating of the indication is +9.
- The Thickness of the diaphragm plate is 14mm.
- The weld is identified as SEG048\*-008.
- The weld is a Complete Joint Penetration (CJP) butt weld joining Deck Panel X1-diaphragm plate DP337A to Deck panel X1-diaphragm plate DP364A.
- The "Y" location is approximately 470mm from Floor beam flange at Panel Point 071.
- The indication is clearly marked by QA on/near the weld.
- OBG Segment 8CE is located in Repair yard (In north end of Blast shop 1).
- This QA generated a TL-6027 UT report for this weld on this date.

Rejected indication found by ultrasonic inspection is less than the maximum allowance aggregate length.

(UT探伤发现的缺陷总长度小于最大允许长度。) SEG048\*-008

1. Gouge or grind from nearer side from metal edge ( $D \leq 0.65T$ , "D" is depth of defects, "T" is thickness of metal) to remove all defects;
2. Follow repair WPS for joint preparation, preheat, and weld deposit;
3. Verify with VT no defects remain in the weld joint prior to welding;
4. Grind the repaired area flush with base metal or the adjacent weld;
5. Perform UT inspection to the weld along with 50mm on each end of the repair area;

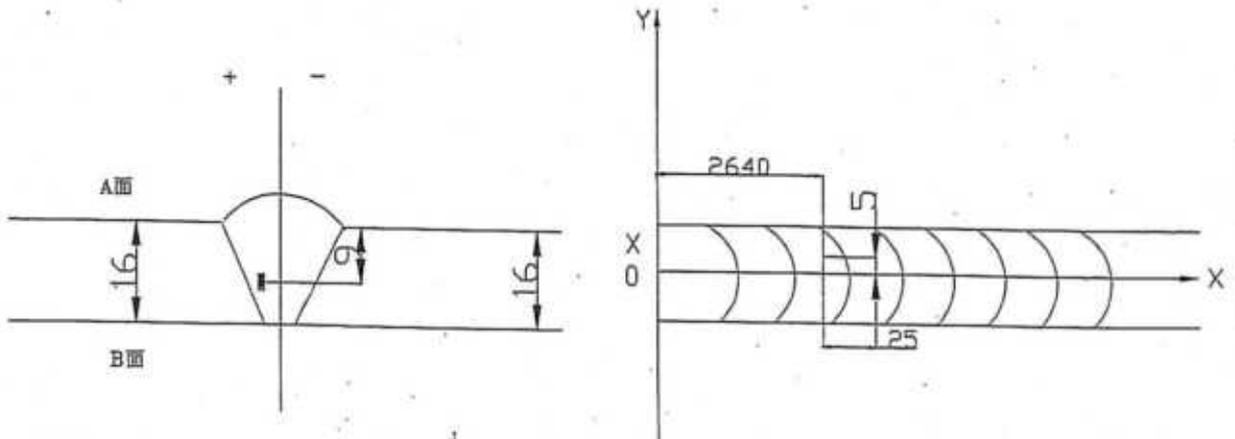
WELD NUMBER: SEG050A-003

Rejected indication found by ultrasonic inspection is less than the maximum allowance aggregate length.

(UT探伤发现的缺陷总长度小于最大允许长度。) SEG050A-003

1. Gouge or grind from nearer side from metal edge ( $D \leq 0.65T$ , "D" is depth of defects, "T" is thickness of metal) to remove all defects;
2. Follow repair WPS for joint preparation, preheat, and weld deposit;
3. Verify with VT no defects remain in the weld joint prior to welding;
4. Grind the repaired area flush with base metal or the adjacent weld;
5. Check the welds according to the working drawings;

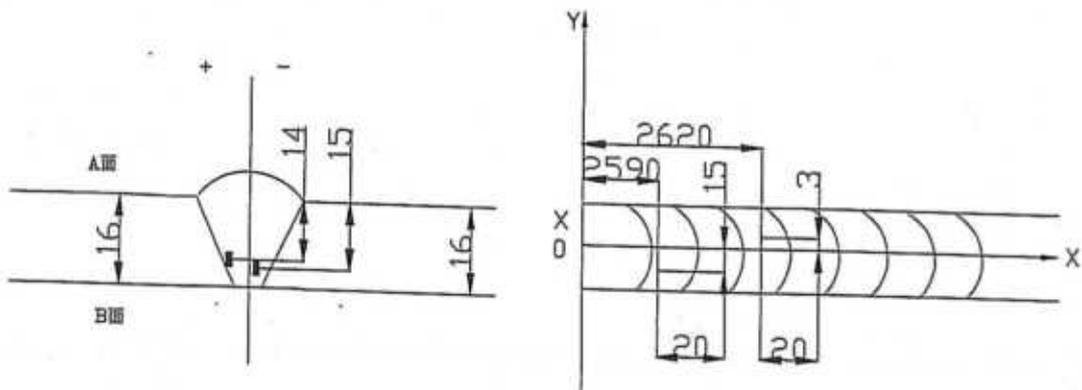
WELD NUMBER: SEG050A-003

Rejected indication found by ultrasonic inspection is less than the maximum allowance aggregate length.

(UT探伤发现的缺陷总长度小于最大允许长度。) SEG050A-003

1. Gouge or grind from nearer side from metal edge ( $D \leq 0.65T$ , "D" is depth of defects, "T" is thickness of metal) to remove all defects;

2. Follow repair WPS for joint preparation, preheat, and weld deposit;

3. Verify with VT no defects remain in the weld joint prior to welding;

4. Grind the repaired area flush with base metal or the adjacent weld;
