Contract #: 04-0120F4Cty: SF/ALA Rte: 80 PM: 13.2/13.9File #: 69.25B**QUALITY ASSURANCE -- NON-CONFORMANCE REPORT****Location:** Changxing Island, Shanghai, P.R. China**Report No:** NCR-000673**Prime Contractor:** American Bridge/Fluor Enterprises, a JV**Date:** 04-Feb-2010**Submitting Contractor:** Zhenhua Port Machinery Company, Ltd (ZPMC), Changxing Island**NCR #:** ZPMC-0641**Type of problem:****Welding****Concrete****Other****Welding****Curing****Procedural****Bridge No:** 34-0006**Joint fit-up****Coating****Other****Component:** Lift 6 West Floorbeam**Procedural****Procedural****Description:** Floorbeam Web Panel- Out of required Flatness**Reference Description:** Lift 6 West Floorbeam Web Plates exceeded the "flatness of panels" requirement**Description of Non-Conformance:**

Contract #: 04-0120F4Cty: SF/ALA Rte: 80 PM: 13.2/13.9File #: xx.25A**QUALITY ASSURANCE -- NON-CONFORMANCE RESOLUTION****Location:** Changxing Island, Shanghai, P.R. China**Report No:** NCS-000770**Prime Contractor:** American Bridge/Fluor Enterprises, a JV**Date:** 19-Mar-2010**Submitting Contractor:** Zhenhua Port Machinery Company, Ltd (ZPMC), Changxing Island **NCR #:** ZPMC-0641**Type of problem:**

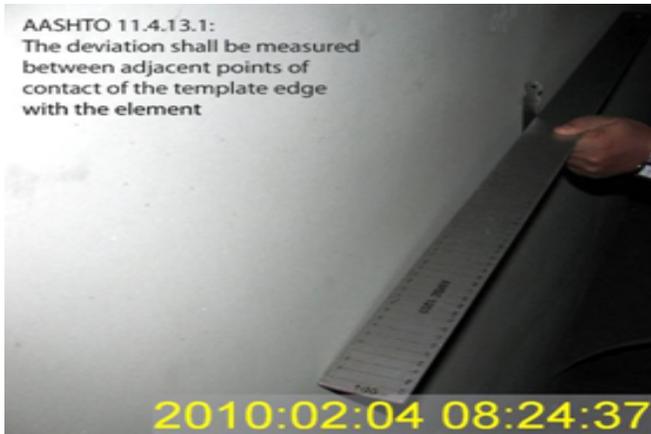
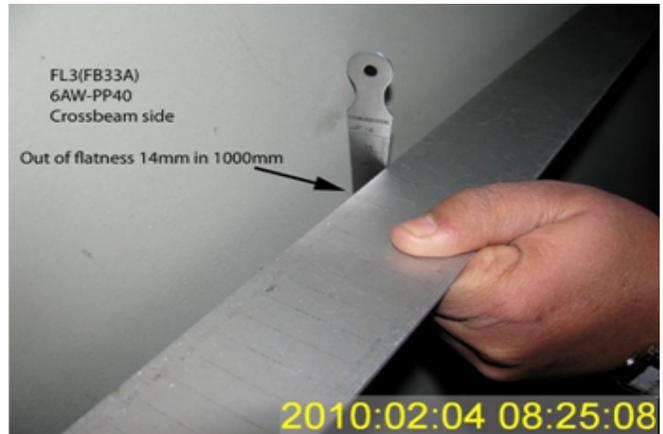
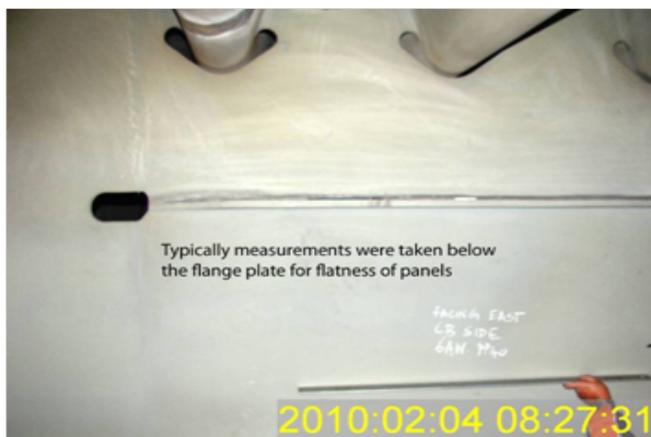
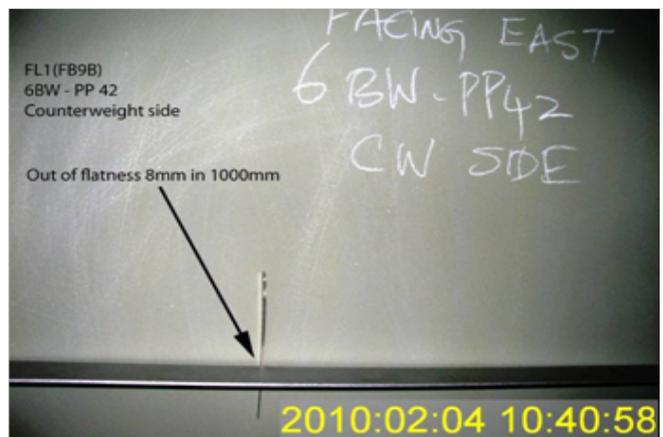
During the Quality Assurance (QA) random in-process visual inspection of OBG Lift 6 West in the OBG Trial Assembly area, this QA inspector discovered the Floorbeam Web Plates exceeded the "flatness of panels" requirements at the following Segments and Panel Points:

PP 38 Counterweight side; The FL1 floor beam FB11B; Deflection 6.5mm over 1000mm

PP 40 Crossbeam side; The FL3 floor beam FB33A; Deflection 14mm over 1000mm

PP 42 Crossbeam side; The FL1 floor beam FB15A; Deflection 6.5mm over 1000mm

PP 42 Counterweight side; The FL1 floor beam FB9B; Deflection 8mm over 1000mm

PP 43 Crossbeam side; The FL1 floor beam FB15A; Deflection 7mm over 1000mm

PP 43 Counterweight side; The FL1 floor beam FB9A; Deflection 7mm over 1000mm

PP 44 Crossbeam side; The FL3 floor beam FB35A; Deflection 13mm over 1000mm

PP 45 Crossbeam side; The FL3 floor beam FB31A; Deflection 10mm over 1000mm

PP 46 Crossbeam side; The FL3 floor beam FB27A; Deflection 7mm over 1000mm

-All the measurements were taken from below the upper Flange plate.

-The maximum out of flatness tolerance allowed per AASHTO 11.4.13.2 requirement is 5mm.

Perform necessary retrofit.
