Contract #: 04-0120F4
 Cty: SF/ALA Rte: 80 PM: 13.2/13.9
 File #: 69.25B

QUALITY ASSURANCE -- NON-CONFORMANCE REPORT

Report No: NCR-000674

NCR #: ZPMC-0642

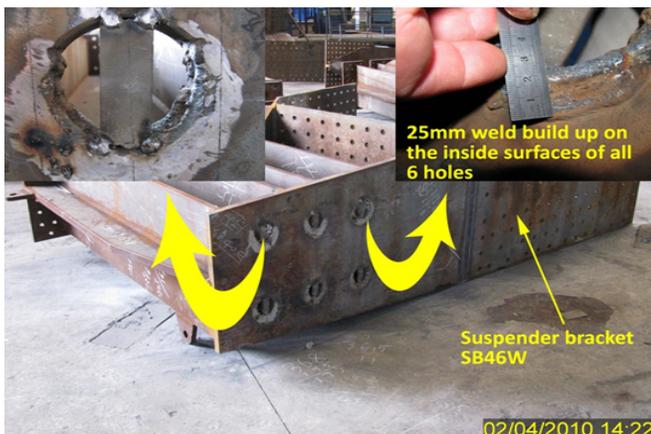
ZPMC personnel have performed weld built up the inside surfaces of suspender rod holes with weld metal without the approval of the Engineer. ZPMC introduced new welds that were not specified in the approved shop drawings.

-This condition exists on all six (6) rod holes on both of the above mentioned brackets.

-Both of the above mentioned suspender brackets are located in OBG bay 19.

ZPMC acknowledges that a CWR should have been issued in this case. ZPMC is providing the WRR that was sued at the time as well as the NDT after to show that the base metal repair was successful. In the future, ZPMC acknowledges that greater attention must be paid to avoid these types of NCRs. Based on this, ZPMC requests closure of this NCR.

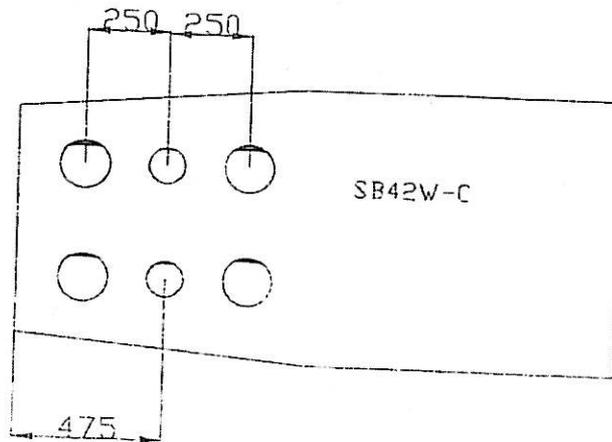
Draft of welding discontinuity:

Suspending bracket (SB42W-C) was needed to build-up 15mm according to inspection report (ZP06-787-J-B-1361).

Weld distortion and fabricate error.

6. 采用进行VT、UT、MT对返修区域进行检测；
 7. 按照图纸及检查报告ZP06-787-J-B-1361处理意见重新钻孔；
1. Elongate the hole by arc gouging, and grind smooth the surface. The elongated hole should conform to the joint detail in Repair WPS. Preheat before gouging according to relevant WPS.

2. Perform VT to ensure no defects exist.
 3. Add steel backing. Preheat and weld according to the repair WPS, weld stringers longitudinally along the elongated direction of the hole.

4. Remove steel backing and back gouge the root pass, and complete the welding.
 5. Grind the repair area flush with adjacent base metal.
 6. Check with VT, UT, MT after welding to the repair area.

7. Drill new holes according to work drawings and disposition of Inspection Report ZP06-787-J-B-1361.

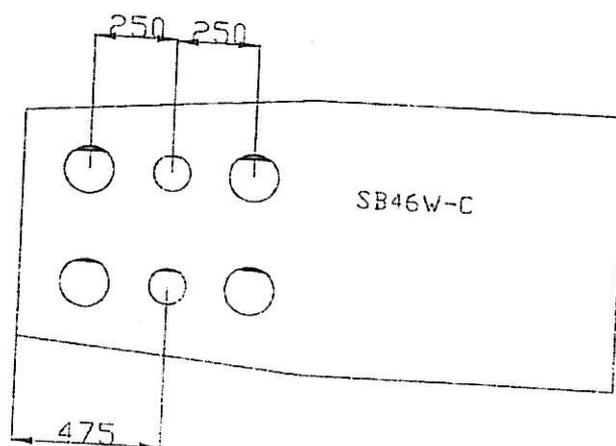
Draft of welding discontinuity:

Suspending bracket (SB46W-C) was needed to build-up 15mm according to inspection report (ZP06-787-J-B-1361).

Weld distortion and fabricate error.

1. 将孔采用碳刨的方法拓宽，并打磨平滑，拓宽的孔应符合修补WPS中的接头细节。碳刨前应根据相应的WPS进行预热；
 2. 焊接前采用VT检测确保无缺陷存在；
 3. 贴加钢衬垫，根据返修WPS进行预热及焊接，焊接时采用线状纵向进行补焊；
 4. 去除衬垫，根部焊道反面碳刨清根焊接；
 5. 焊后将焊缝打磨与周围母材齐平；
 6. 采用进行VT、UT、MT对返修区域进行检测；
 7. 按照图纸及检查报告ZP06-787-J-B-1361重新钻孔；
1. Elongate the hole by arc gouging, and grind smooth the surface. The elongated hole should conform to the joint detail in Repair WPS. Preheat before gouging according to relevant WPS.
 2. Perform VT to ensure no defects exist.
 3. Add steel backing. Preheat and weld according to the repair WPS, weld stringers longitudinally along the elongated direction of the hole.
 4. Remove steel backing and back gouge the root pass, and complete the welding.
 5. Grind the repair area flush with adjacent base metal.
 6. Check with VT, UT, MT after welding to the repair area.
 7. Drill new holes according to work drawings and disposition of Inspection Report ZP06-787-J-B-1361.
