Contract #: 04-0120F4Cty: SF/ALA Rte: 80 PM: 13.2/13.9File #: 69.25B**QUALITY ASSURANCE -- NON-CONFORMANCE REPORT****Location:** Changxing Island, Shanghai, P.R. China**Report No:** NCR-000675**Prime Contractor:** American Bridge/Fluor Enterprises, a JV**Date:** 04-Feb-2010**Submitting Contractor:** Zhenhua Port Machinery Company, Ltd (ZPMC), Changxing Island**NCR #:** ZPMC-0643**Type of problem:**

Reference Description: Improper Storage and Handling of Lift 12 West Floorbeam 3069-004**Description of Non-Conformance:**

To:	AMERICAN BRIDGE/FLUOR, A JV 375 BURMA ROAD OAKLAND CA 95607	Date:	06-Feb-2010
Dear:	Mr. Charles Kanapicki	Contract No:	04-0120F4 04-SF-80-13.2 / 13.9
Attention:	Mr. Thomas Nilsson Project/Fabrication Manager	Job Name:	SAS Superstructure
Subject:	NCR No. ZPMC-0643	Document No:	05.03.06-000633
Reference Description:	Improper Storage and Handling of Lift 12 West Floorbeam 3069-004

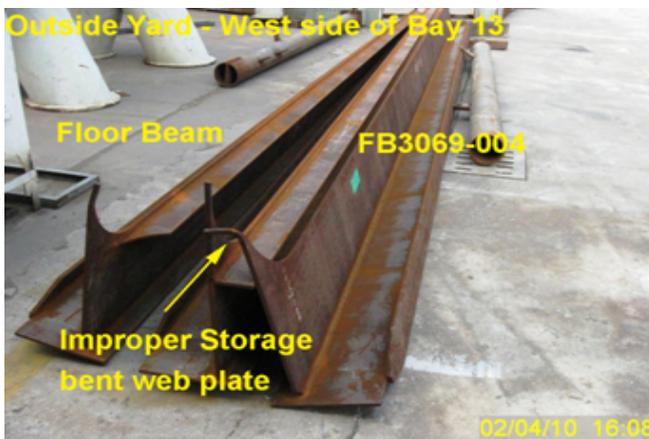
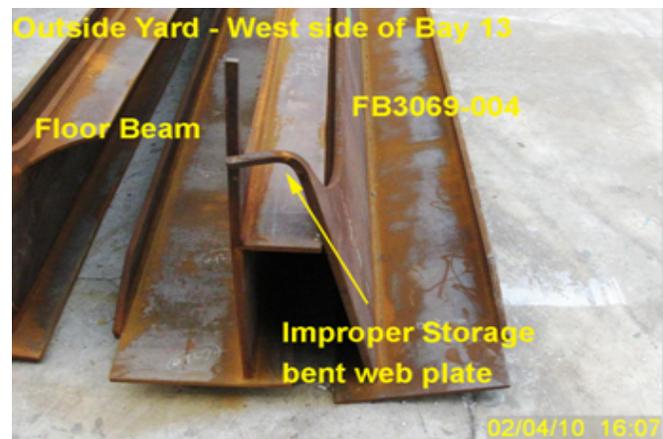
During Quality Assurance visual review of welds located on Lift 12W Floor Beams, this Quality Assurance Inspector (QA) discovered the following issues:

- One (1) Floor Beam had been damage and bent due to improper handling and/or storage.
- This Floor Beam component is identified as FB3069-004.
- The Green Tag number is identified as 11278.
- The material is designated as A709 Grade 345 Non-Seismic Performance Critical Member (Non-SPCM).
- This Floor Beam is located in the outside yard west side of Bay 13.

Standard Specifications July 1999, Section 6-1.3; "Articles or materials to be incorporated in the work shall be stored in such a manner as to ensure the preservation of their quality and fitness for the work and to facilitate inspection".

Standard Specifications July 1999, Section 55-1.04; "In handling and shipping of the steel work, every care

shall be taken to avoid bending, scraping or overstressing the pieces. All pieces bent or otherwise injured will be rejected.”

Standard Specifications July 1999, Section 55-3.09; “Finish members shall be true to line and free from twists, bends and open joints.”

ZPMC has repaired the bent angle and is providing the heat straightening record and NDT to show that the repair was successful. Based on this ZPMC requests closure of this NCR.

The provided HSR does not adequately address the repairs required to resolve the NCR. The HSR indicates that the damage was a result of "bounce distortion" yet the corrective action says to control welding parameters. Additionally, the amount of distortion noted in the NCR could not have been corrected by heat alone. Please provide a description of the methods actually used to repair the bent flange.

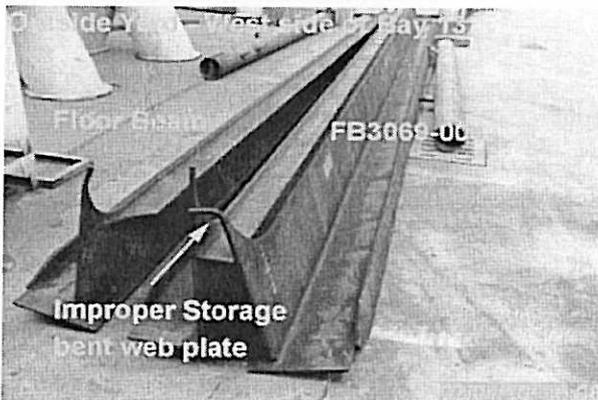
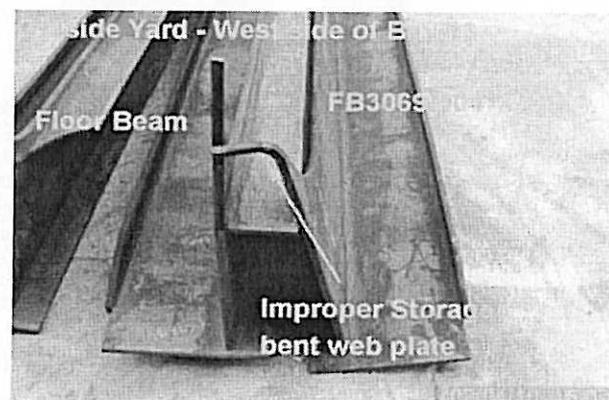
During Quality Assurance visual review of welds located on Lift 12W Floor Beams, this Quality Assurance Inspector (QA) discovered the following issues:

- One (1) Floor Beam had been damage and bent due to improper handling and/or storage.
- This Floor Beam component is identified as FB3069-004.
- The Green Tag number is identified as 11278.
- The material is designated as A709 Grade 345 Non-Seismic Performance Critical Member (Non-SPCM).
- This Floor Beam is located in the outside yard west side of Bay 13.

Standard Specifications July 1999, Section 6-1.3; "Articles or materials to be incorporated in the work shall be stored in such a manner as to ensure the preservation of their quality and fitness for the work and to facilitate inspection".

Standard Specifications July 1999, Section 55-1.04; "In handling and shipping of the steel work, every care

shall be taken to avoid bending, scraping or overstressing the pieces. All pieces bent or otherwise injured will be rejected.”

Standard Specifications July 1999, Section 55-3.09; “Finish members shall be true to line and free from twists, bends and open joints.”

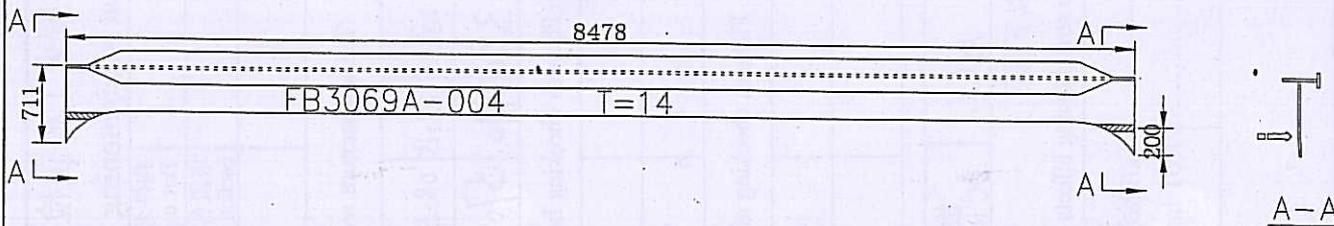
简图 Sketch

Cause 原因 Bounce distortion 撞击变形

Type of Defect 缺陷类型 Bounce distortion 撞击变形

缺陷去除方法(Defect Removal Method): Flame Straightening by oxygen acetylene 运用氧乙炔进行校火

后续NDE(Post-Removal NDE): After finishing heat straightening, the weld of the heat area shall perform NDT according to the approved shop drawing 校火后, 根据图纸要求对热影响区域进行NDT检测。

纠正措施(Corrective Action(s)): Control current, voltage and weld speed according to relevant WPS. If necessary anti-deformation or hold down device can be added. 依据相应的WPS的要求控制电流, 电压和焊接速度。如有必要, 可使用反变形设施进行校正。

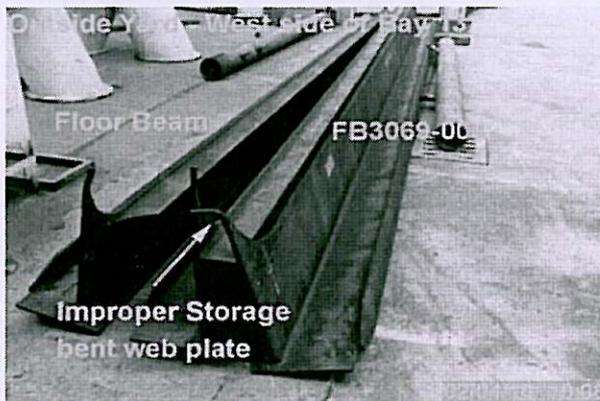
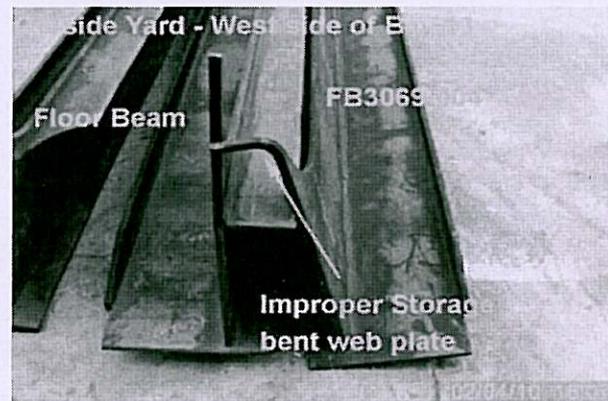
During Quality Assurance visual review of welds located on Lift 12W Floor Beams, this Quality Assurance Inspector (QA) discovered the following issues:

- One (1) Floor Beam had been damage and bent due to improper handling and/or storage.
- This Floor Beam component is identified as FB3069-004.
- The Green Tag number is identified as 11278.
- The material is designated as A709 Grade 345 Non-Seismic Performance Critical Member (Non-SPCM).
- This Floor Beam is located in the outside yard west side of Bay 13.

Standard Specifications July 1999, Section 6-1.3; "Articles or materials to be incorporated in the work shall be stored in such a manner as to ensure the preservation of their quality and fitness for the work and to facilitate inspection".

Standard Specifications July 1999, Section 55-1.04; "In handling and shipping of the steel work, every care

shall be taken to avoid bending, scraping or overstressing the pieces. All pieces bent or otherwise injured will be rejected.”

Standard Specifications July 1999, Section 55-3.09; “Finish members shall be true to line and free from twists, bends and open joints.”

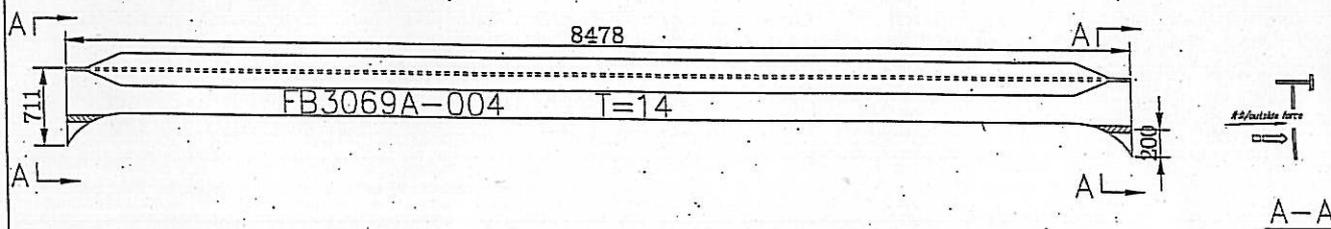
简图 Sketch

Bounce distortion 撞击变形

缺陷去除方法(Defect Removal Method): Oxy-acetylene hand torch 氧乙炔火焰校正

Provide VT to the heat straightened area and its close area. Perform MT if necessary. 对火工校正区域及其临近区域进行VT检测。如有必要,进行MT检测。

Fasten subcomponent to transportation trailer securely prior to transport. 转运之前将构件安全地紧固在转运拖车上。
