Contract #: 04-0120F4Cty: SF/ALA Rte: 80 PM: 13.2/13.9File #: 69.25B**QUALITY ASSURANCE -- NON-CONFORMANCE REPORT****Location:** Changxing Island, Shanghai, P.R. China**Report No:** NCR-000677**Prime Contractor:** American Bridge/Fluor Enterprises, a JV**Date:** 08-Feb-2010**Submitting Contractor:** Zhenhua Port Machinery Company, Ltd (ZPMC), Changxing Island**NCR #:** ZPMC-0644**Type of problem:****Welding****Concrete****Other****Welding****Curing****Procedural****Bridge No:** 34-0006**Joint fit-up****Coating****Other****Component:** Tower Strut ED1-A6001-1**Procedural****Procedural****Description:****Reference Description:** Missed MT Transverse Indication by QC, Tower Strut ED1-A6001-1**Description of Non-Conformance:**

Job Name: SAS Superstructure
Document No: 05.03.06-000634

Reference Description: Missed MT Indication/ Tower Strut ED1-A6001-1/ Transverse Indication

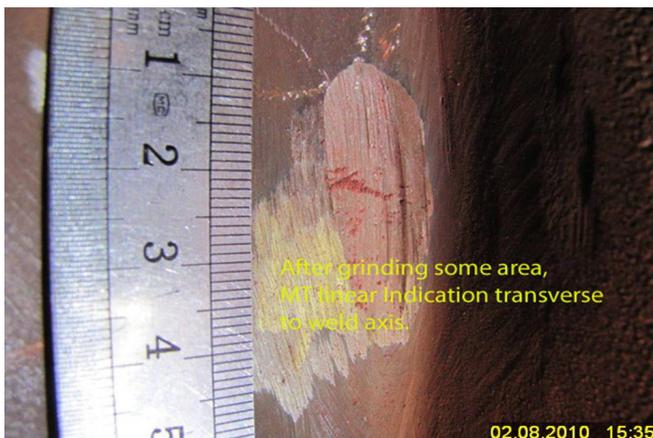
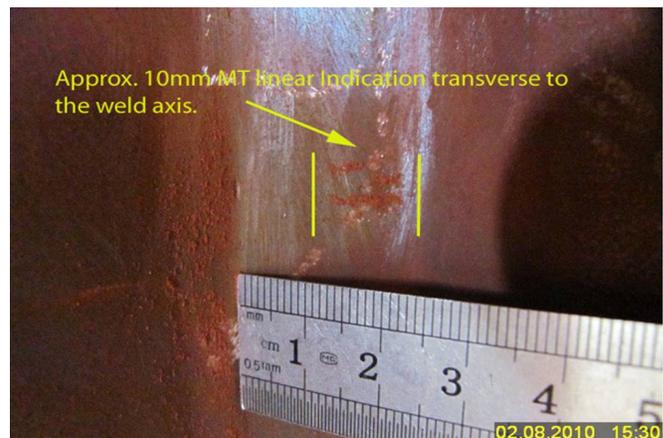
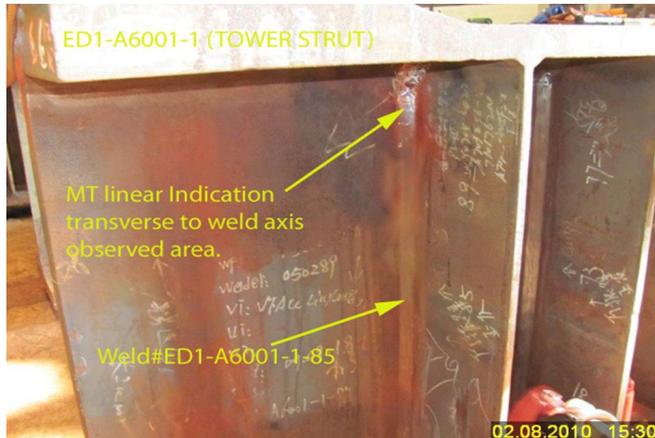
During the Quality Assurance (QA) Magnetic Particle Testing (MT) review of welds located in Tower Strut ED1-A6001-1, Caltrans QA discovered one (1) linear indication transverse to the weld axis measuring approximately 10mm in length.

- The weld is identified as: ED1-A6001-1-85.
- The weld is a fillet weld joining the web to stiffener.
- The material is designated as Seismic Performance Critical Member (SPCM)
- The member is located in Bay 10

The Notice of Witness Inspection Number (NWIT) is 005198. The indication is located on fillet weld area that has been previously tested and accepted by ZPMC Quality Control (QC) personnel. As per the contract documents, ZPMC's QC personnel are required to perform one hundred percent (100%) MT inspection of this weld.

Propose a resolution for this non-conformance that addresses the failure of Quality Control to identify the linear indication during magnetic particle testing of the welds. Provide documentation of the steps/actions taken by the Quality Control Manager to prevent future occurrences.

In addition to the Quality Control non-conformance, address the material/workmanship for the identified non-conformance including documentation that the deficiencies have been brought into compliance with the contract requirements. Additionally address the probable causes for the indications and the actions that will be taken to limit future occurrences.

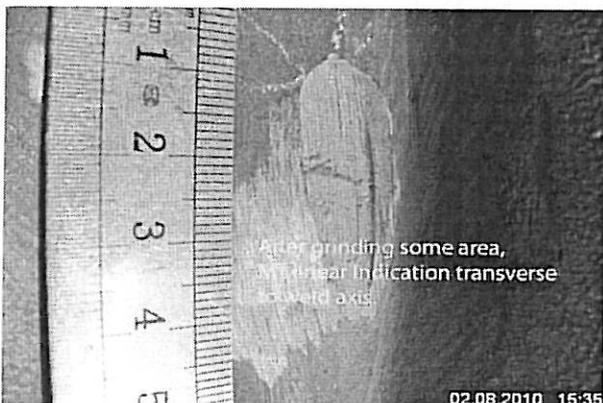
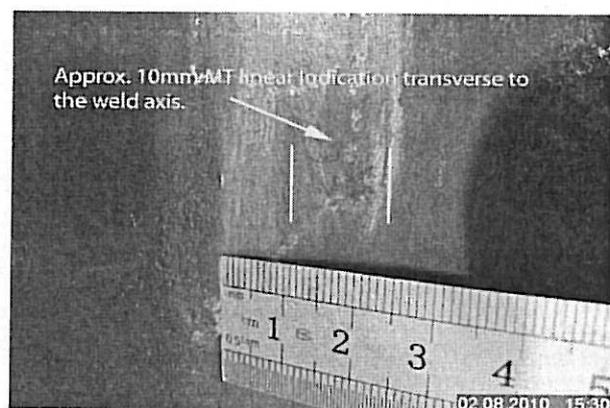
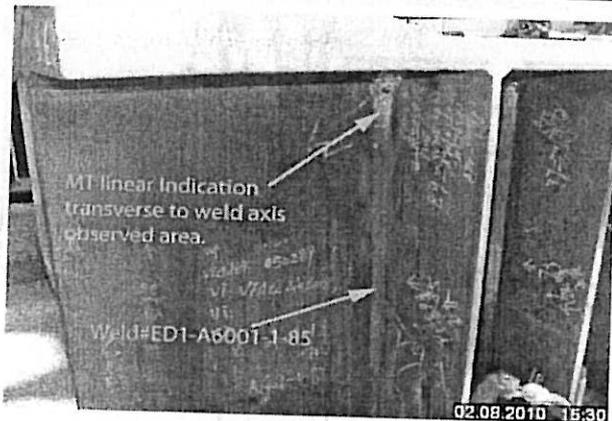
During the Quality Assurance (QA) Magnetic Particle Testing (MT) review of welds located in Tower Strut ED1-A6001-1, Caltrans QA discovered one (1) linear indication transverse to the weld axis measuring approximately 10mm in length.

-The weld is identified as: ED1-A6001-1-85.

-The weld is a fillet weld joining the web to stiffener.

The Notice of Witness Inspection Number (NWIT) is 005198. The indication is located on fillet weld area that has been previously tested and accepted by ZPMC Quality Control (QC) personnel. As per the contract documents, ZPMC's QC personnel are required to perform one hundred percent (100%) MT inspection of this weld.

Repair weld and verify with NDT

Weld ED1-A6001-1-85 was repaired (T-WR3066) and verified with 100% MT inspection (T787-MT-8027).

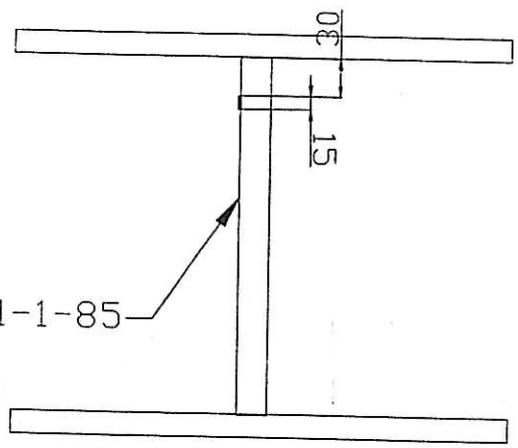
WELD NUMBER: ED1-A6001-1-85

One pore was found by use of MT on ED1-A6001-1-85.

- 1、 碳刨后,焊接接头没有有效打磨;
 - 2、 起弧和收弧没有交错布置,以将焊渣减少到最少;
 - 3、 焊道间没有有效的清理.
1. The weld joint was not ground sufficiently after arc-gouging.
 2. The arc starts and stops were not staggered to minimize slag entrapment.
 3. Interpass cleaning was not performed properly.

1. Grind repair area smoothly, VT to verify repair area is free of all defects.
2. QC will monitor and direct welder and grinder doing repair;
3. QC shall monitor all welding passes being deposited;
4. QC shall ensure all slag has been removed prior the deposition of next pass;
5. Preheat and maintain interpass temperature control in accordance with the WPS ;
6. Perform VT, MT and UT accordance with the drawing & contract requirements

- 1、碳刨后的接头位置打磨圆滑过渡，保证每道焊缝的接头可以交错布置；
 - 2、认真仔细检查每道焊缝和加强焊道的清理；
 3. 焊缝中所有的焊渣全部去除后，表面的缺陷全部打磨干净。
1. The joint shall be ground to a smooth transition to ensure that arc starts and stops are in a staggered Arrangement.
 2. QC shall inspect the weld passes more carefully and enforcing interpass cleaning.
 3. All weld slag shall be removed and surface defects ground during interpass cleaning.
