Quality Assurance and Source Inspection

Contract #: 04-0120F4Cty: SF/ALA Rte: 80 PM: 13.2/13.9File #: 69.25B**QUALITY ASSURANCE -- NON-CONFORMANCE REPORT****Location:** Changxing Island, Shanghai, P.R. China**Report No:** NCR-000678**Prime Contractor:** American Bridge/Fluor Enterprises, a JV**Date:** 09-Feb-2010**Submitting Contractor:** Zhenhua Port Machinery Company, Ltd (ZPMC), Changxing Island**NCR #:** ZPMC-0645**Type of problem:**

Reference Description: A few issues were noted for the weld build up on Lifts 6E and 6W Deck Panel Edges at bolted splice connection

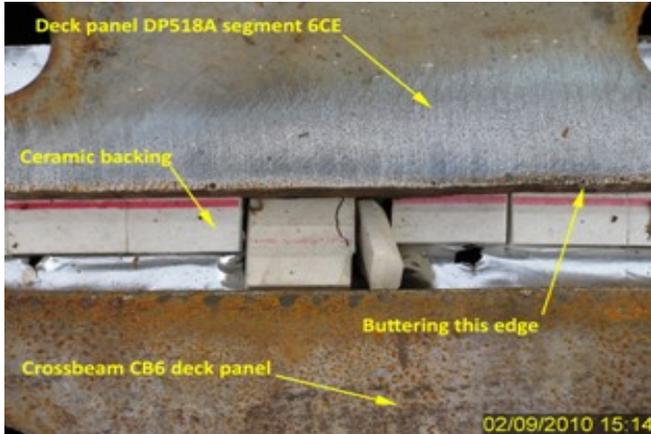
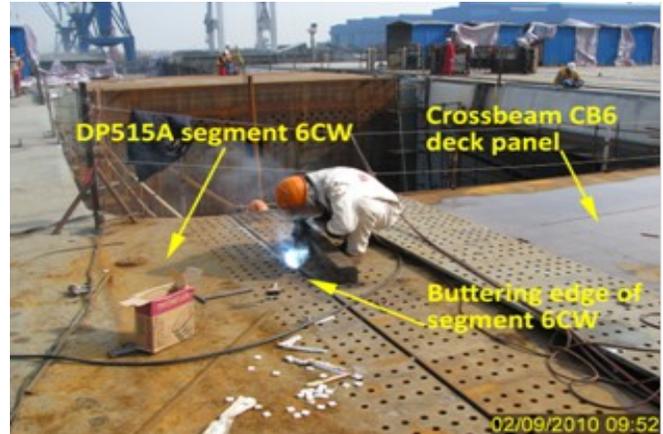
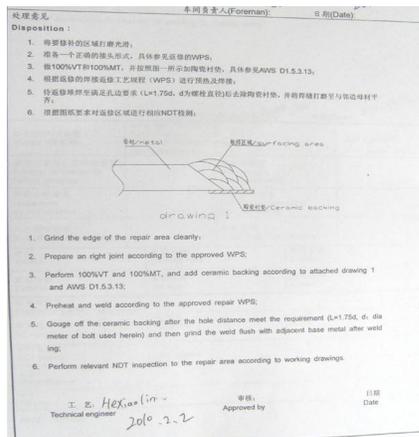
- ZPMC personnel are performing weld build up of the deck panel edge (DP515A and DP518A) by buttering. These edges are to be aligned adjacent to the CrossBeam6 deck panel for the bolted splice connection. The welding procedure was being performed without the prior Engineer's approval. Furthermore, ZPMC personnel did not follow the repair procedures noted in their internal documentation, weld repair report (B-WR 10561).

- Bevel angle noted in "drawing 1" in the disposition of the B-WR 10561 was not observed during the welding operation.
- The type and percentage of NDT inspection to be performed is not known as it is not specified clearly in note 6 of the disposition in B-WR 10561. Furthermore, it is noted that the working drawings do not have a specified weld detail or NDT requirement at this location.

- ZPMC welder performed FCAW of this edge with many times of stop and restart passes without cleaning the "crater area" of the weld prior to resuming the welding process.

AWS D1.5 2002 section 3.7.4 specifies “Prior approval of the Engineer shall be obtained for repairs to base metal (other than those required by 3.2), repair of major or delayed cracks, repairs to ESW and EGW welds with internal defects, or for a revised design to compensate for deficiencies.”

AWS D1.5 2002 section 3.11.1 “Before welding over previously deposited metal, all slag shall be removed and adjacent base metal shall be brushed clean. This requirement shall apply not only to successive layers but also to successive beads and to the crater area when welding is resumed after any interruption. ”

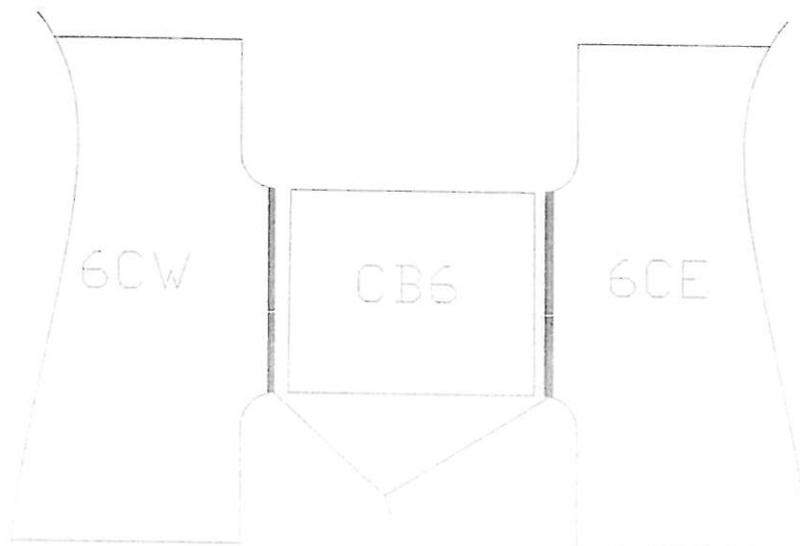
此两处需要堆焊

检查发现箱梁6CE、6CW与联系梁对接处,其顶板端口因孔边距不足,需堆焊处理。见附图:

After inspection box 6CE and 6CW and strut plate butt weld, the hole distance size wasn't enough and needed to build up. The detail sees following draft.

焊接变形和制造误差。

Weld distortion and fabricate error.

1. 将要修补的区域打磨光滑;
2. 准备一个正确的接头形式, 具体参见返修的WPS;
3. 做100%VT和100%MT, 并贴陶瓷衬垫, 具体参见AWS D1.5.3.13;
4. 根据返修的焊接返修工艺规程(WPS)进行预热及焊接;
5. 待返修堆焊至满足孔边要求 ($L=1.75d$, d 为螺栓直径)后去除陶瓷衬垫, 并将焊缝打磨至与邻边母材平齐;
6. 根据图纸要求对返修区域进行相应NDT检测;

1. Grind the edge of the repair area cleanly;
2. Prepare an right joint according to the approved WPS;
3. Perform 100%VT and 100%MT, and add ceramic backing according to AWS D1.5.3.13;
4. Preheat and weld according to the approved repair WPS;
5. Gouge off the ceramic backing after the hole distance meet the requirement ($L=1.75d$, d : dia meter of bolt used herein) and then grind the weld flush with adjacent base metal after welding;
6. Perform relevant NDT inspection to the repair area according to working drawings.
