## QUALITY ASSURANCE -- NON-CONFORMANCE REPORT

**Report No:** NCR-000679

**Reference Description:** ZPMC performed a non-approved tack welding of scaffolding to the OBG Segment 7DW Side Panel

**Job Name:** SAS Superstructure  
**Document No:** 05.03.06-000636

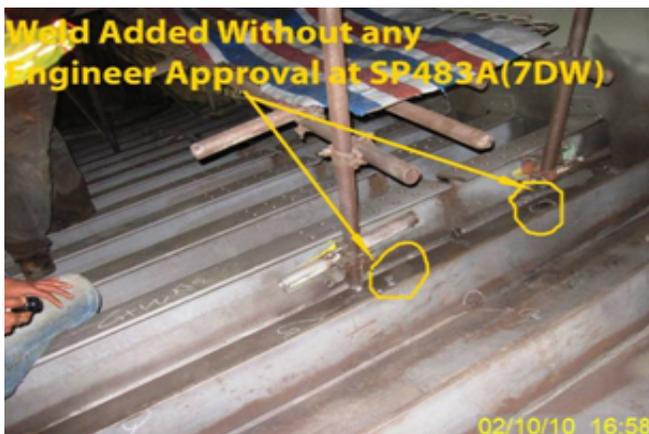
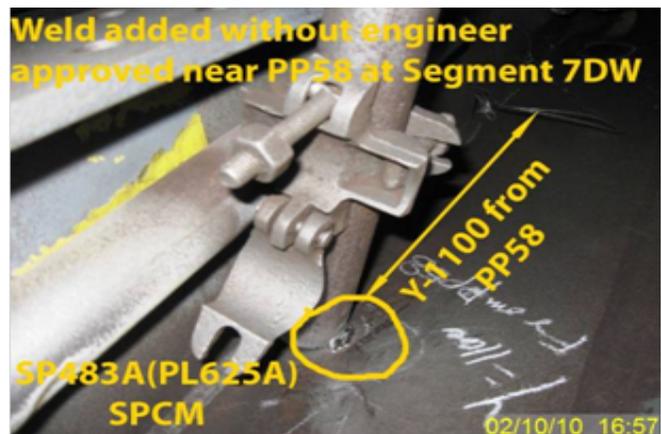
- ZPMC has temporarily tack welded 2 scaffolding legs to a Seismic Performance Critical Member (see pictures for reference).
- The approved shop drawings do not specify any welds in these areas.
- The size and length of the tack welds do not meet the requirements of AWS D1.5 2002, table 12.2.
- The member is a side panel identified as: SP483A.
- The Side panel is designated on the approved shop drawings as (SPCM).
- The Side panel is located between panel point PP057 and PP058 on the Cross Beam side.
- The location of the temporary tack welds are 340mm and 1100mm from PP058.
- The material composition of the scaffolding being welded to the side panel is not known.
- OBG Segment 7DW is located inside the Blast Shop.

AWS D1.5-2002 Table 12.2 specifies tack welds outside the joint shall be a minimum of 75mm in length and refers to footnote 3 which specifies "tack welds outside the joint shall require the Engineers approval."

The areas where unidentified material was tacked welded shall be ground out such that any impurities introduced are removed. MT should then be performed and the base metal repaired per approved methods. Additionally, a description of the measures being taken to ensure that similar non-conformances do not occur in the future.

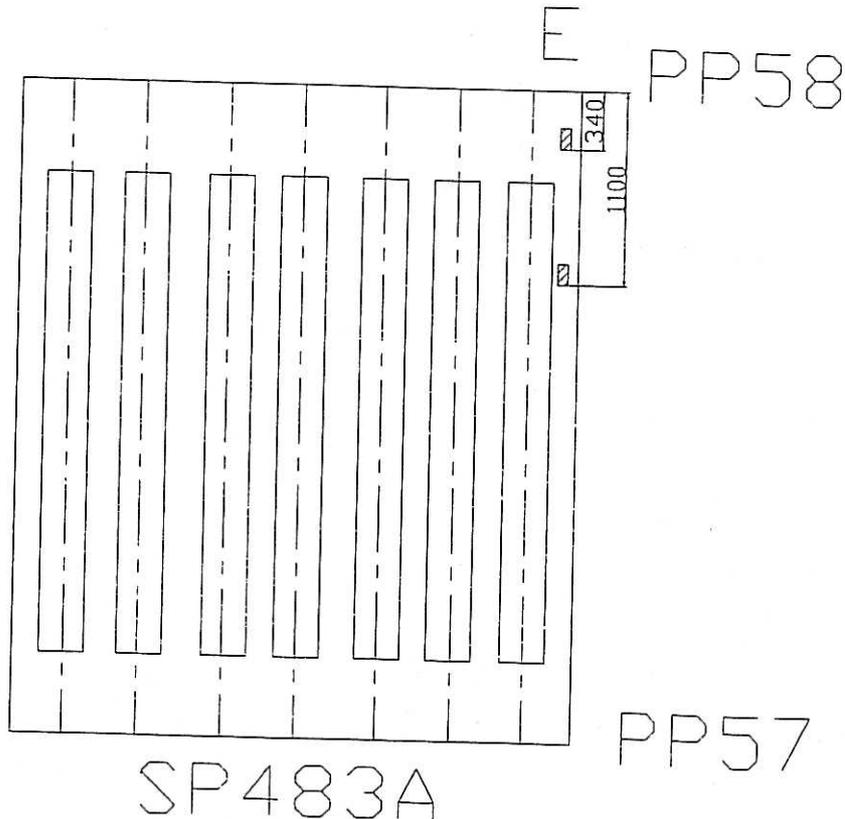
**Draft of welding discontinuity:**

There are two unacceptable tack welds between SP483A and the bracket of scaffold in segment 7DW, which need to be removed and repair again.

Worker operated error.

1. Remove the repair area including unknown base metal mentioned above away by the way of grinding, and grind the repair area cleanly;
2. Perform 100%VT and MT to the repair area to make sure no defects exist;
3. Preheat and weld according to the relevant WPS;
4. Grind the welds to flush with the adjacent base metal;
5. Perform relevant NDT inspection to the repair welds according to the working drawings.
