Contract #: 04-0120F4
 Cty: SF/ALA Rte: 80 PM: 13.2/13.9
 File #: 69.25B

QUALITY ASSURANCE -- NON-CONFORMANCE REPORT

Report No: NCR-000681

Reference Description: Side Panel to Open Rib Stiffener welds

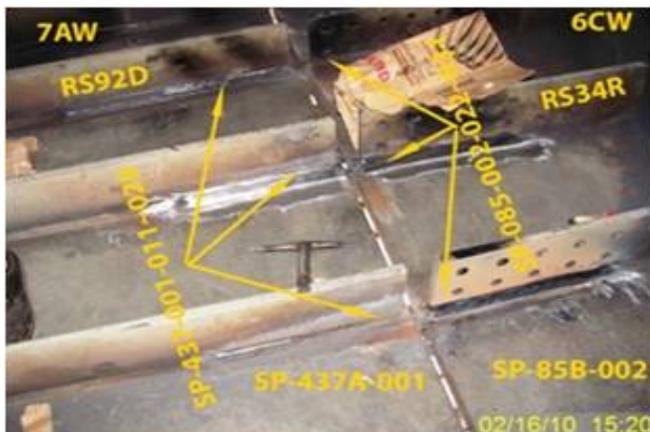
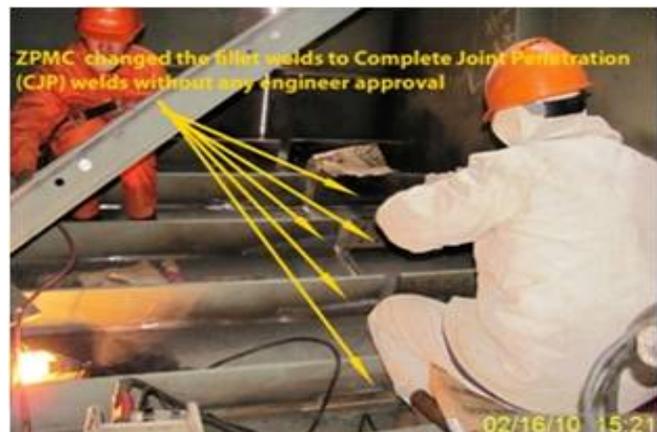
During random in-process inspection of Orthotropic Box Girder (OBG) segments 6CW and 7AW, this Quality Assurance Inspector (QA) discovered the following issues:

- ZPMC has deviated from the approved weld joint design without the Engineers approval.
 - ZPMC personnel installed Complete Joint Penetration (CJP) welds in lieu of fillet welds as detailed on approved shop drawings SP085 and SP437.
 - The affected joints in segment 6CW are identified as SP085-002-022~031.
 - The affected joints in segment 7AW are identified as SP437-001-011~020.
 - The welds are located in between Panel Point 47 (PP47) and PP48 on the Crossbeam side.
 - The welds in question are at the hold back locations joining RS34R Open Rib Stiffeners to Side Panel SP085B-002 on segment 6CW, and the RS92D Open Rib Stiffeners to Side Panel SP437A-001 on segment 7AW.
 - OBG Segments 6CW and 7AW are located in the OBG Trial Assembly Yard.
- For further information, please see the pictures below.

AWS D1.5-2002 section 6.5.1; “The Inspector shall make certain that the size, length, and location of all welds conform to the requirements of this code and to the detail drawings and that no unspecified welds have been added without approval”.

AWS D1.5 2002 section 3.7.4 “Prior approval of the Engineer shall be obtained for repairs to base metal (other than those required by 3.2), repair of major or delayed cracks, repairs to ESW and EGW welds with internal defects, or for a revised design to compensate for deficiencies.”

Reference Resolution: ZPMC has received approval to change the weld joints into complete joint penetration welds. Attached is NDT documentation to show that the welds are acceptable.

ZPMC has received approval to change the weld joints into complete joint penetration welds. Attached is NDT documentation to show that the welds are acceptable. Based on this ZPMC requests closure of this NCR.

Contractor submitted request to change joint type after work was complete, and supplied post repair NDT reports verifying the welds in question are in conformance with the Contract weld quality requirements.

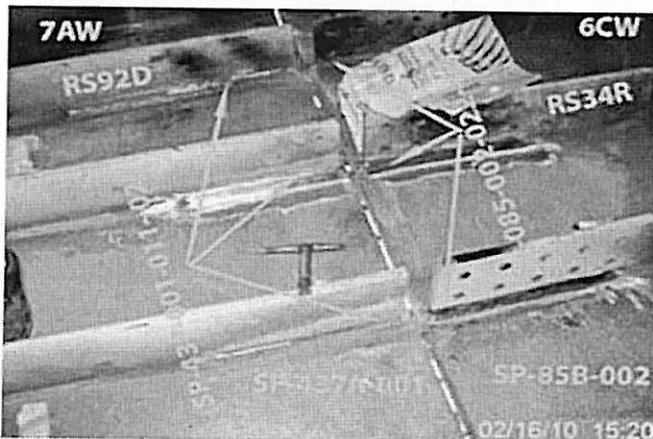
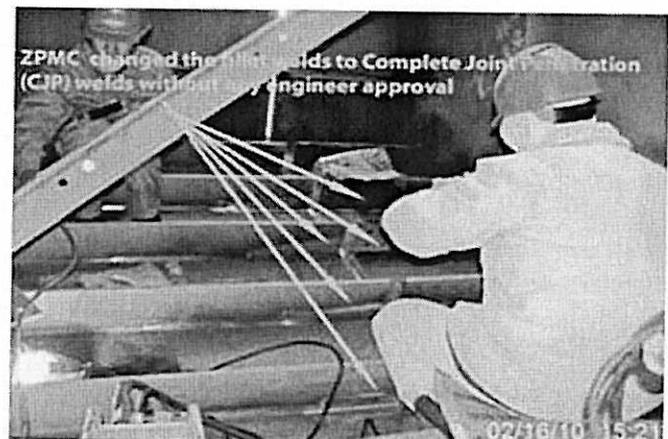
During random in-process inspection of Orthotropic Box Girder (OBG) segments 6CW and 7AW, this Quality Assurance Inspector (QA) discovered the following issues:

- ZPMC has deviated from the approved weld joint design without the Engineers approval.
- ZPMC personnel installed Complete Joint Penetration (CJP) welds in lieu of fillet welds as detailed on approved shop drawings SP085 and SP437.
- The affected joints in segment 6CW are identified as SP085-002-022~031.
- The affected joints in segment 7AW are identified as SP437-001-011~020.
- The welds are located in between Panel Point 47 (PP47) and PP48 on the Crossbeam side.
- The welds in question are at the hold back locations joining RS34R Open Rib Stiffeners to Side Panel SP085B-002 on segment 6CW, and the RS92D Open Rib Stiffeners to Side Panel SP437A-001 on segment 7AW.
- OBG Segments 6CW and 7AW are located in the OBG Trial Assembly Yard.

AWS D1.5-2002 section 6.5.1; "The Inspector shall make certain that the size, length, and location of all welds conform to the requirements of this code and to the detail drawings and that no unspecified welds have been added without approval".

AWS D1.5 2002 section 3.7.4 "Prior approval of the Engineer shall be obtained for repairs to base metal (other than those required by 3.2), repair of major or delayed cracks, repairs to ESW and EGW welds with internal defects, or for a revised design to compensate for deficiencies."

Document locations of weld type changes and perform NDT required to verify weld quality.
