Contract #: 04-0120F4  
 Cty: SF/ALA Rte: 80 PM: 13.2/13.9  
 File #: 69.25B

## QUALITY ASSURANCE -- NON-CONFORMANCE REPORT

**Report No:** NCR-000685

**Reference Description:** The welder was not using his qualified weld process/position while performing base metal repairs on Segment 8AE Deck Panel

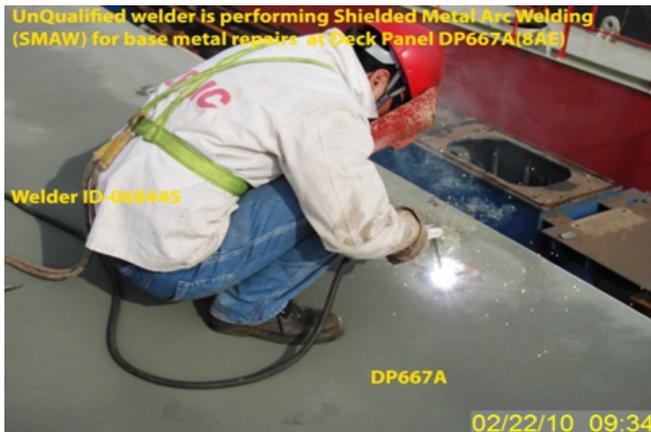
- Welder was not qualified to perform base metal repairs in this process/position.
- Repairs being performed using the Shielded Metal Arc Welding (SMAW) process.
- The welder is qualified for Flux Cored Arc Welding (FCAW) only.
- The welder is identified as Mr. Wang Zhao Cong (068445).
- The base metal repairs were being performed at temporary attachment removal sites on the deck panel near the bike path side.
- The plate identifications under repair are identified as:
- DP667A, Plate number-PL1376A and DP470A, Plate number-PL436C.
- During the repair, Quality Control (QC) Inspector could not provide a weld repair report (WRR) for the repairs.
- OBG Segment 8AE is currently located outside the north end of bay 19.

AWS D1.5/2002, Section 5.24.1.2: "A welder, welding operator, or tack welder shall be qualified for each process used."

Propose a resolution for the identified non-conformance with revised procedures to prevent future occurrences. Provide NDT report indicating acceptability of the repair. A response for the resolution of this issue is expected within days.

**Reference Resolution:** ZPMC has written an internal NCR and removed the welds in question. ZPMC is providing the NDT to show that the welds are acceptable, based on this ZPMC requests closure of this NCR.

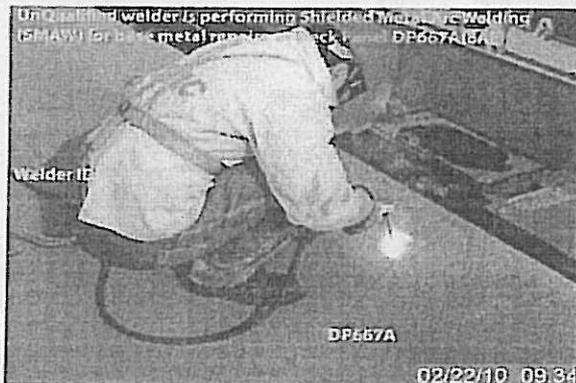
- Welder was not qualified to perform base metal repairs in this process/position.
- Repairs being performed using the Shielded Metal Arc Welding (SMAW) process.
- The welder is qualified for Flux Cored Arc Welding (FCAW) only.
- The welder is identified as Mr. Wang Zhao Cong (068445).
- The base metal repairs were being performed at temporary attachment removal sites on the deck panel near the bike path side.
- The plate identifications under repair are identified as:
  - DP667A, Plate number-PL1376A and DP470A, Plate number-PL436C. WR11053
- During the repair, Quality Control (QC) Inspector could not provide a weld repair report (WRR) for the repairs.
- OBG Segment 8AE is currently located outside the north end of bay 19.

AWS D1.5/2002, Section 5.24.1.2: "A welder, welding operator, or tack welder shall be qualified for each process used."

Remove said weld and have qualified personnel replace it.

Weld was removed and replaced by welder qualified for the applicable position and process. The Contractor issued an internal NCR regarding this matter and supplied NDT documentation verifying the weld meets Contract weld quality requirements.

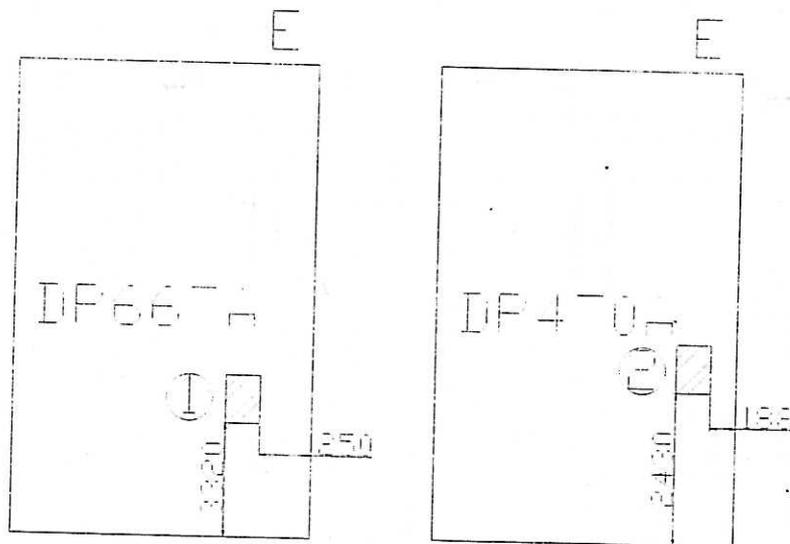
Draft of welding discontinuity:

After inspection 8AE box deck plate DP667/DP470A, repair base metal didn't according to technology procedure, and remove unaccepted weld and repair, 1. L=24mm 2. L=18mm, the detail position sees the following draft.

Worker operated error caused base metal gouged.

1. QC and CWI should be present to witness the repair, direct and supervise all repair operations during this repair to ensure the repair is per the disposition requirements, and the AWS D1.5 code requirements.
2. Grind the repair area to a smooth finish according to the approved repair WPS.
3. Prepare the joint according to the approved WPS.
4. Notify QA verbally prior to NDT. Perform 100%MT and 100%VT of the repair area.
5. Remove all defects by grinding to ensure all defects are completely removed if defects still exist, and repeat "step 4" to assure complete removal of all defects if necessary.
6. Clean the repair area of all loose debris including MT powder.
7. Preheat and weld according to the approved WPS.
8. Grind the weld flush after welding.
9. Notify QA verbally prior NDT. Perform 100%MT and 100%VT of the repair area.

**Train and educate operator to improve operation skill.**
 车间负责人(Foreman): *Li Zhigan* 日期(Date): *10.03.15*
