Contract #: 04-0120F4
 Cty: SF/ALA Rte: 80 PM: 13.2/13.9
 File #: 69.25B

QUALITY ASSURANCE -- NON-CONFORMANCE REPORT

Report No: NCR-000688

Reference Description: OBG Segment 6AE FL3 at PP39 was damaged during the transportation of the Crossbeam

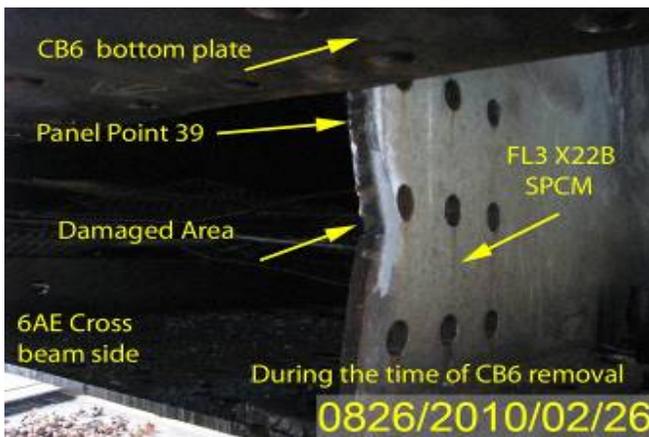
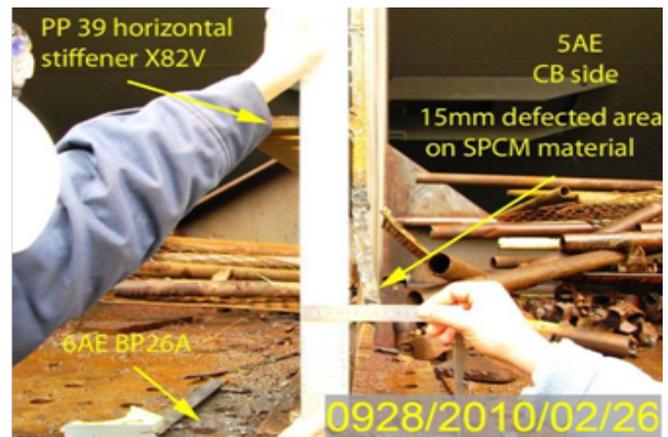
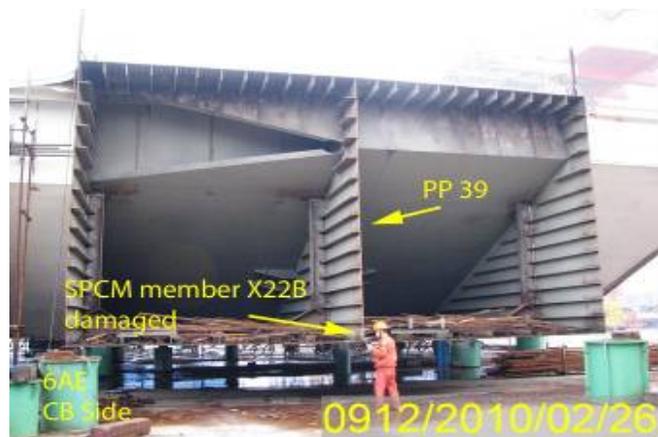
- One (1) damaged/bent FL3 plate member damaged at panel point (PP) 39 at Segment 6AE.
- The damaged plate is designated as X22B
- Length of deflected area is over approximately 250mm in length at the lower portion of the plate.
- The maximum deflection of 15mm is measured using a 1000mm straight edge.
- The steel material is designated as Seismic Performance Critical Member (SPCM).
- The OBG 6AE segment is located at the Trial Assembly yard.

-Standard Specifications July 1999, Section 55-1.04; "In handling of the steel work, every care shall be taken to avoid bending, scraping or overstressing the pieces. All pieces bent or otherwise injured will be rejected."

-Standard Specifications July 1999, Section 55-3.09; "Finished members shall be true to line and free from twists, bends and open joints."

ZPMC has repaired the floorbeam with heat straightening and is providing the heat straightening report used and the hardness testing results after to show that the base metal is acceptable. These results have been accepted my CT METS. Based on this ZPMC requests closure of this NCR.

ZPMC performed heat straightening and has fixed the deflection on FL3. Due to the heat straightening procedure was rejected by engineer and to verify the base metal's soundness, hardness testing was performed. After verification by hardness testing the base metal was found to be acceptable by QCM. ZPMC is providing the HSR and hardness testing result, requests this NCR to be closed.

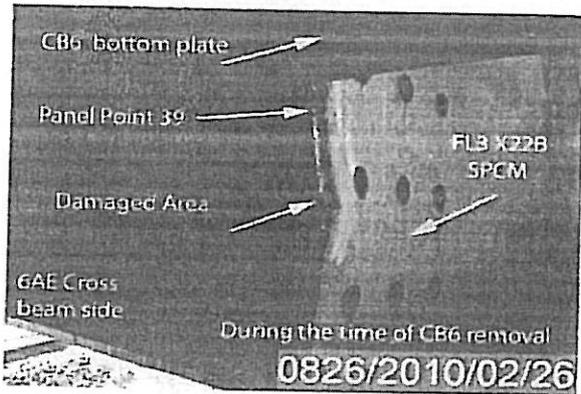
- One (1) damaged/bent FL3 plate member damaged at panel point (PP) 39 at Segment 6AE.
- The damaged plate is designated as X22B
- Length of deflected area is over approximately 250mm in length at the lower portion of the plate.
- The maximum deflection of 15mm is measured using a 1000mm straight edge.
- The steel material is designated as Seismic Performance Critical Member (SPCM).
- The OBG 6AE segment is located at the Trial Assembly yard.

-Standard Specifications July 1999, Section 55-1.04; "In handling of the steel work, every care shall be taken to avoid bending, scraping or overstressing the pieces. All pieces bent or otherwise injured will be rejected."

-Standard Specifications July 1999, Section 55-3.09; "Finished members shall be true to line and free from twists, bends and open joints."

Contractor provided results of hardness tests verifying material affected by heat straightening conforms with Contract hardness requirements.

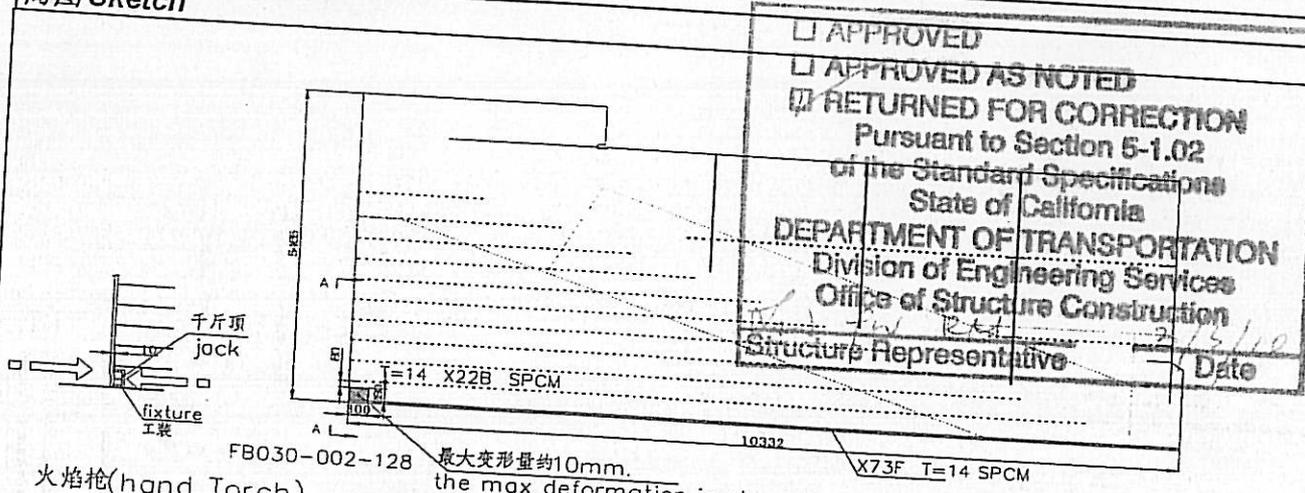
Cause 原因: Welding distortion 焊接变形

Type of Defect 缺陷类型: Welding distortion 焊接变形

FB030-002-128 最大变形量约 10mm.
 the max deformation is about 10mm.
 注: 最大变形量约 10mm, 用千斤顶将焊接变形量顶到位, 固定不动, 再进行火工校正。
 NOTE: the max deformation is about 10mm, Correct the welding distortion by use of jacking, and then perform heat straightening with the jack still on the flange plate.

缺陷去除方法 (Defect Removal Method): Flame Straightening by oxygen acetylene 运用氧乙炔进行校火

Jacking shall not be used to plastically deform the flange. The Jack shall only be used as a fixture. The weld of the heat area shall perform 100%VT, MT, UT after finishing heat straightening, according to the approved shop drawing. 不能使用千斤顶进行塑性变形。千斤顶只能用作固定装置。校火后需按照图纸上的要求对热影响区域进行 100%VT, MT, UT 检测。

Increase the flange anti-deformation allowance during the course of fit-up, and Control the welding parameters according to associated WPS. 在装配的过程中增加反变形余量。根据相关 WPS 控制焊接参数。

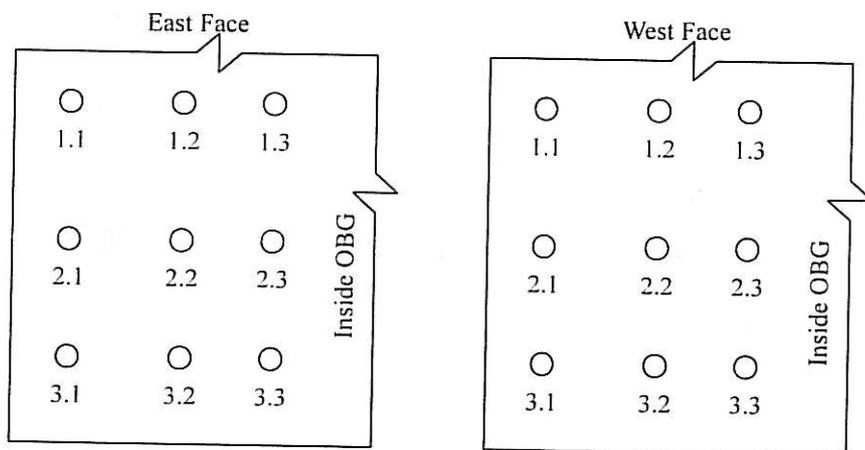
Sketch 3 Hardness Location Points

6E FL3 Hardness Test Result						
Hardness Tester Type: TH140						
Location	6E FL3 (East Face)			6E FL3 (West Face)		
	X	Y	Hardness	X	Y	Hardness
1.1	29cm	5cm	143 HB	29cm	5cm	143 HB
1.2	18cm	12.5cm	190 HB	18cm	12.5cm	159 HB
1.3	6.5cm	21cm	162 HB	6.5cm	21cm	175 HB
2.1	29cm	5cm	153 HB	29cm	5cm	151 HB
2.2	18cm	12.5cm	155 HB	18cm	12.5cm	180 HB
2.3	6.5cm	21cm	153 HB	6.5cm	21cm	174 HB
3.1	29cm	5cm	197 HB	29cm	5cm	154 HB
3.2	18cm	12.5cm	176 HB	18cm	12.5cm	170 HB
3.3	6.5cm	21cm	176 HB	6.5cm	21cm	160 HB
