**DEPARTMENT OF TRANSPORTATION**

Contract #: 04-0120F4Cty: SF/ALA Rte: 80 PM: 13.2/13.9File #: 69.25B**QUALITY ASSURANCE -- NON-CONFORMANCE REPORT****Location:** Changxing Island, Shanghai, P.R. China**Report No:** NCR-000689**Prime Contractor:** American Bridge/Fluor Enterprises, a JV**Date:** 27-Feb-2010**Submitting Contractor:** Zhenhua Port Machinery Company, Ltd (ZPMC), Changxing Island**NCR #:** ZPMC-0656**Type of problem:**

**Reference Description:** Missed MT Transverse Indications by QC on the LD to FB weld splice on Segment 6BE

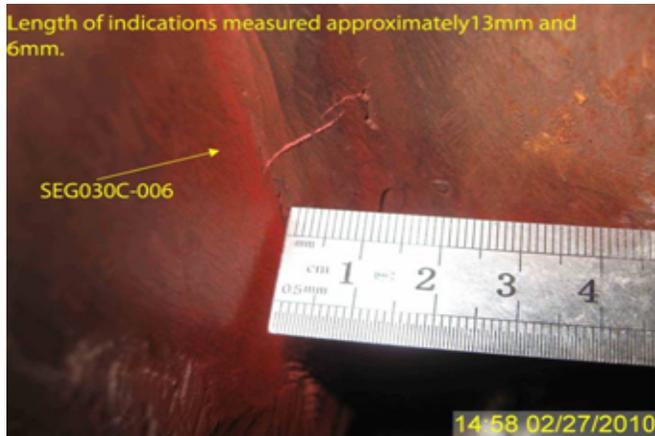
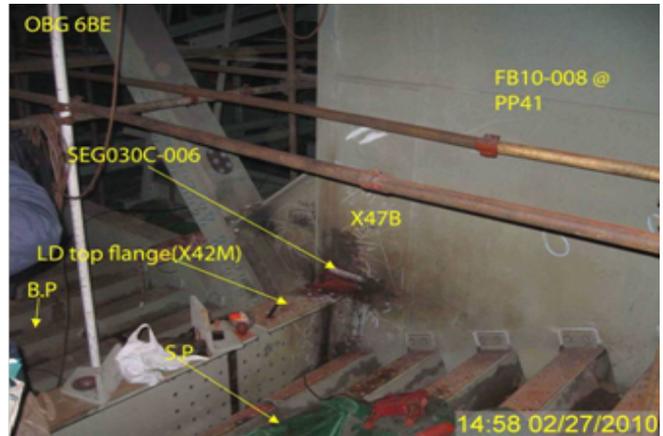
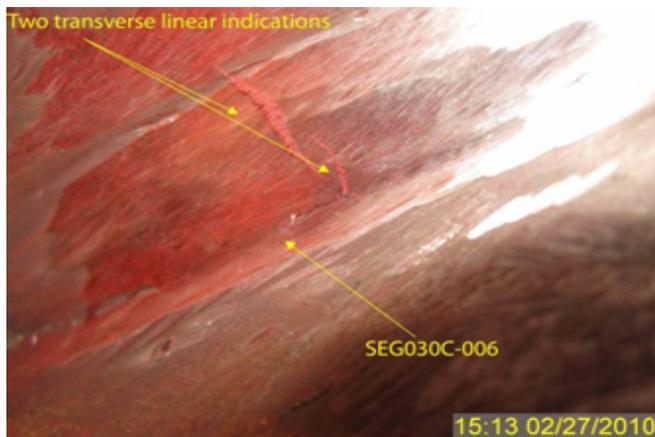
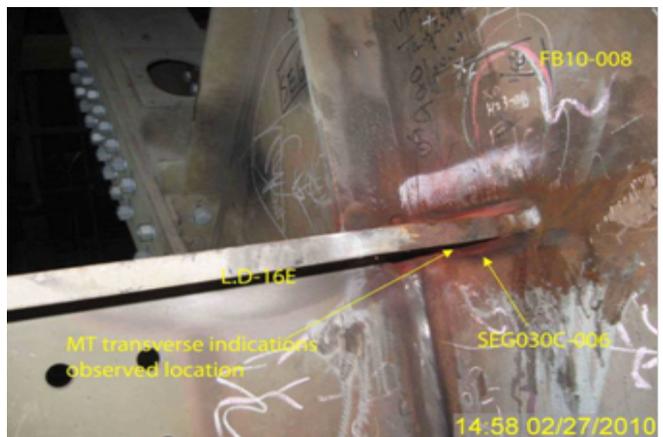
During the Quality Assurance (QA) Magnetic Particle (MT) testing review of welds located on OBG Segment 6BE, this QA Inspector discovered the following issue:

- Two (2) Transverse linear indications in the Longitudinal Diaphragm 16E flange (X42M), CJP attachment to panel point 41 Floor Beam web (X47B).
- The indications are located at Y locations 110 and 115 respectively when measures from the leading edge of the flange.
- The weld designation is SEG030C-006
- The transverse indications are clearly marked on the weld.
- Length of indications measured approximately 13mm and 6mm.
- The weld was previously cut apart and re-welded due to issues with fit up.
- The OBG segment 6BE is located in the trail assembly.
- The Notice of Witness Inspection Number (NWIT) is 005237. The indication is located inside the area that has been previously tested and accepted by ZPMC Quality Control (QC) personnel. As per the contract documents, ZPMC QC personnel are required to perform 100% Magnetic particle inspection of these welds.

AWS D1.5 (02) Section 6.26.2 – “Welds that are subject to MT in addition to visual inspection shall have no cracks.

Propose a resolution for the identified non-conformance with revised procedures to prevent future occurrences and repair the indications per contract requirements and submit required repair documentation including passing NDT for the Engineer's review. A response for the resolution of this issue is expected within 7 days.

**Reference Resolution:** ZPMC has repaired the missed indication and is providing NDT documentation to show that it is acceptable.

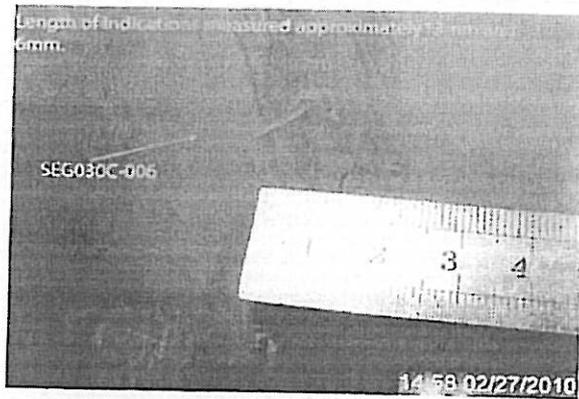
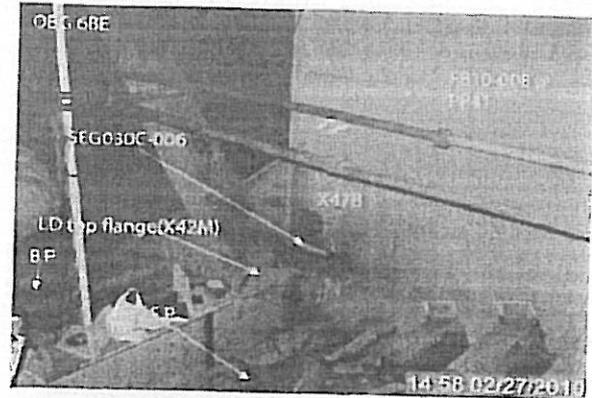
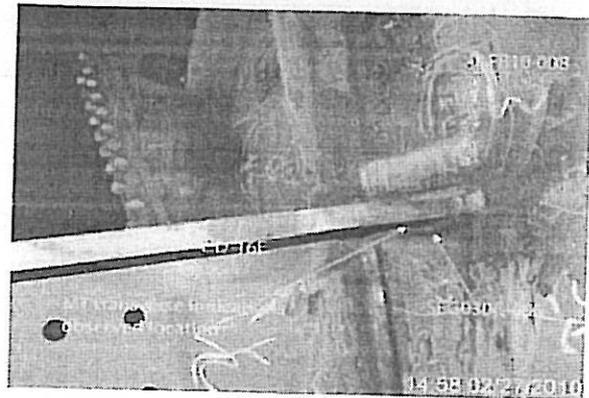
During the Quality Assurance (QA) Magnetic Particle (MT) testing review of welds located on OBG Segment 6BE, this QA Inspector discovered the following issue:

- Two (2) Transverse linear indications in the Longitudinal Diaphragm 16E flange (X42M), CJP attachment to panel point 41 Floor Beam web (X47B).
- The indications are located at Y locations 110 and 115 respectively when measures from the leading edge of the flange.
- The weld designation is SEG030C-006
- The transverse indications are clearly marked on the weld.
- Length of indications measured approximately 13mm and 6mm.
- The weld was previously cut apart and re-welded due to issues with fit up.
- The OBG segment 6BE is located in the trail assembly.
- The Notice of Witness Inspection Number (NWIT) is 005237. The indication is located inside the area that has been previously tested and accepted by ZPMC Quality Control (QC) personnel. As per the contract documents, ZPMC QC personnel are required to perform 100% Magnetic particle inspection of these welds.

AWS D1.5 (02) Section 6.26.2 – “Welds that are subject to MT in addition to visual inspection shall have no cracks.

Repair said indications and perform NDT required to verify weld quality.

Contractor supplied post repair NDT reports verifying welds are now in conformance with Contract specifications.
